## Main Inspections Small Photos

Mainline ID: <b>CCC00010_P1_C15</b>	City: <b>YOUNGSTOWN</b>	Street: <b>MEADOW BROOK AVE</b>	Project name: <b>071520.201076.ABC STORMWATER.CTV.1123</b>
Start date/time: <b>7/15/2020 11:15 AM</b>	Total length:	Weather: <b>1</b>	Surveyed by: <b>JHIPC</b>
Upstream MH No: <b>CC00010_P1_M15</b>	Depth US: <b>8.4 ft.</b>	Downstream MH No: <b>CC00010_P1_M16</b>	Depth DS:
Shape: <b>C</b>	Material: <b>CMP</b>	Height: <b>60 in.</b>	Width: <b>60 in.</b>
Customer: <b>ABC</b>	Owner: <b>ABC</b>	Sewer use: <b>SW</b>	Lining method:
Length surveyed: <b>572.3 ft.</b>	Purpose: <b>F</b>	Media label:	Pre-cleaning: <b>J</b>
Additional info:

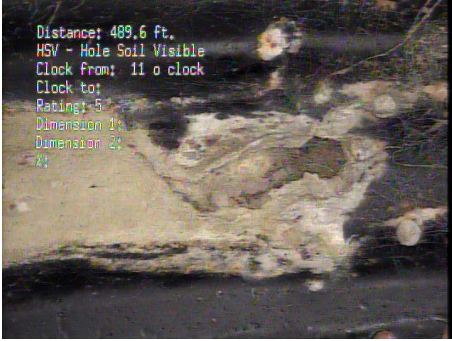
Distance	Dir.	Code	Description	Cont. From/To	%	Joint Rating	Remarks
489.6 ft.	D	HSV	Hole Soil Visible	11 /		<input type="checkbox"/> 5

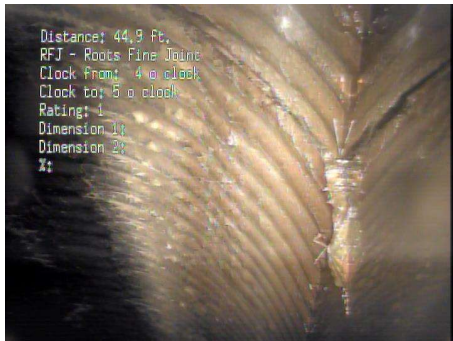
Distance	Dir.	Code	Description	Cont.	From/To	%	Joint	Rating	Remarks
0.0 ft.	D	AMH	Manhole		/		<input type="checkbox"/>		CC00010_P1_M16
0.0 ft.	D	MWL	Water Level		/	10	<input type="checkbox"/>		
44.9 ft.	D	RFJ	Roots Fine Joint		4 / 5		<input checked="" type="checkbox"/>	<b>1</b>

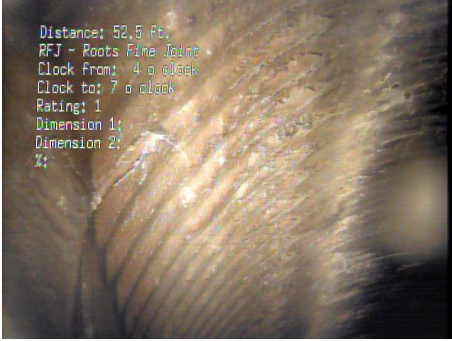
Distance	Dir.	Code	Description	Cont.	From/To	%	Joint	Rating	Remarks
52.5 ft.	D	RFJ	Roots Fine Joint		4 / 7		<input checked="" type="checkbox"/>	1

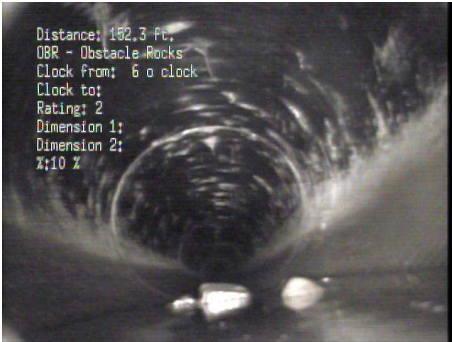
152.3 ft.	D	OBR	Obstacle Rocks		6 /	10	<input type="checkbox"/>	2

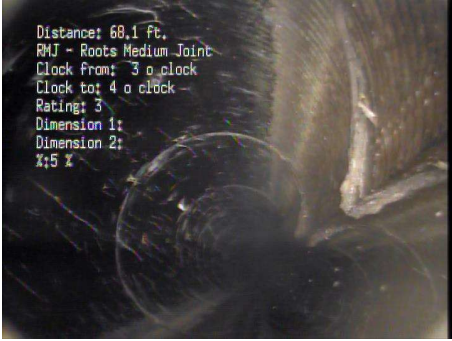
Distance	Dir.	Code	Description	Cont.	From/To	%	Joint	Rating	Remarks
68.1 ft.	D	RMJ	Roots Medium Joint	S02	3 / 4	5	<input checked="" type="checkbox"/>	3

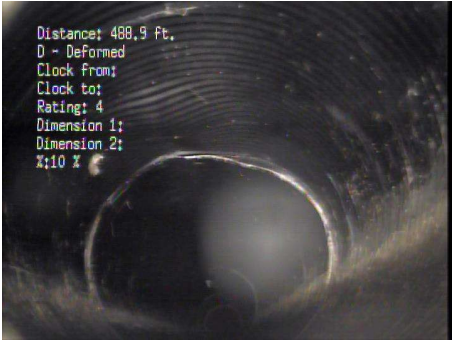
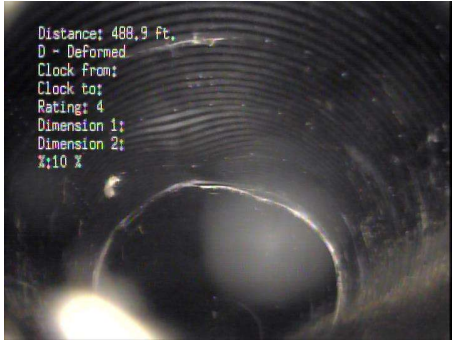
88.9 ft.	D	RMJ	Roots Medium Joint	F02	3 / 4	5	<input checked="" type="checkbox"/>	3	
88.9 ft.	D	OBR	Obstacle Rocks	F01	8 /	10	<input type="checkbox"/>	2	
139.9 ft.	D	LL	Alignment Left		/	20	<input type="checkbox"/>	2	
147.8 ft.	D	TBI	Tap Break-in Intruding		2 /		<input type="checkbox"/>	2	
199.7 ft.	D	OBR	Obstacle Rocks		5 / 7	5	<input type="checkbox"/>	2	
488.9 ft.	D	D	Deformed		/	10	<input type="checkbox"/>	4

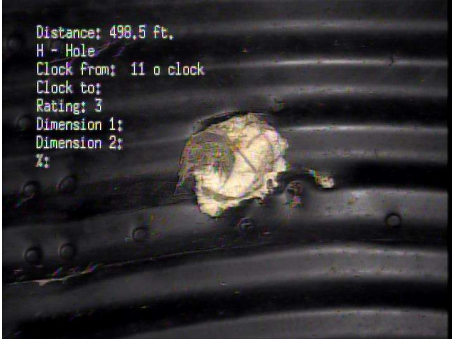
498.5 ft.	D	H	Hole		11 /		<input type="checkbox"/>	3

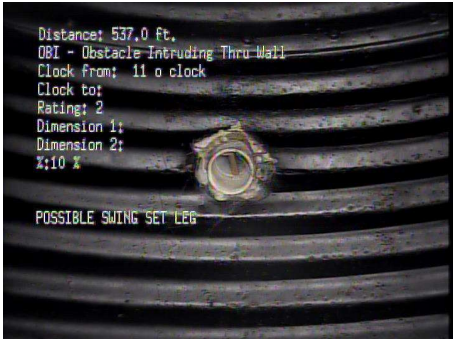
Distance	Dir.	Code	Description	Cont.	From/To	%	Joint	Rating	Remarks
506.3 ft.	D	OBR	Obstacle Rocks		6 /	10	<input type="checkbox"/>	2	
537.0 ft.	D	H	Hole		11 /		<input type="checkbox"/>	3	
537.0 ft.	D	OBI	Obstacle Intruding Thru Wall		11 /	10	<input type="checkbox"/>	2	POSSIBLE SWING SET LEG

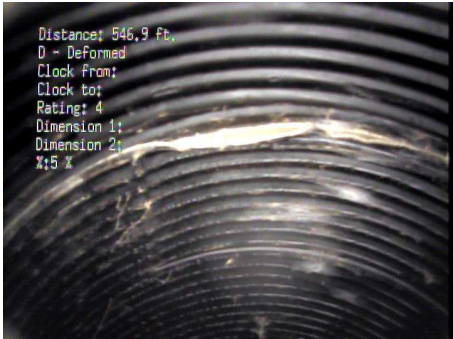
546.9 ft.	D	D	Deformed		/	5	<input type="checkbox"/>	4

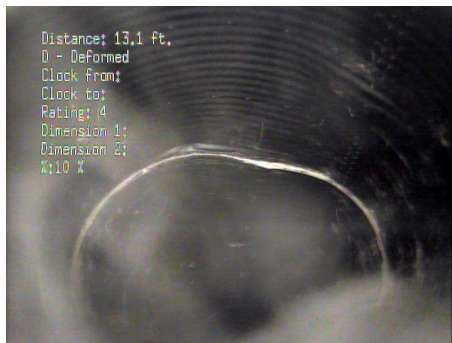
Distance	Dir.	Code	Description	Cont.	From/To	%	Joint	Rating	Remarks
0.0 ft.	D	AMH	Manhole		/		<input type="checkbox"/>		CC00010_P1_M16
0.0 ft.	D	MWL	Water Level		/	15	<input type="checkbox"/>		
13.1 ft.	D	D	Deformed		/	10	<input type="checkbox"/>	4

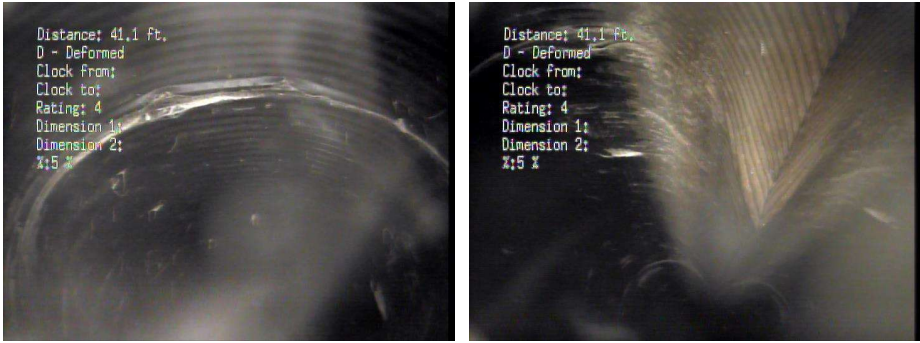
Distance	Dir.	Code	Description	Cont.	From/To	%	Joint	Rating	Remarks	
41.1 ft.	D	D	Deformed		/	5	<input type="checkbox"/>	4

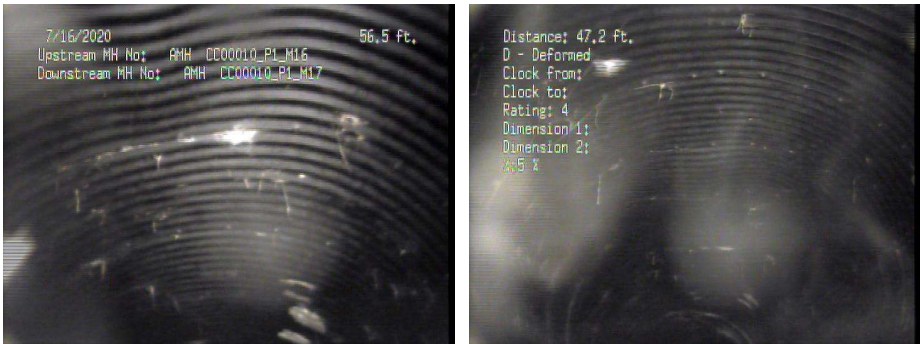
47.2 ft.	D	D	Deformed	S01	/	5	<input type="checkbox"/>	4

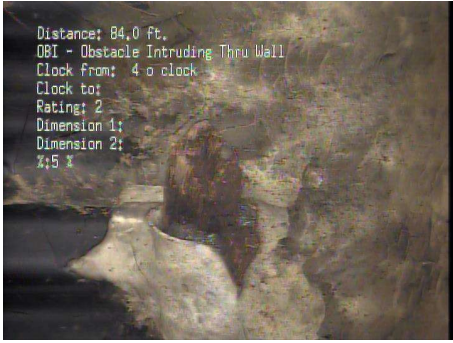
84.0 ft.	D	H	Hole		4 /		<input type="checkbox"/>	3		
84.0 ft.	D	OBI	Obstacle Intruding Thru Wall		4 /	5	<input type="checkbox"/>	2

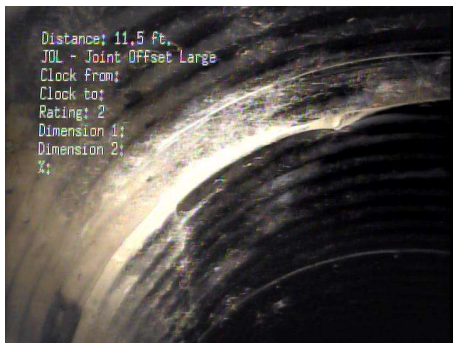
Distance	Dir.	Code	Description	Cont.	From/To	%	Joint	Rating	Remarks
0.0 ft.	U	AMH	Manhole		/		<input type="checkbox"/>		CC00010_P10_M17
0.0 ft.	U	MWL	Water Level		/	10	<input type="checkbox"/>		
11.5 ft.	U	JOL	Joint Offset Large		/		<input type="checkbox"/>	2

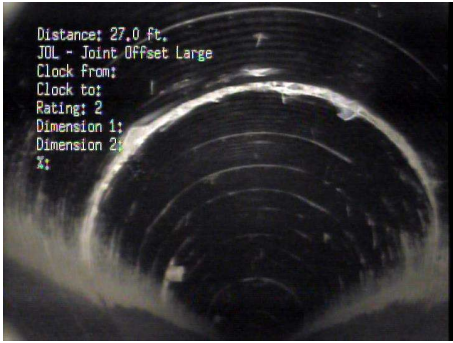
Distance	Dir.	Code	Description	Cont. From/To	%	Joint Rating	Remarks
27.0 ft.	U	JOL	Joint Offset Large	/		<input type="checkbox"/> 2	
<div data-bbox="115 218 565 558" data-label="Image">

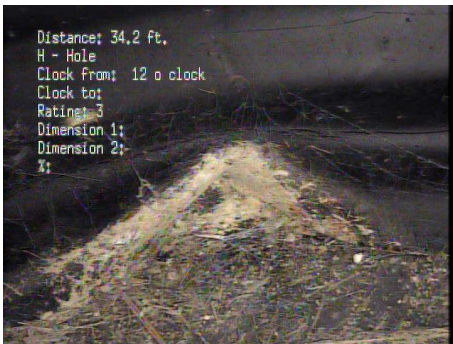
</div>							
34.2 ft.	U	H	Hole	12 /		<input type="checkbox"/> 3	
<div data-bbox="115 667 565 1008" data-label="Image">

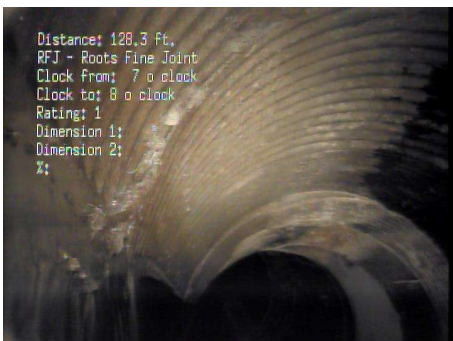
</div>							
42.1 ft.	U	TBI	Tap Break-in Intruding	10 /		<input type="checkbox"/> 2	
63.7 ft.	U	TBI	Tap Break-in Intruding	10 /		<input type="checkbox"/> 2	
80.6 ft.	U	JOM	Joint Offset Medium	/		<input type="checkbox"/> 1	
98.8 ft.	U	OBR	Obstacle Rocks	7 /	5	<input type="checkbox"/> 2	
128.3 ft.	U	JOM	Joint Offset Medium	/		<input type="checkbox"/> 1	
128.3 ft.	U	RFJ	Roots Fine Joint	7 / 8		<input checked="" type="checkbox"/> 1

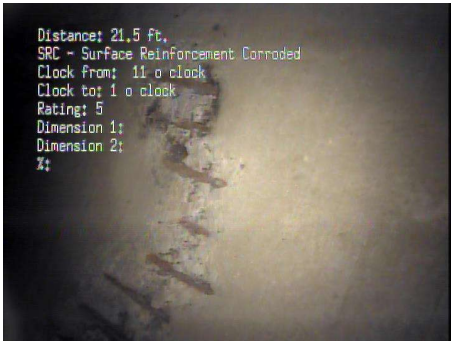
Distance	Dir.	Code	Description	Cont.	From/To	%	Joint	Rating	Remarks
21.5 ft.	D	SRC	Surface Reinforcement Corroded		11 / 1		<input type="checkbox"/>	5
