PACP Report with Pipe Run and Incident Snapshots

Surveyed by: DAN	Certificate number: U-716-07004752	Owner:	Customer:	Drainage area:	P/O number:	Sheet number:
Pipe segment ref.: SMH033_SMH032	Start date/time: 20220307 09:47	Street: FAIRLAWN ST		City: SMITHVILLE		
Location details:		Upstream MH No: SMH033	Rim to invert:	Grade to invert:	Rim to grade:	
Pipe use: SS	Direction: U	Flow control:	Downstream MH No: SMH032	Rim to invert:	Grade to invert:	Rim to grade:
Height: 8 in.	Width:	Shape: C	Material: VCP	Lining method:	Pipe joint length:	Total length: 123.700 ft.
Media label:	PreCleaning: L	Date cleaned:	Weather: 3	Length surveyed: 123.700 ft.	Purpose:	Sewer category:
Project name: Sewer Cleaning & CCTV - Project No. 210670		Additional info:

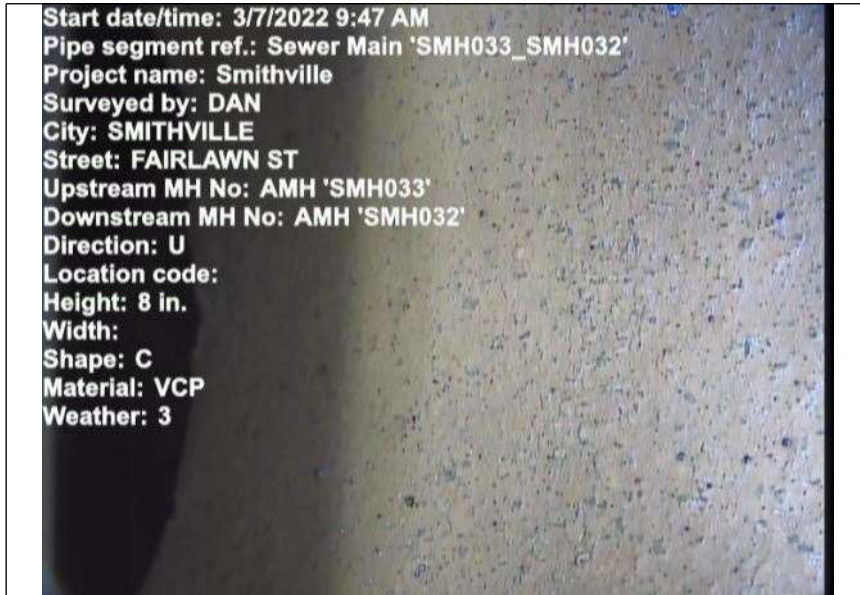
At: 0 ft. AMH - Manhole
Joint: No SMH032

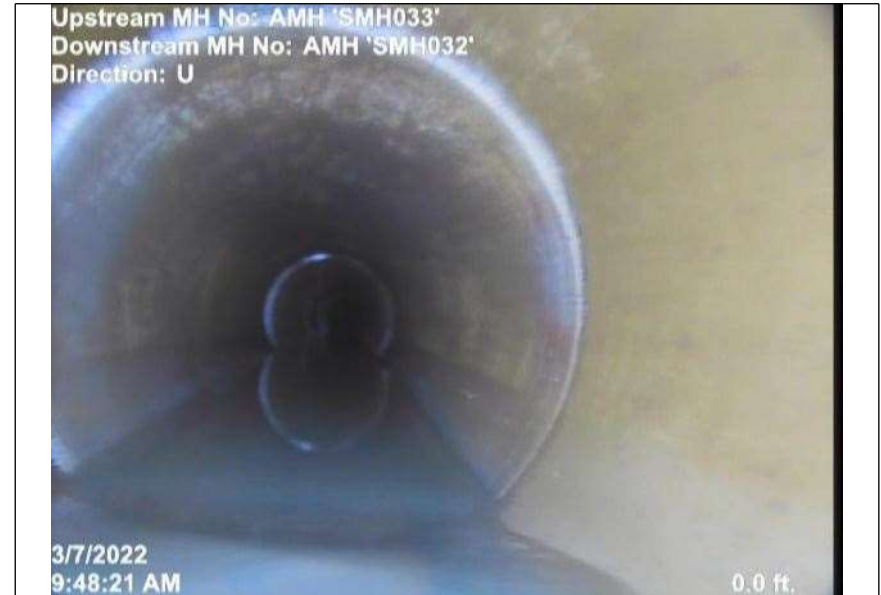
At: 0 ft. MWL - Miscellaneous Water Level
Joint: No 5%

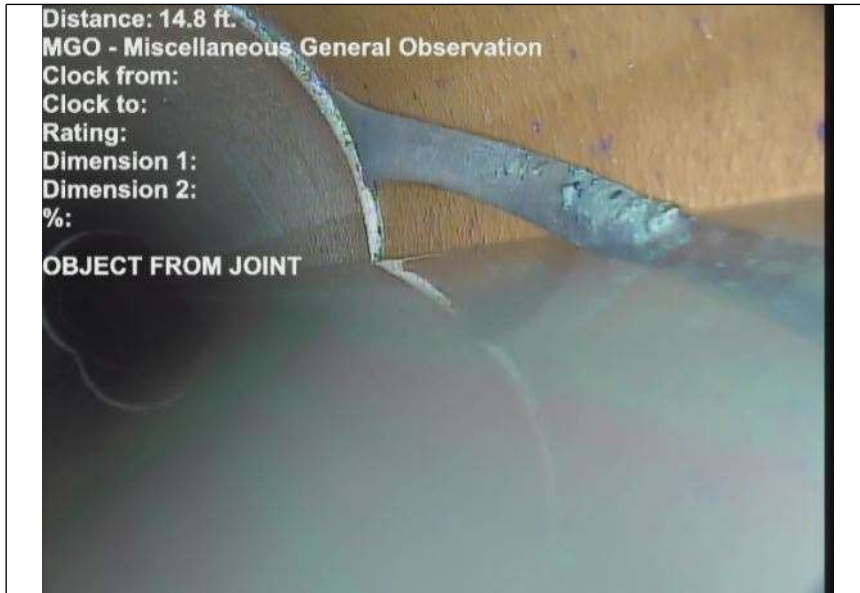
At: 14.8 ft. MGO - Miscellaneous General Observation
Joint: No OBJECT FROM JOINT

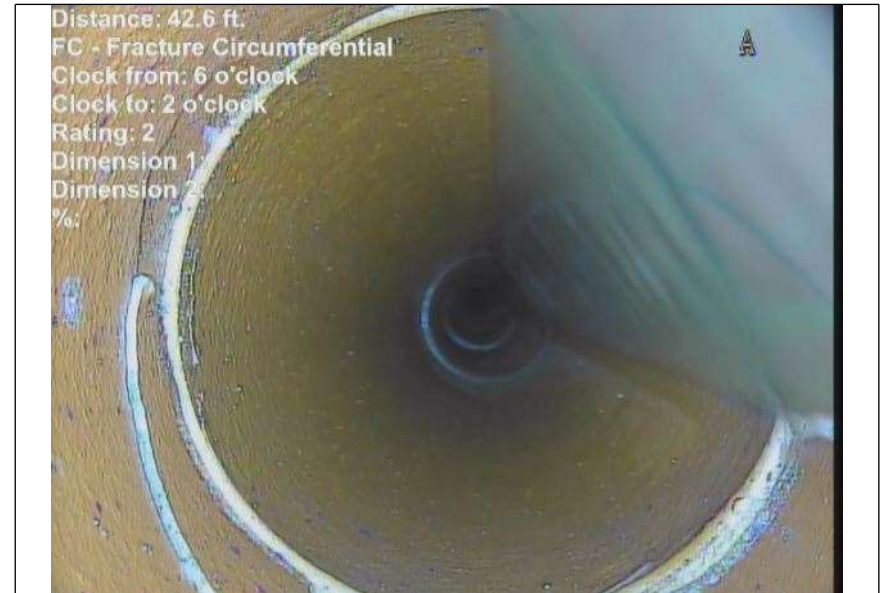
At: 42.6 ft. 6/2 FC - Fracture Circumferential
Joint: No

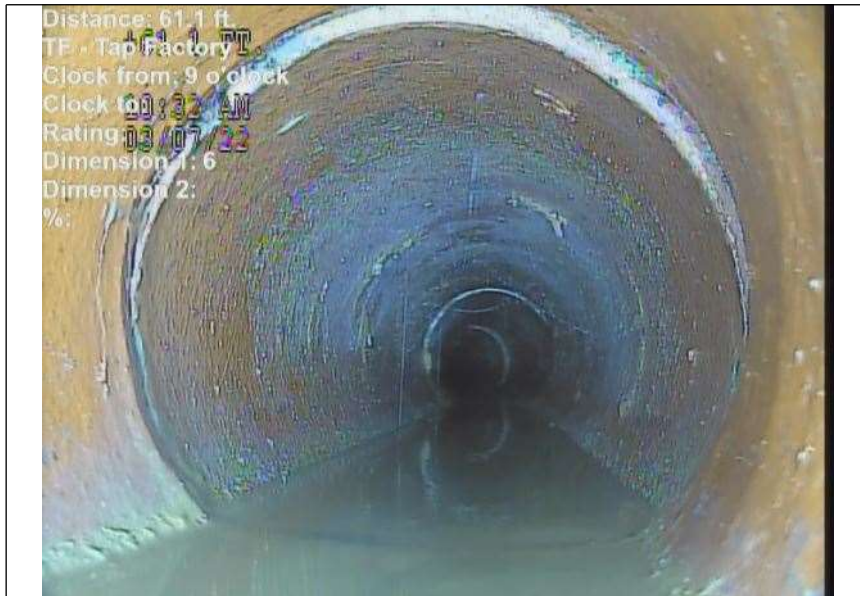
At: 61.1 ft. 9/. TF - Tap Factory

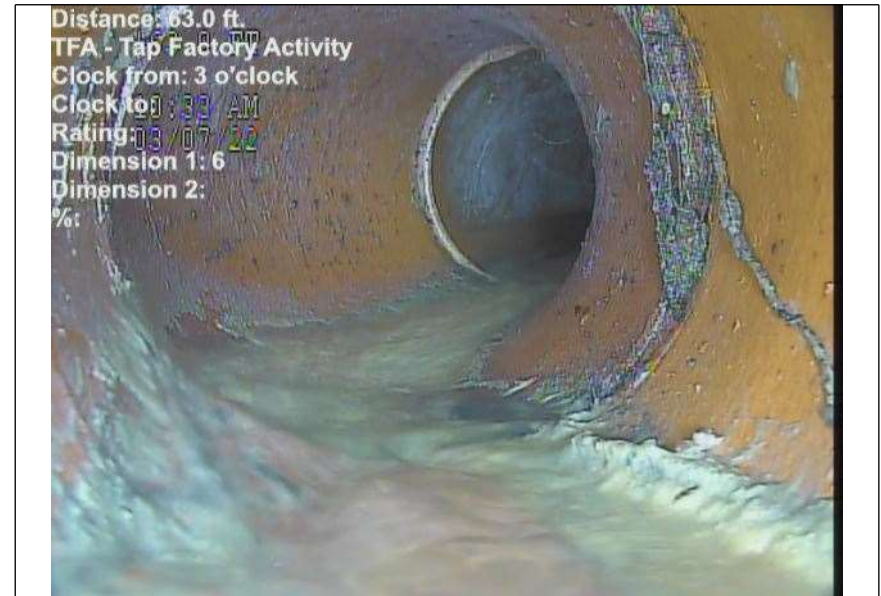
At: 63 ft. 3/. TFA - Tap Factory Activity

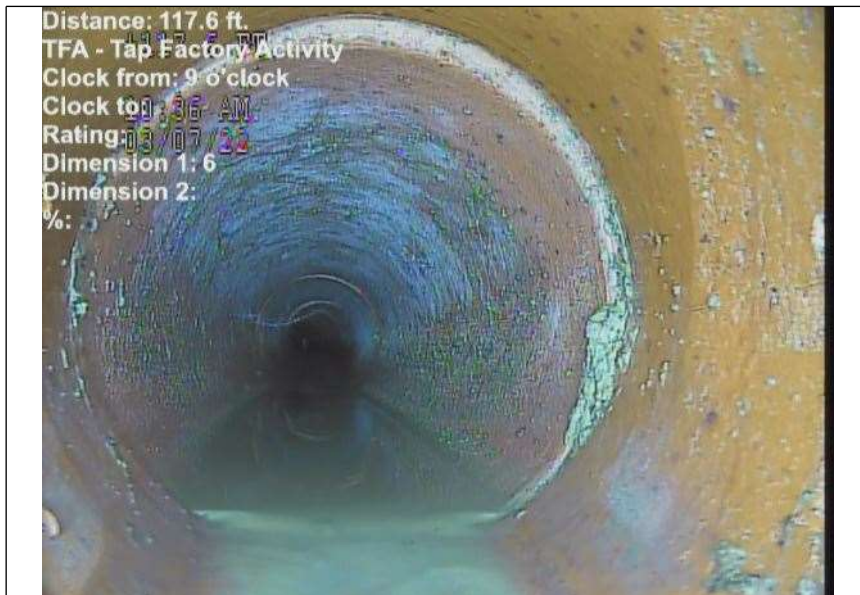
At: 117.6 ft. 9/. TFA - Tap Factory Activity

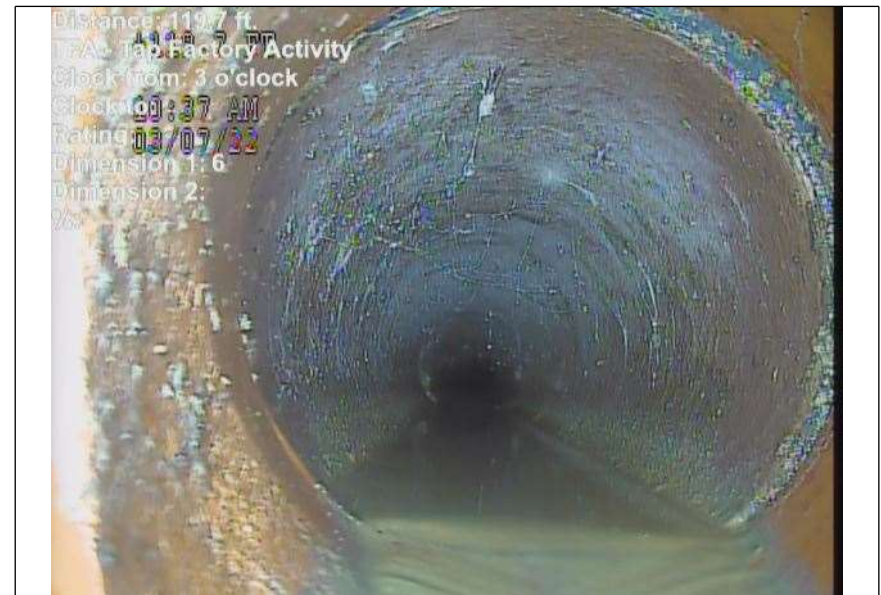
At: 119.7 ft. 3/. TFA - Tap Factory Activity

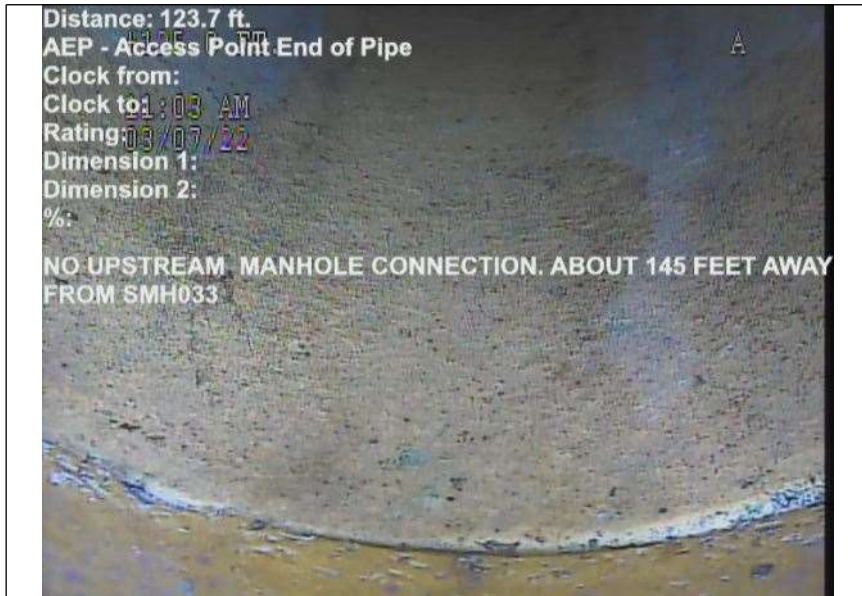
At: 123.7 ft. AEP - Access Point End of Pipe
Joint: No NO UPSTREAM MANHOLE CONNECTION. ABOUT 145 FEET AWAY FROM SMH033
