PACP Report with Pipe Run and Incident Snapshots

Surveyed by: DAN	Certificate number: U-716-07004752	Owner:	Customer:	Drainage area:	P/O number:	Sheet number:			
Pipe segment ref.: SMH040_SMH041	Start date/time: 20220308 11:37	Street: SUMMIT	City: SMITHVILLE						
Location details:		Upstream MH No: SMH040	Rim to invert:	Grade to invert:	Rim to grade:				
Pipe use: SS	Direction: U	Flow control:	Downstream MH No: SMH041	Rim to invert:	Grade to invert:	Rim to grade:			
Height: 8 in.	Width:	Shape: C	Material: VCP	Lining method:	Pipe joint length:	Total length: 139.200 ft.	Length surveyed: 139.200 ft.	Purpose:	Sewer category:
Media label:	PreCleaning: L	Date cleaned:	Weather: 1	Location code:	Pressure value:				
Project name: Sewer Cleaning & CCTV - Project No. 210670		Additional info:

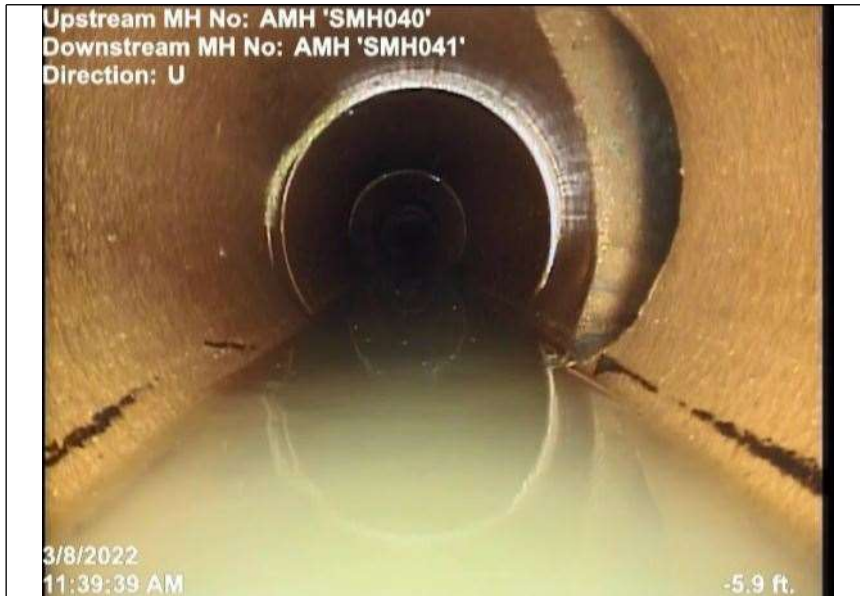
At: 0 ft. MWL - Miscellaneous Water Level
Joint: No 5 %

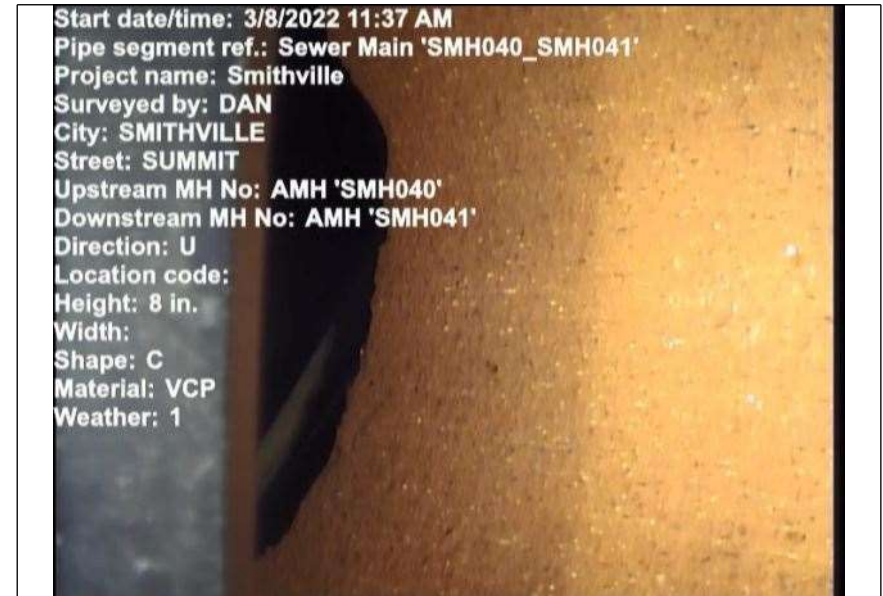
At: 0 ft. AMH - Manhole
Joint: No SMH041

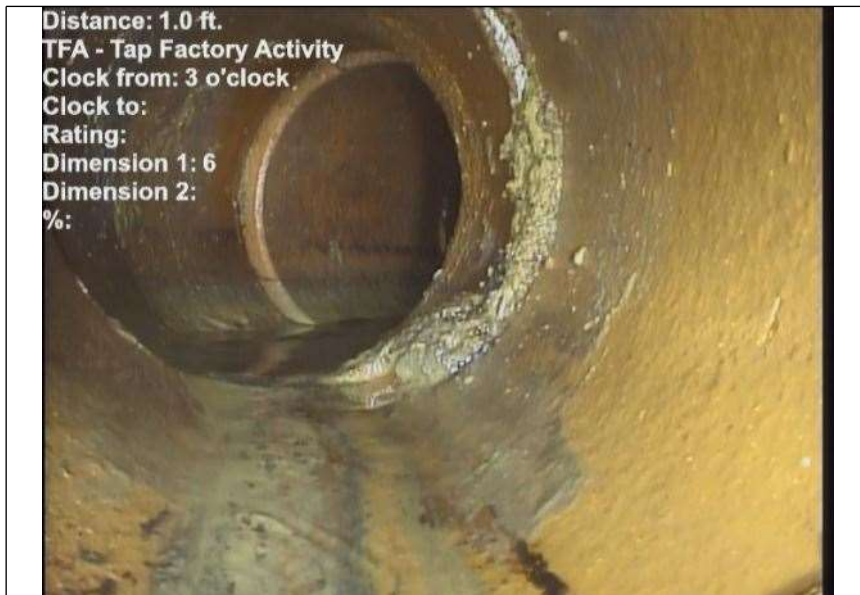
At: 1 ft. 3/. TFA - Tap Factory Activity
Joint: No

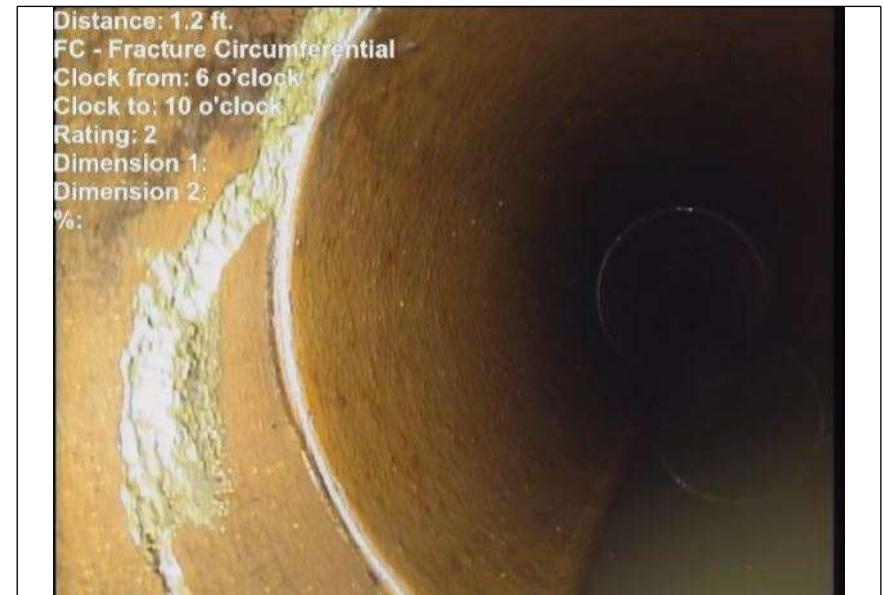
At: 1.2 ft. 6/10 FC - Fracture Circumferential
Joint: No

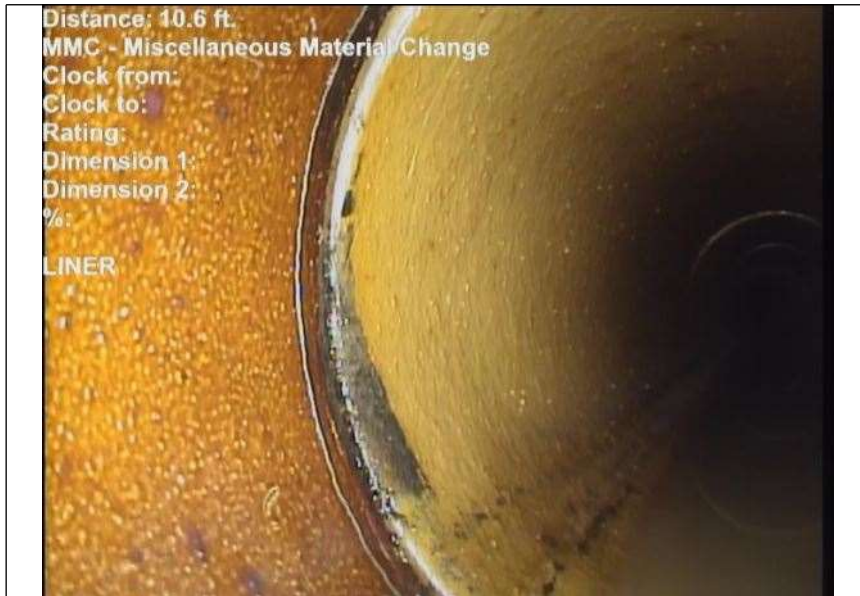
At: 10.6 ft. RPR - Point Repair Replacement
Joint: No LINER

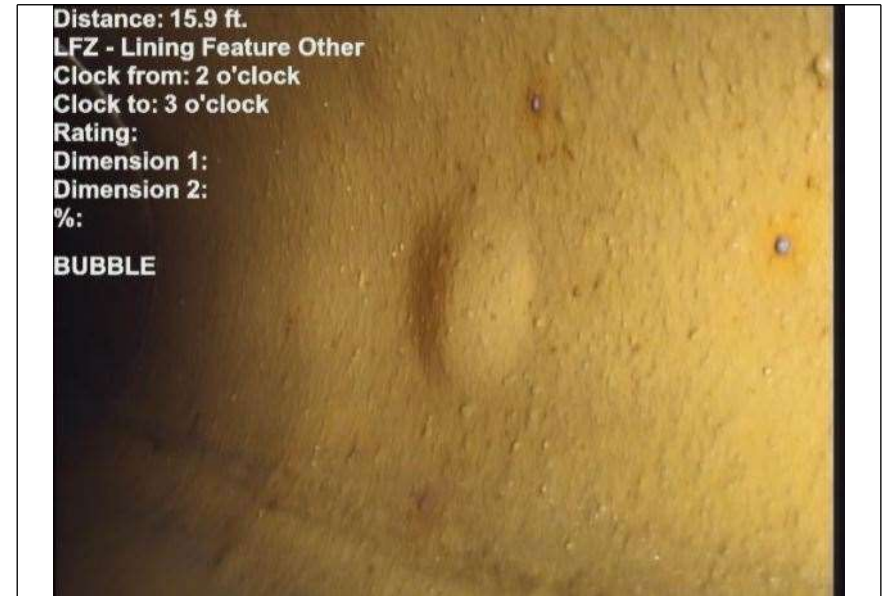
At: 15.9 ft. 2/3 LFZ - Lining Feature Other
Joint: No BUBBLE

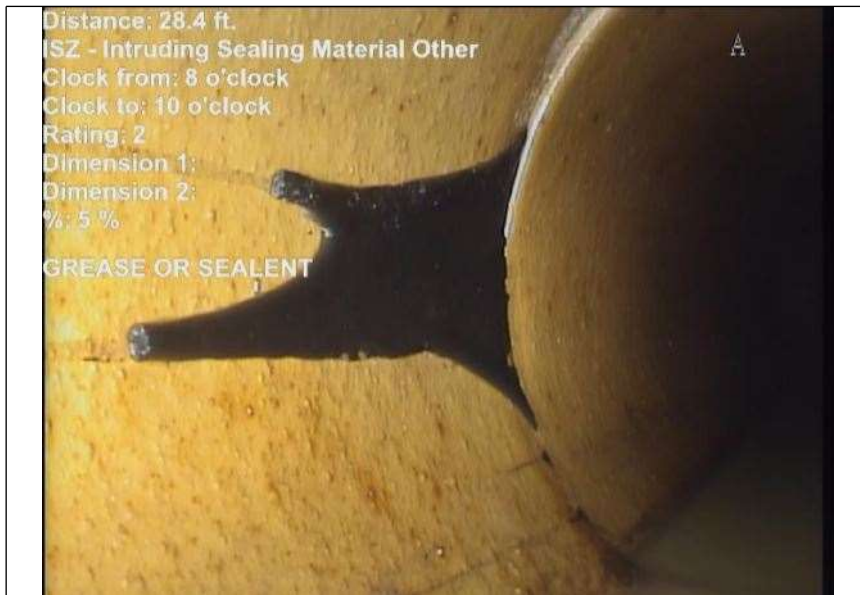
At: 28.4 ft. 8/10 ISZ - Intruding Sealing Material Other
Joint: No 5 % GREASE OR SEALANT

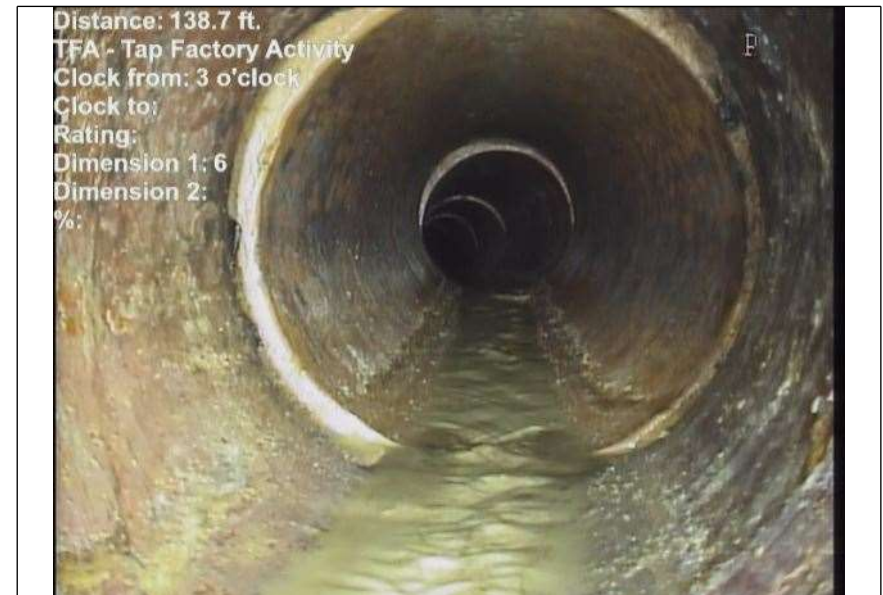
At: 138.7 ft. 3/ TFA - Tap Factory Activity
Joint: No

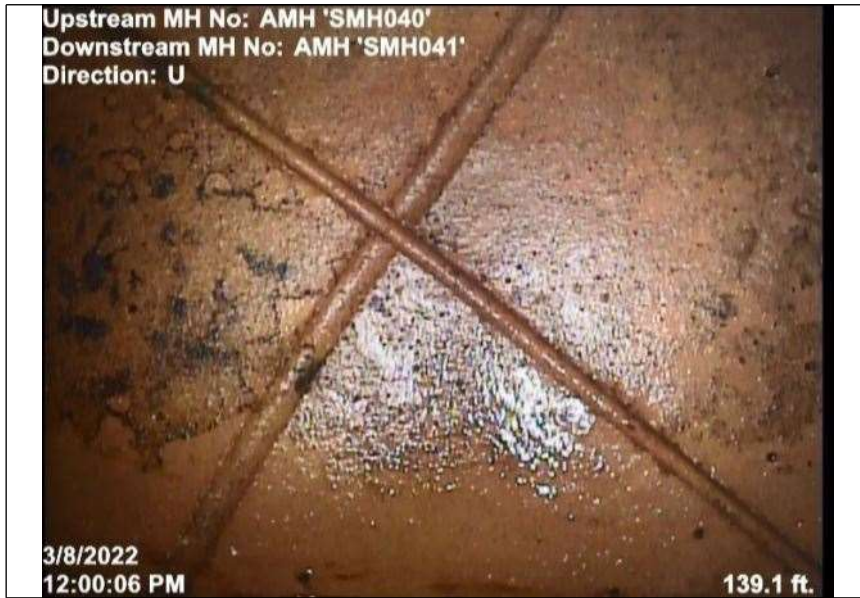
At: 139.2 ft. RPR - Point Repair Replacement
Joint: No LINER ENDS

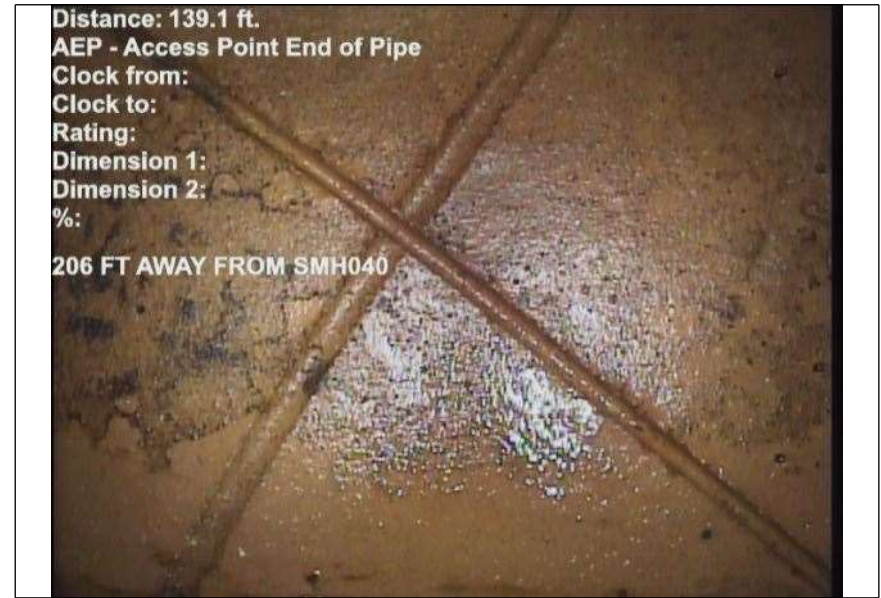
At: 139.2 ft. AEP - Access Point End of Pipe
Joint: No 206 FT AWAY FROM SMH040
