PACP Report with Pipe Run and Incident Snapshots

Surveyed by: DAN	Certificate number: U-716-07004752	Owner:	Customer:	Drainage area:	P/O number:	Sheet number:			
Pipe segment ref.: SMH041_SMH042	Start date/time: 20220308 12:16	Street: SUMMIT	City: SMITHVILLE						
Location details:	Upstream MH No: SMH041	Rim to invert:	Grade to invert:	Rim to grade:					
Pipe use: SS	Direction: D	Flow control:	Downstream MH No: SMH042	Rim to invert:	Grade to invert:	Rim to grade:			
Height: 8 in.	Width:	Shape: C	Material: VCP	Lining method:	Pipe joint length:	Total length: 297.900 ft.	Length surveyed: 285.100 ft.	Purpose:	Sewer category:
Media label:	PreCleaning: L	Date cleaned:	Weather: 1	Location code:	Pressure value:				
Project name: Sewer Cleaning & CCTV - Project No. 210670	Additional info:

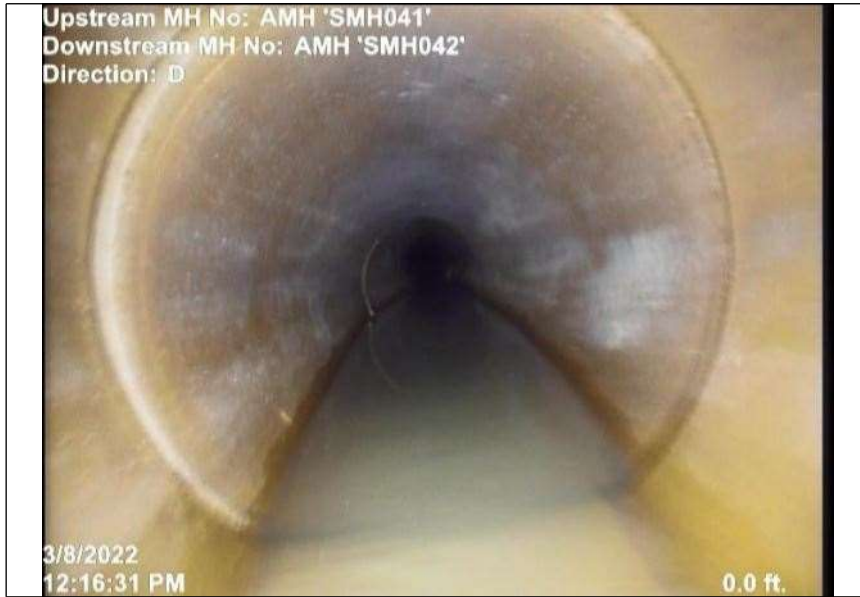
At: 0 ft. MWL - Miscellaneous Water Level
Joint: No 5 %

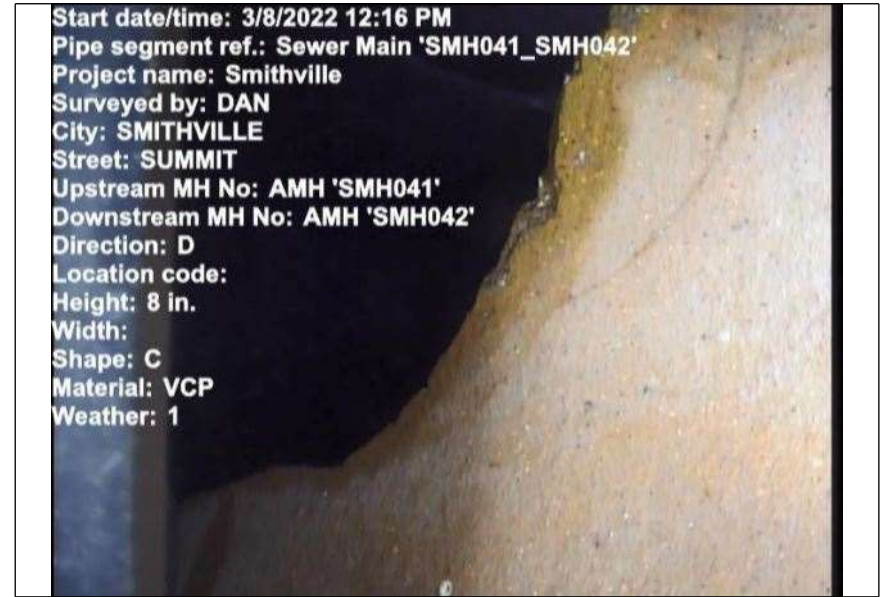
At: 0 ft. AMH - Manhole
Joint: No SMH041

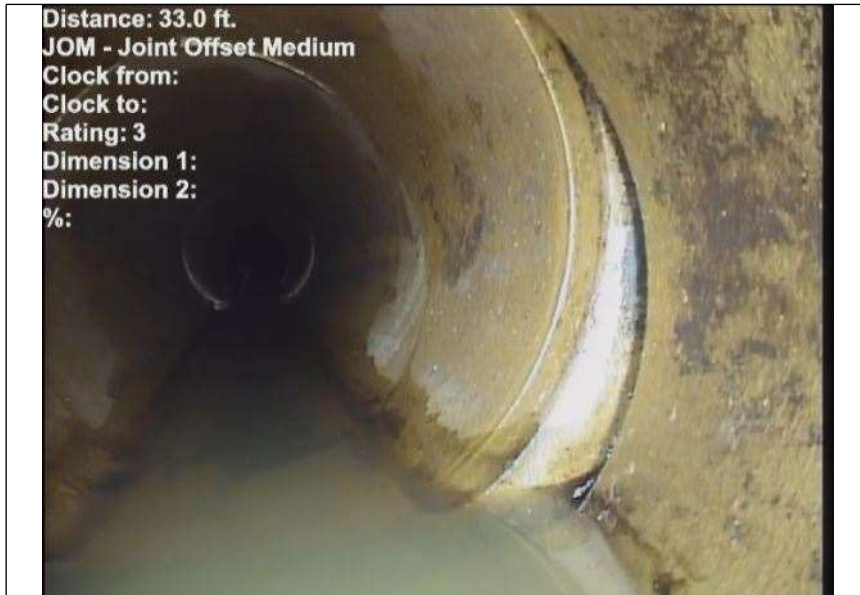
At: 33 ft. JOM - Joint Offset Medium
Joint: No

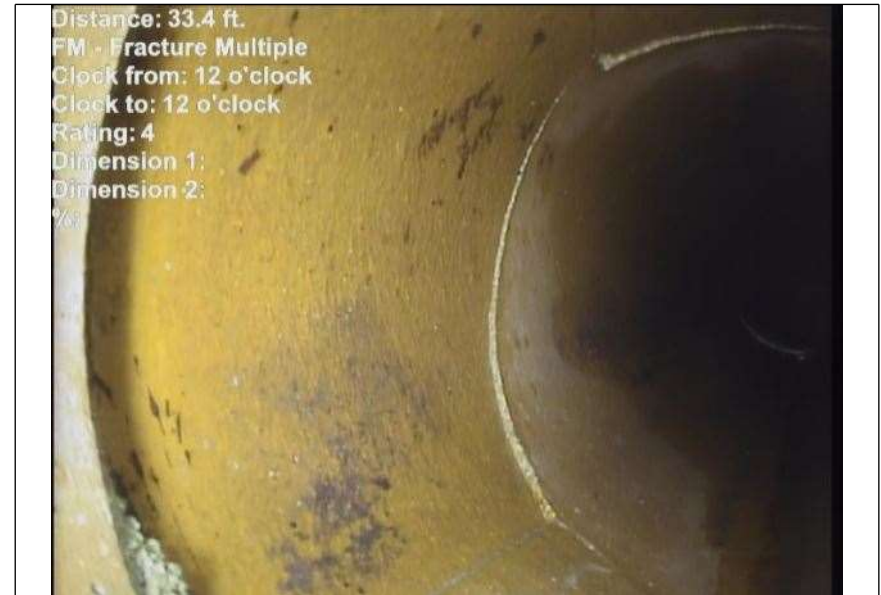
At: 33.4 ft. 7/5 FM - Fracture Multiple
Joint: No

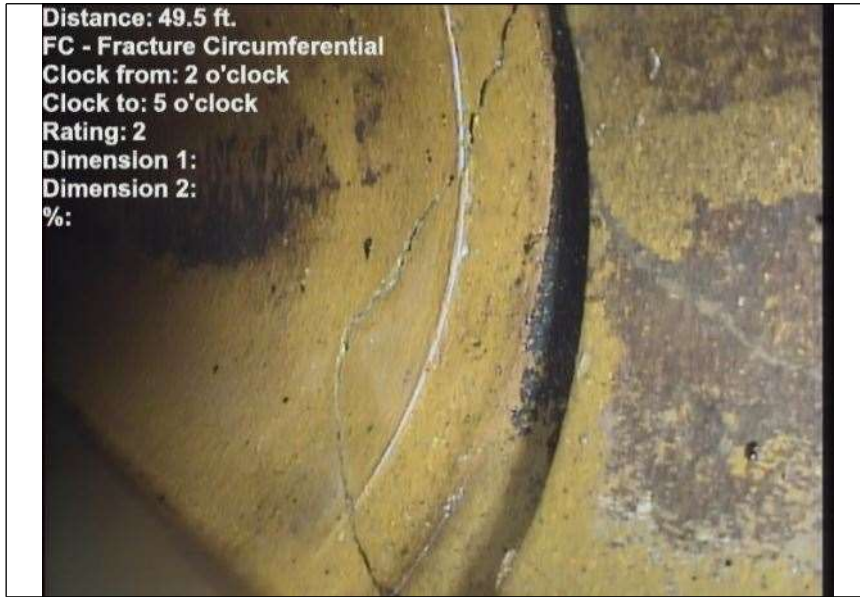
At: 49.5 ft. 2/5 FC - Fracture Circumferential
Joint: No

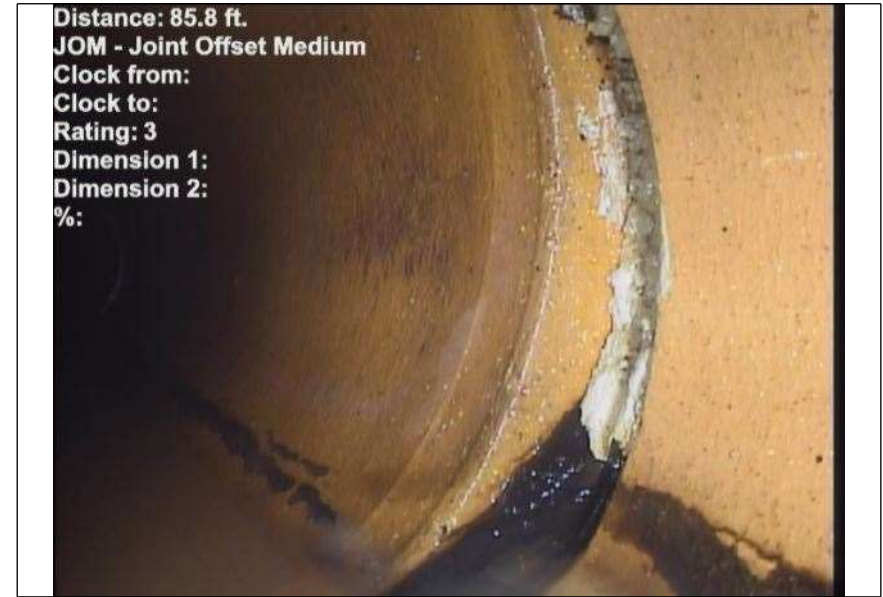
At: 85.8 ft. JOM - Joint Offset Medium
Joint: No

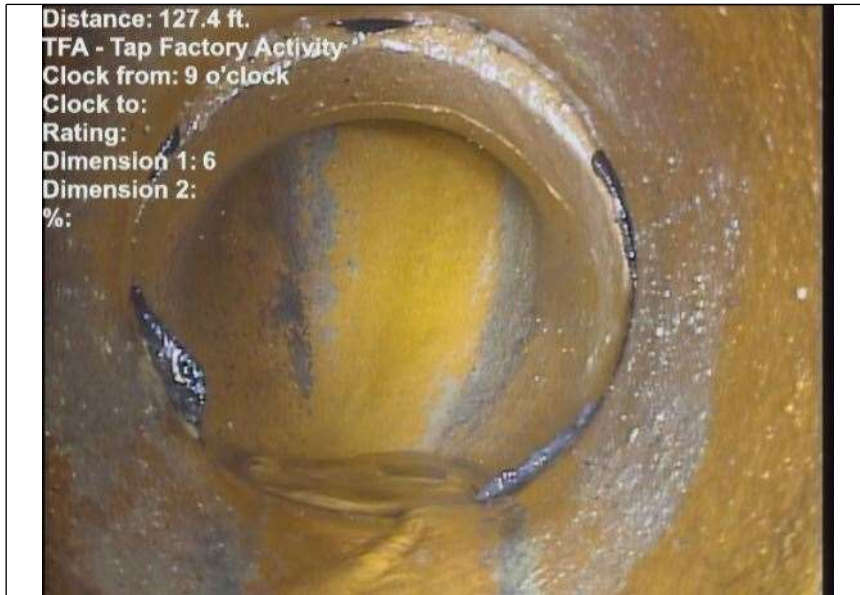
At: 127.4 ft. 9/ TFA - Tap Factory Activity
Joint: No

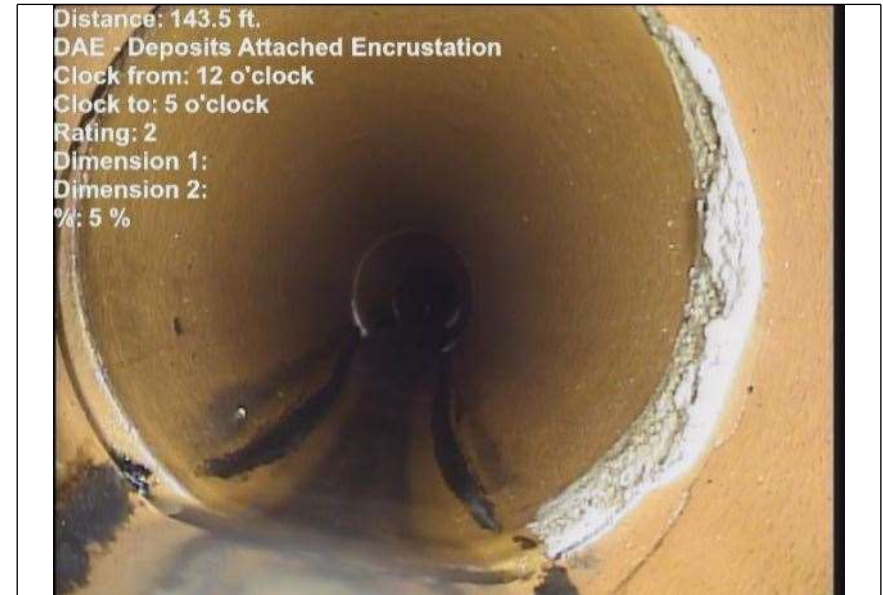
At: 143.5 ft. DAE - Deposits Attached Encrustation
12/5
Joint: No 5 %

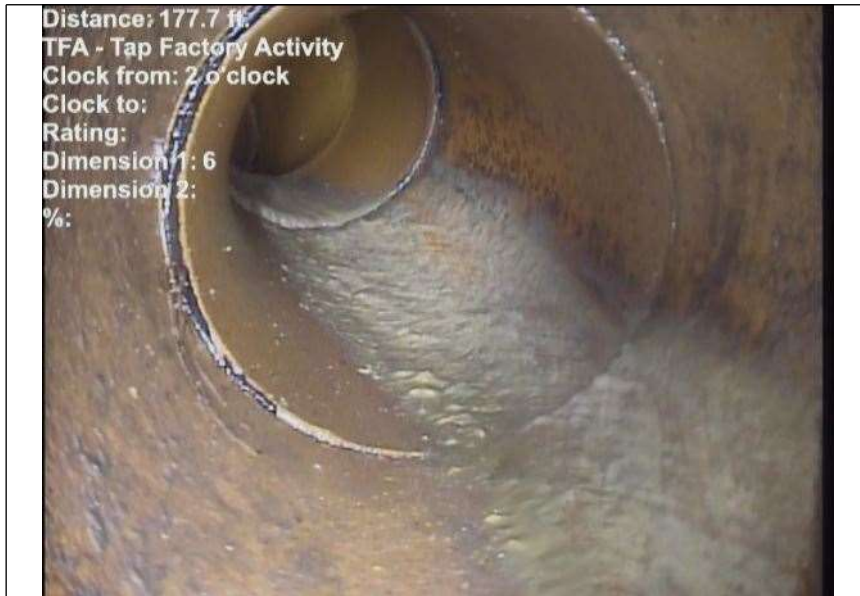
At: 177.7 ft. 2/. TFA - Tap Factory Activity
Joint: No

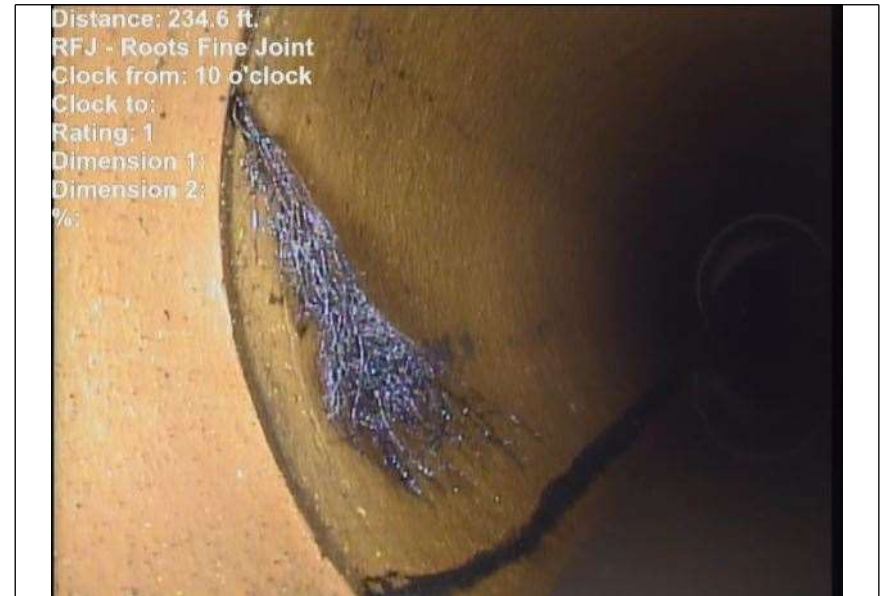
At: 234.6 ft. 10/. RFJ - Roots Fine Joint
Joint: Yes

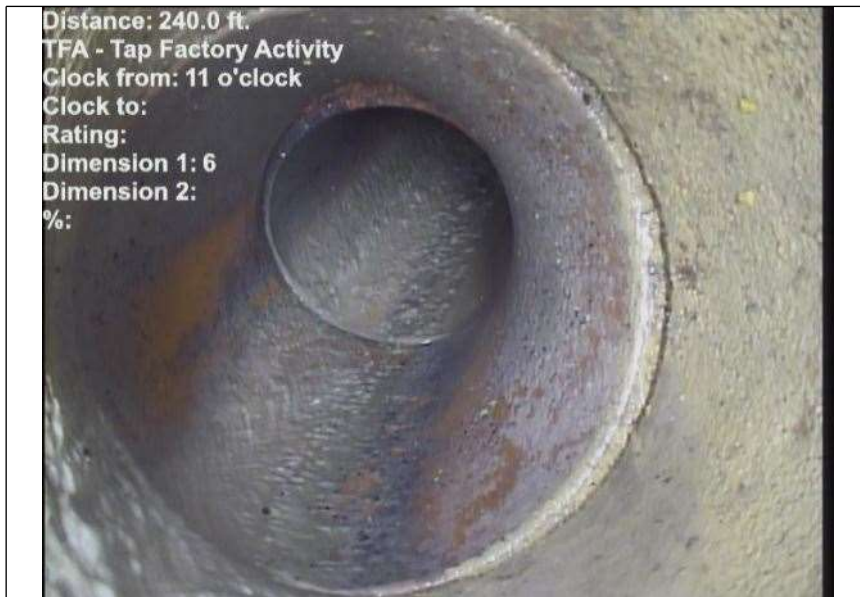
At: 240 ft. 11/. TFA - Tap Factory Activity
Joint: No

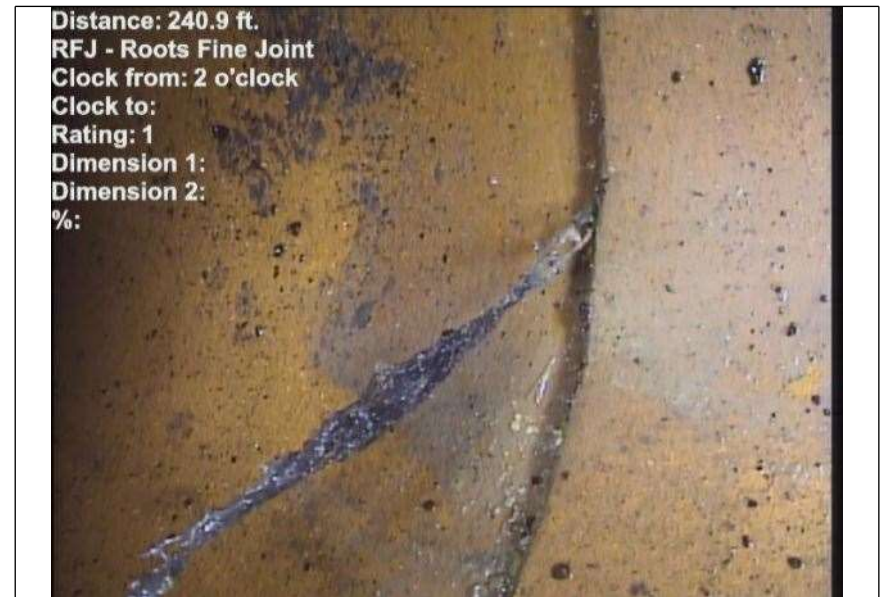
At: 240.9 ft. 2/. RFJ - Roots Fine Joint
Joint: Yes

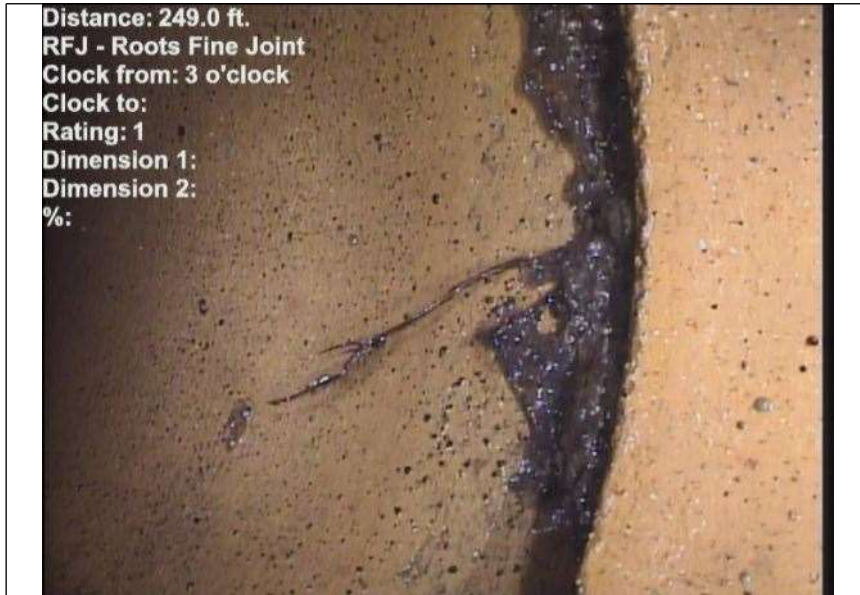
At: 249 ft. 3/. RFJ - Roots Fine Joint
Joint: Yes

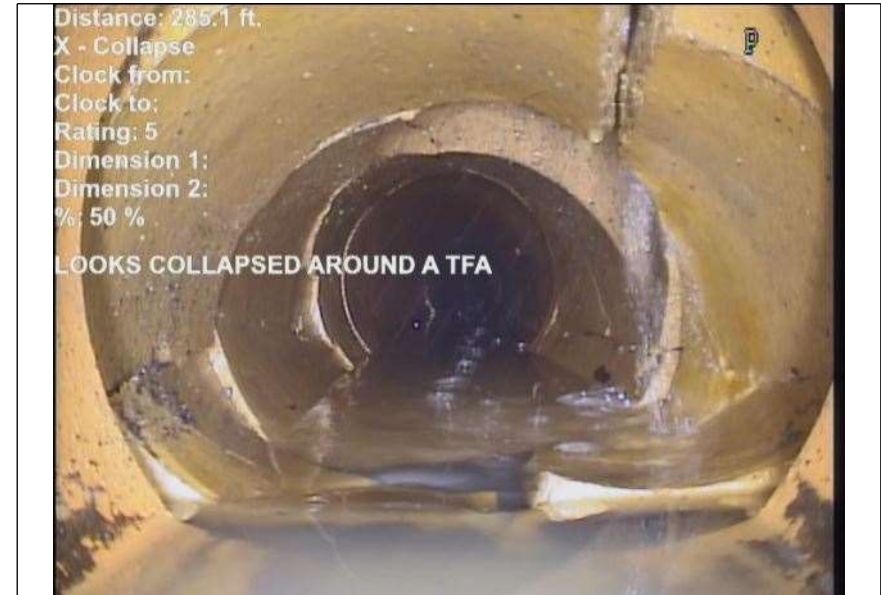
249.0 ft.	00:13:10	RFJ						<input checked="" type="checkbox"/>	3 /		1	SMH041_SMH042_RFJ_249.0 ft.JPG	
285.1 ft.	00:15:13	X					50	<input type="checkbox"/>	/		5	SMH041_SMH042_X_285.1 ft.JPG	LOOKS COLLAPSED AROUND A TFA

At: 285.1 ft. X - Collapse
Joint: No 50 % LOOKS COLLAPSED AROUND A TFA

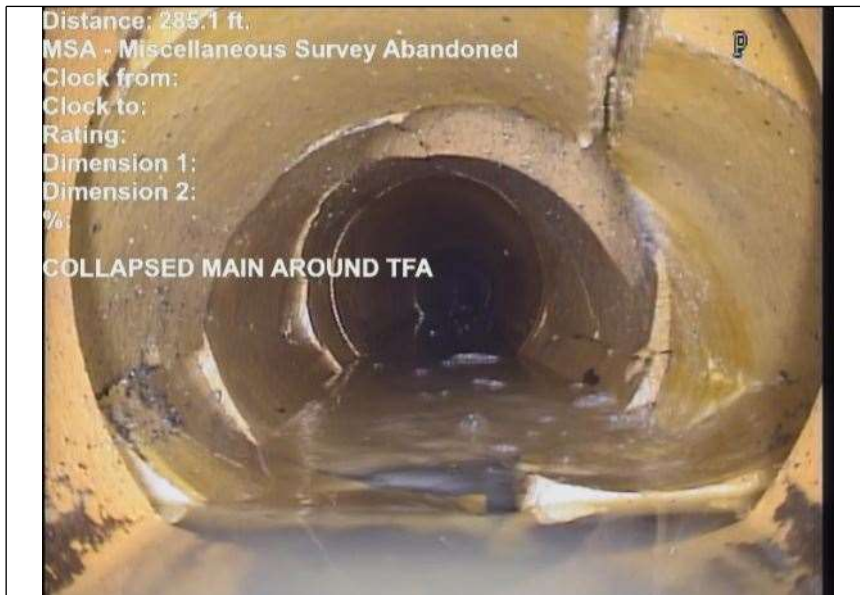
285.1 ft.	00:20:09	MSA						<input type="checkbox"/>	/			SMH041_SMH042_MSA_285.1 ft.JPG	COLLAPSED MAIN AROUND TFA

Stopped at 285.1 ft. with flow
on 3/8/2022 12:37:11 PM

At: 285.1 ft. MSA - Miscellaneous Survey Abandoned
Joint: No COLLAPSED MAIN AROUND TFA
