## PACP Report with Pipe Run and Incident Snapshots

Surveyed by: <b>DAN</b>		Certificate number: <b>U-716-07004752</b>		Owner:		Customer:		Drainage area:		P/O number:		Sheet number:							
Pipe segment ref.: <b>SMH041_SMH042.</b>				Start date/time: <b>20220308 13:07</b>		Street: <b>SUMMIT ST</b>				City: <b>SMITHVILLE</b>									
Location details:				Upstream MH No: <b>SMH041</b>				Rim to invert:		Grade to invert:		Rim to grade:							
Pipe use: <b>SS</b>		Direction: <b>U</b>		Flow control:		Downstream MH No: <b>SMH042</b>				Rim to invert:		Grade to invert:		Rim to grade:					
Height: <b>8 in.</b>		Width:		Shape: <b>C</b>		Material: <b>VCP</b>		Lining method:		Pipe joint length:		Total length: <b>297.900 ft.</b>		Length surveyed: <b>12.800 ft.</b>		Purpose:		Sewer category:	
Media label:				PreCleaning: <b>L</b>		Date cleaned:		Weather: <b>1</b>		Location code:		Pressure value:							
Project name: <b>Sewer Cleaning &amp; CCTV - Project No. 210670</b>				Additional info:

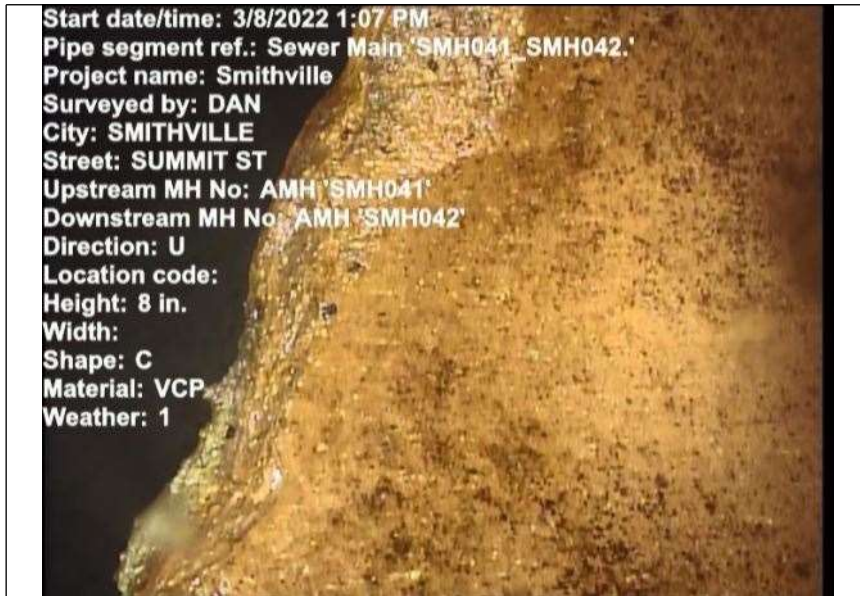
At: 0 ft. AMH - Manhole  
Joint: No SMH042

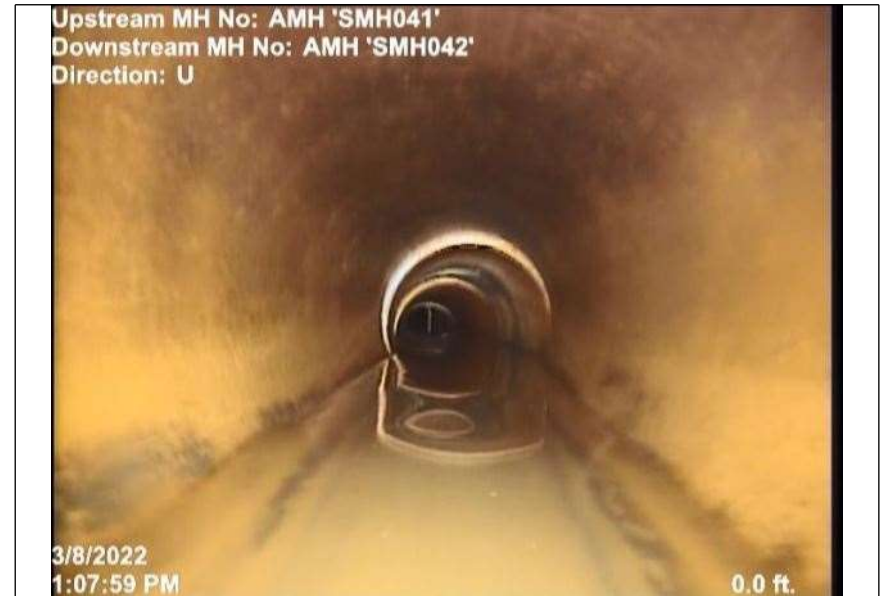
At: 0 ft. MWL - Miscellaneous Water Level  
Joint: No 5 %

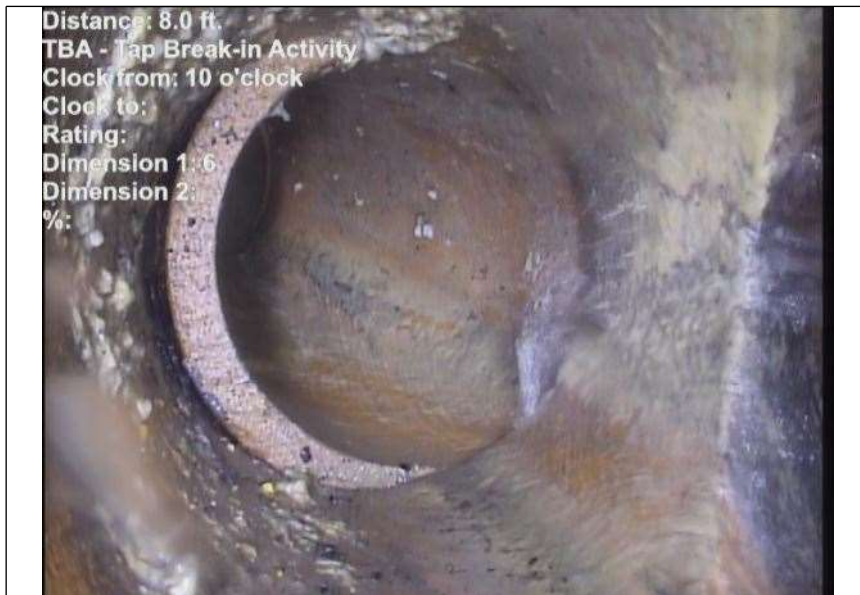
At: 8 ft. 10/ TBA - Tap Break-in Activity  
Joint: No

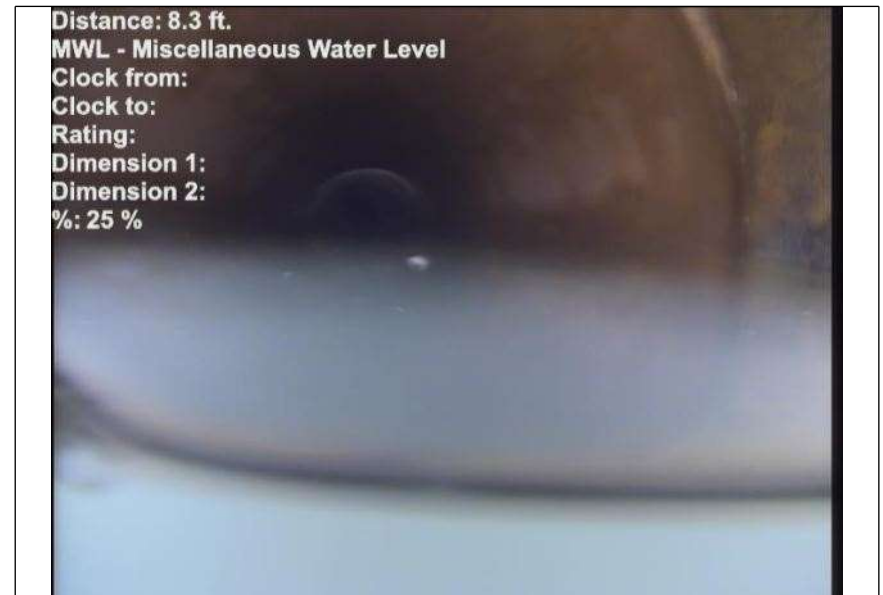
At: 8.3 ft. MWL - Miscellaneous Water Level  
Joint: No 25 %
