PACP Report with Pipe Run and Incident Snapshots

Surveyed by: DAN	Certificate number: U-716-07004752	Owner:	Customer:	Drainage area:	P/O number:	Sheet number:
Pipe segment ref.: SMH042_SMH043	Start date/time: 20220308 13:41	Street: SUMMIT ST		City: SMITHVILLE		
Location details:		Upstream MH No: SMH042	Rim to invert:	Grade to invert:	Rim to grade:	
Pipe use: SS	Direction: D	Flow control:	Downstream MH No: SMH043	Rim to invert:	Grade to invert:	Rim to grade:
Height: 8 in.	Width:	Shape: C	Material: VCP	Lining method:	Pipe joint length:	Total length: 398.400 ft.
Media label:	PreCleaning: L	Date cleaned:	Weather: 1	Length surveyed: 398.400 ft.	Purpose:	Sewer category:
Project name: Sewer Cleaning & CCTV - Project No. 210670		Additional info:

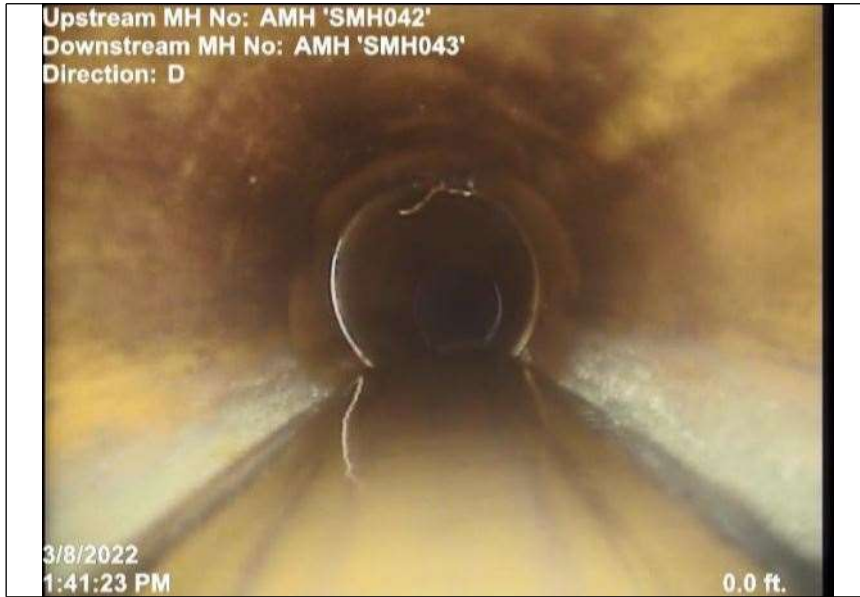
At: 0 ft. MWL - Miscellaneous Water Level
Joint: No 5 %

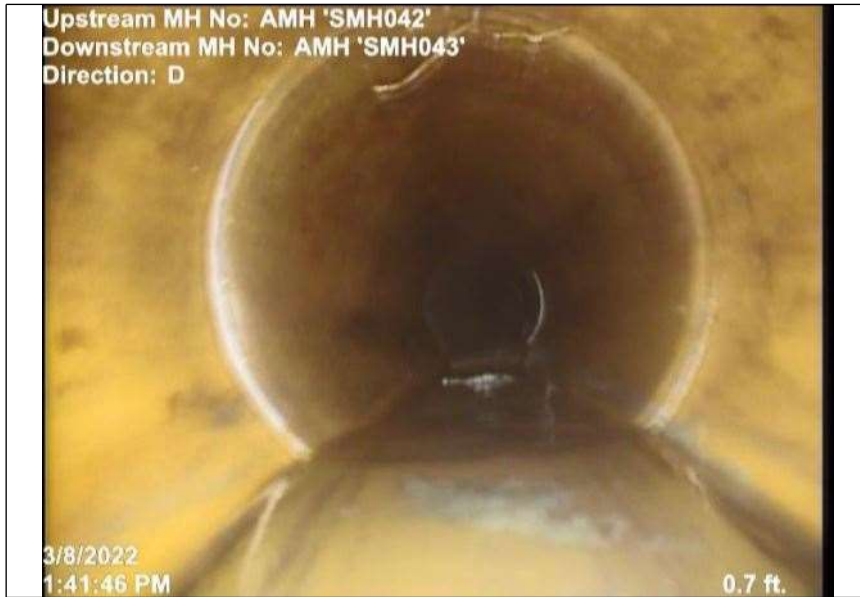
At: 0.994 ft. RFJ - Roots Fine Joint
12/1
Joint: Yes

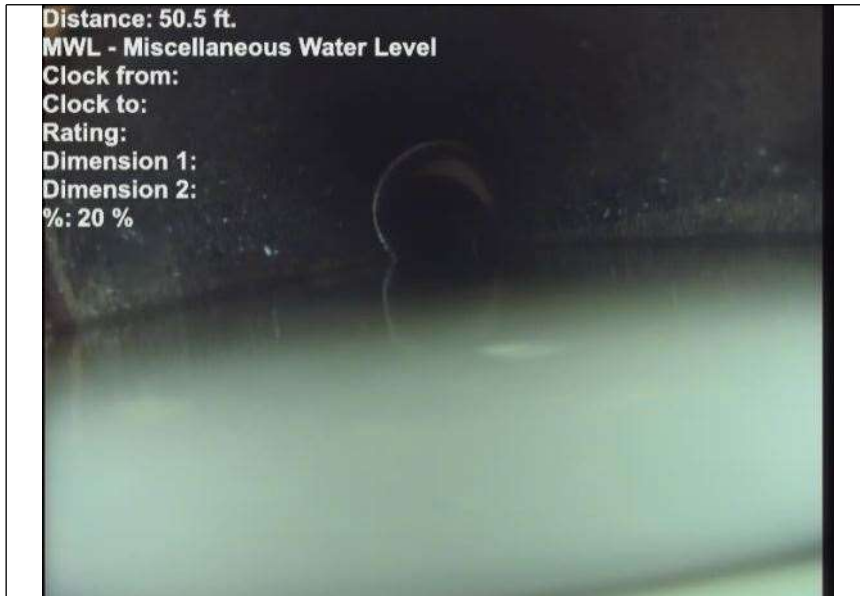
At: 50.5 ft. MWL - Miscellaneous Water Level
Joint: No 20 %

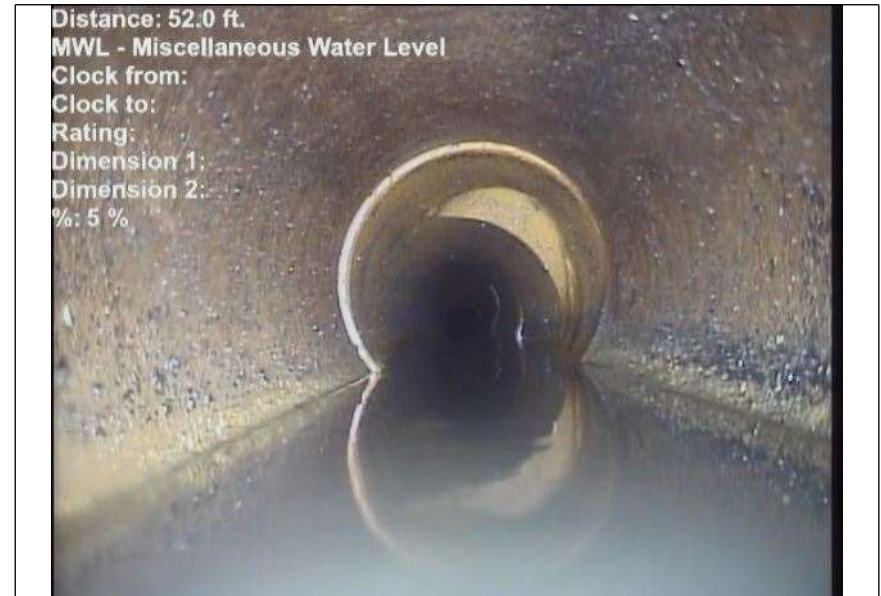
At: 52 ft. MWL - Miscellaneous Water Level
Joint: No 5 %

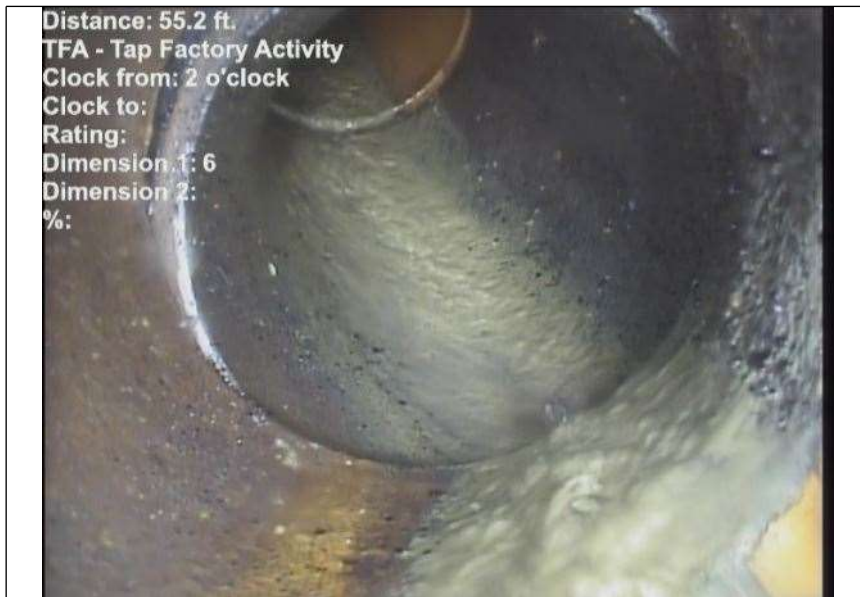
At: 55.2 ft. 2/. TFA - Tap Factory Activity
Joint: No

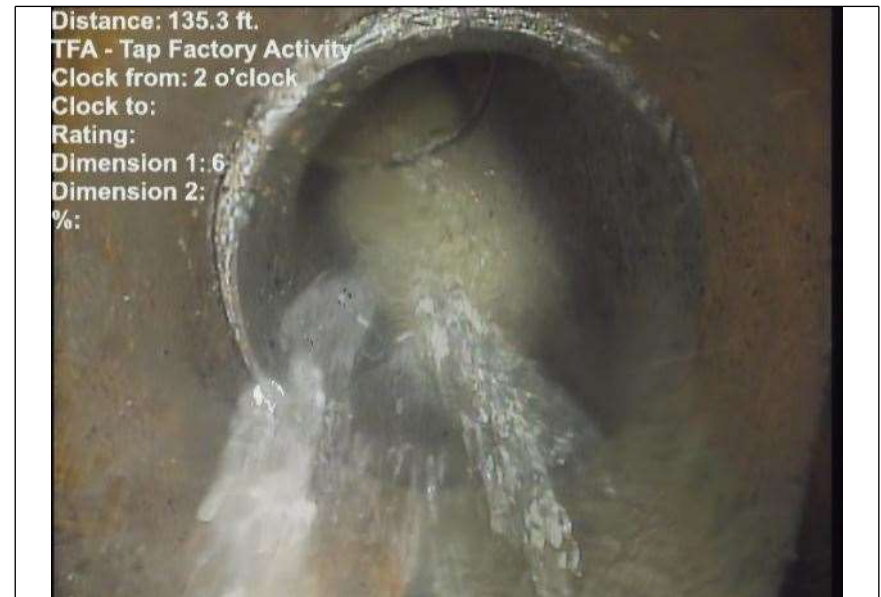
At: 135.3 ft. 2/. TFA - Tap Factory Activity
Joint: No

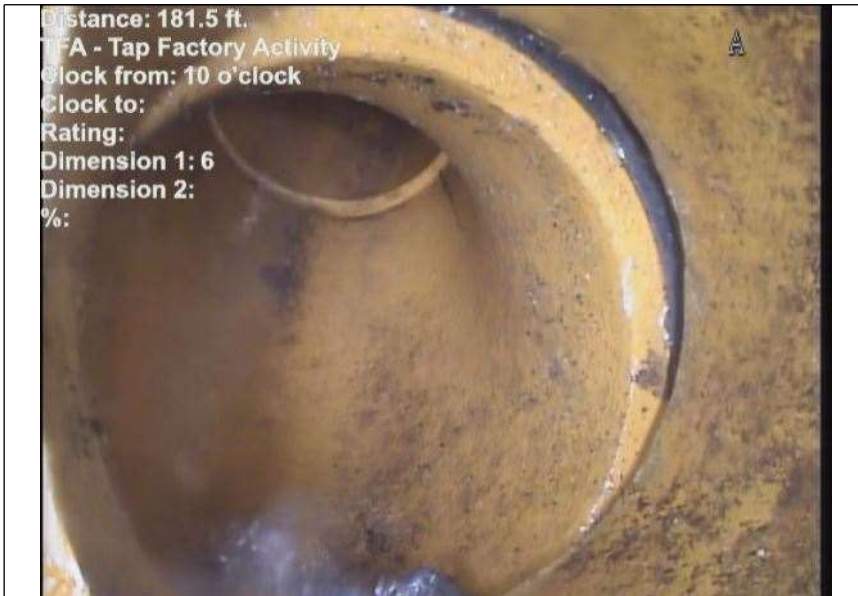
At: 181.5 ft. 10/. TFA - Tap Factory Activity

Joint: No

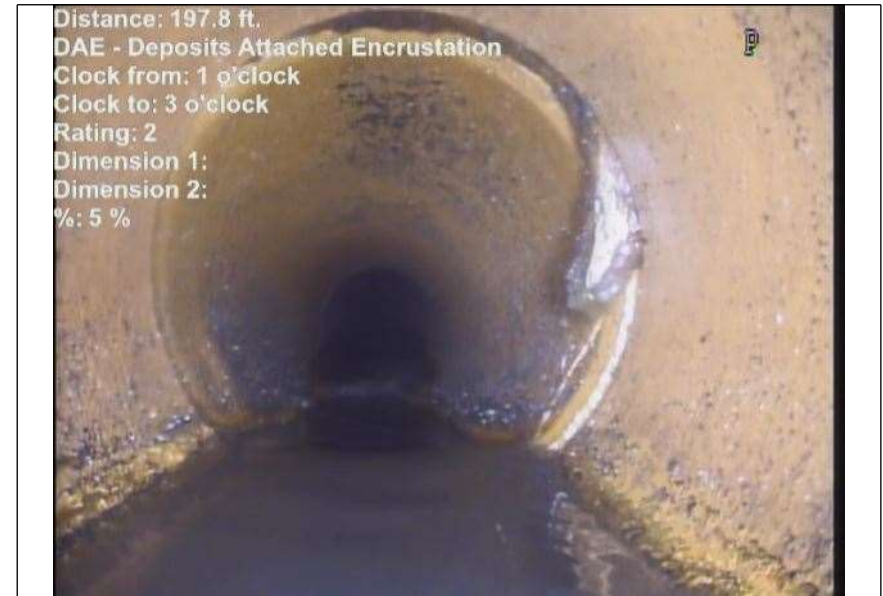
At: 197.8 ft. 1/3 DAE - Deposits Attached Encrustation

Joint: No 5 %

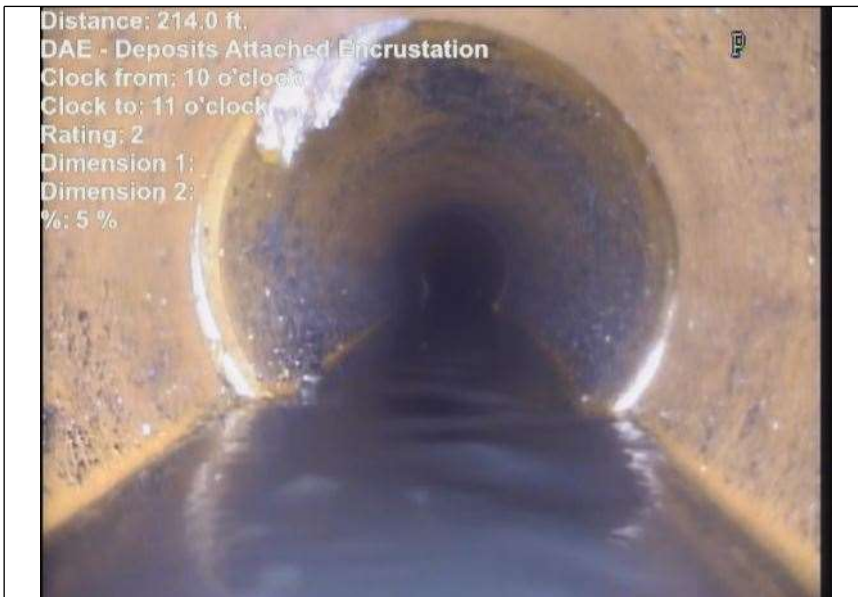
At: 214 ft. 10/11 DAE - Deposits Attached Encrustation

Joint: No 5 %

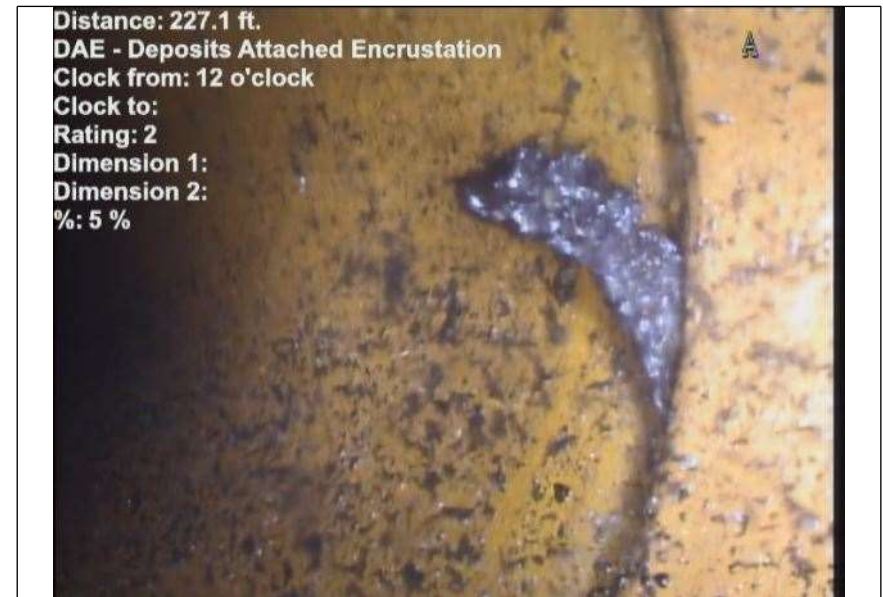
At: 227.1 ft. 12/. DAE - Deposits Attached Encrustation

Joint: No 5 %

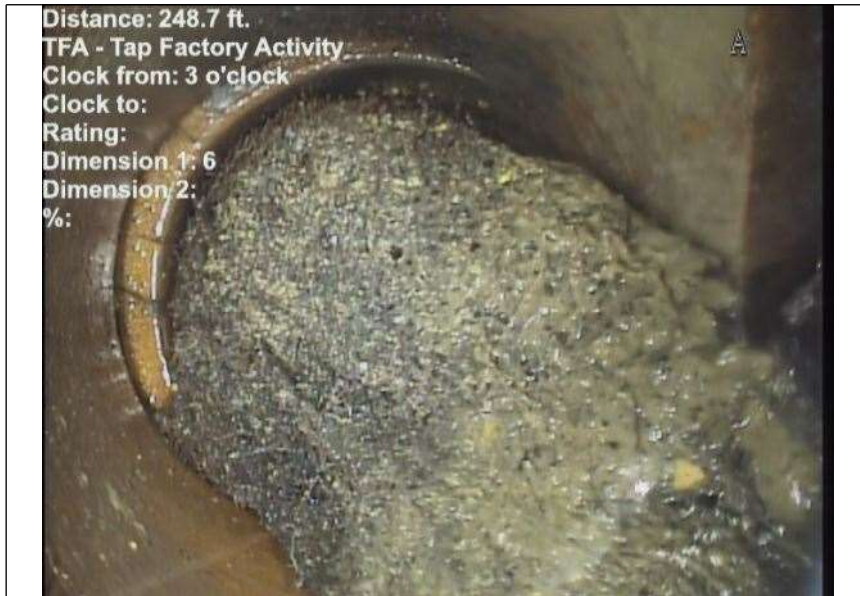
At: 248.7 ft. 3/. TFD - Tap Factory Defective
Joint: No RTL

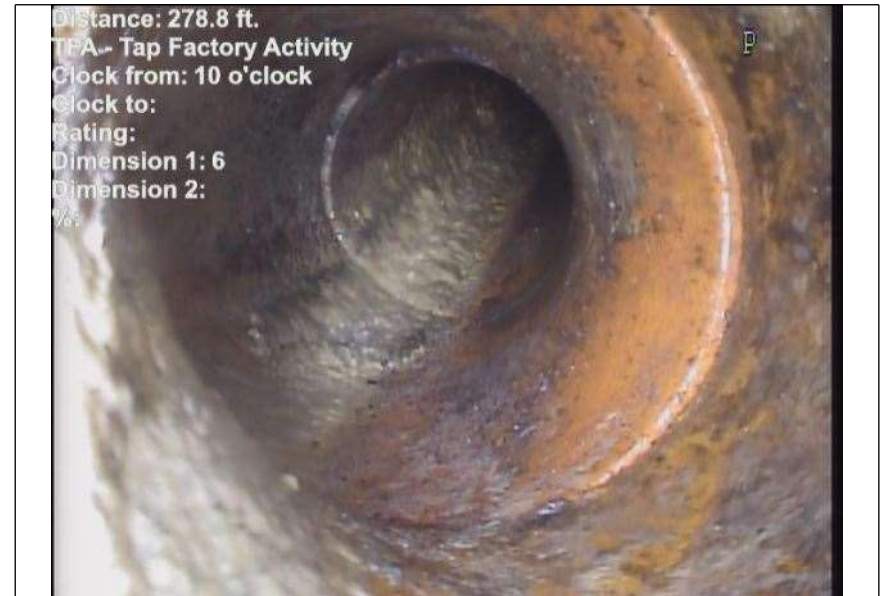
At: 278.8 ft. 10/. TFA - Tap Factory Activity
Joint: No

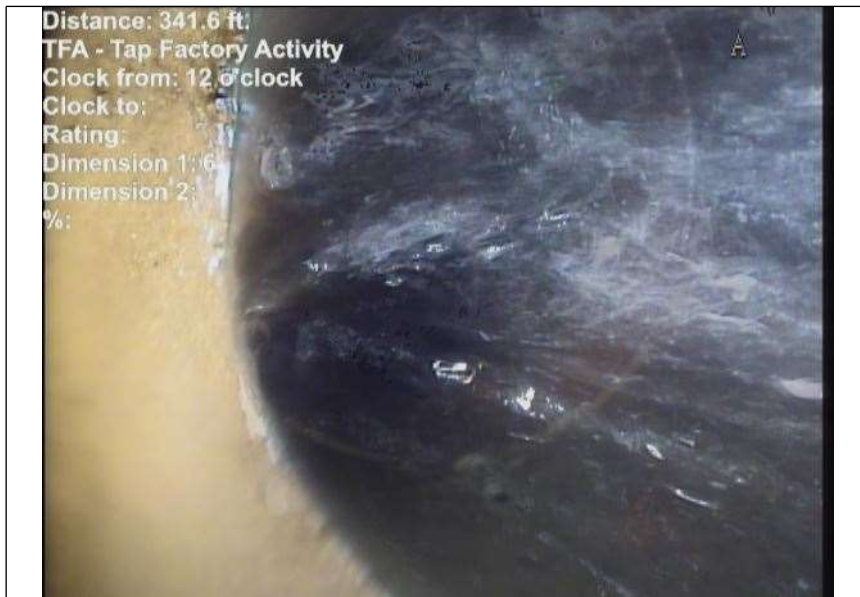
At: 341.6 ft. 12/. TFA - Tap Factory Activity
Joint: No

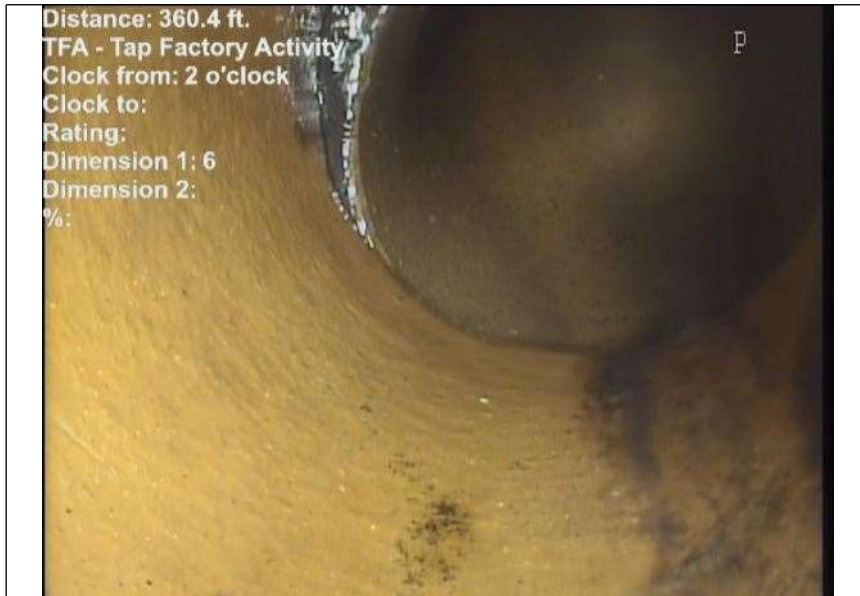
At: 360.4 ft. 2/. TFA - Tap Factory Activity
Joint: No

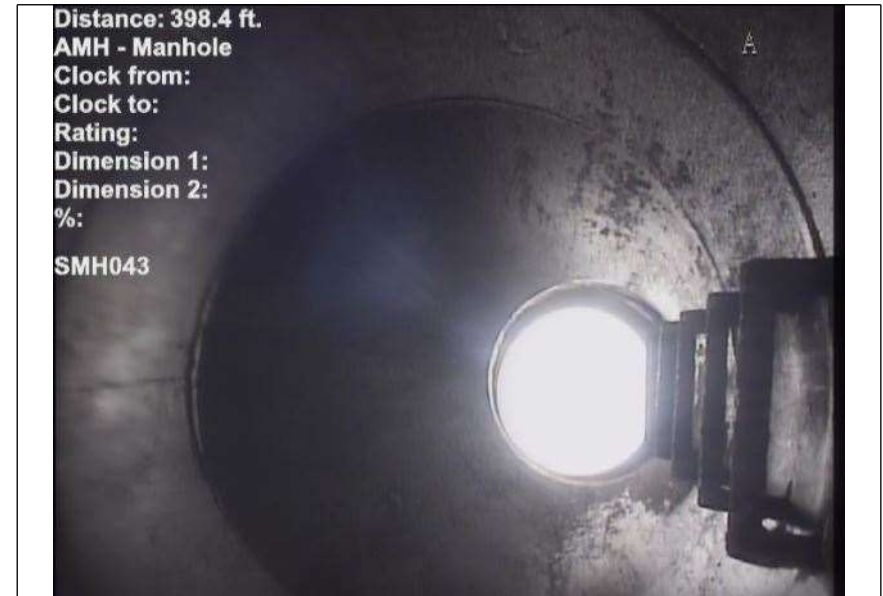
At: 398.4 ft. AMH - Manhole
Joint: No SMH043
