PACP Report with Pipe Run and Incident Snapshots

Surveyed by: DAN	Certificate number: U-716-07004752	Owner:	Customer:	Drainage area:	P/O number:	Sheet number:
Pipe segment ref.: SMH043_SMH044	Start date/time: 20220308 14:22	Street: SUMMIT ST		City: SMITHVILLE		
Location details:		Upstream MH No: SMH043	Rim to invert:	Grade to invert:	Rim to grade:	
Pipe use: SS	Direction: D	Flow control:	Downstream MH No: SMH044	Rim to invert:	Grade to invert:	Rim to grade:
Height: 8 in.	Width:	Shape: C	Material: VCP	Lining method:	Pipe joint length:	Total length: 298.400 ft.
Media label:	PreCleaning: L	Date cleaned:	Weather: 1	Length surveyed: 51.200 ft.	Purpose:	Sewer category:
Project name: Sewer Cleaning & CCTV - Project No. 210670		Additional info:

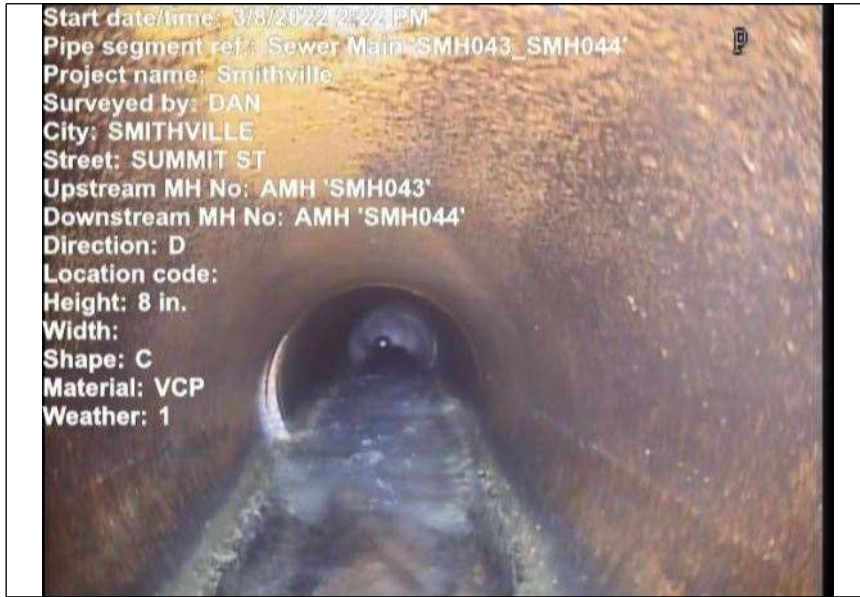
At: 0 ft. AMH - Manhole
Joint: No SMH043

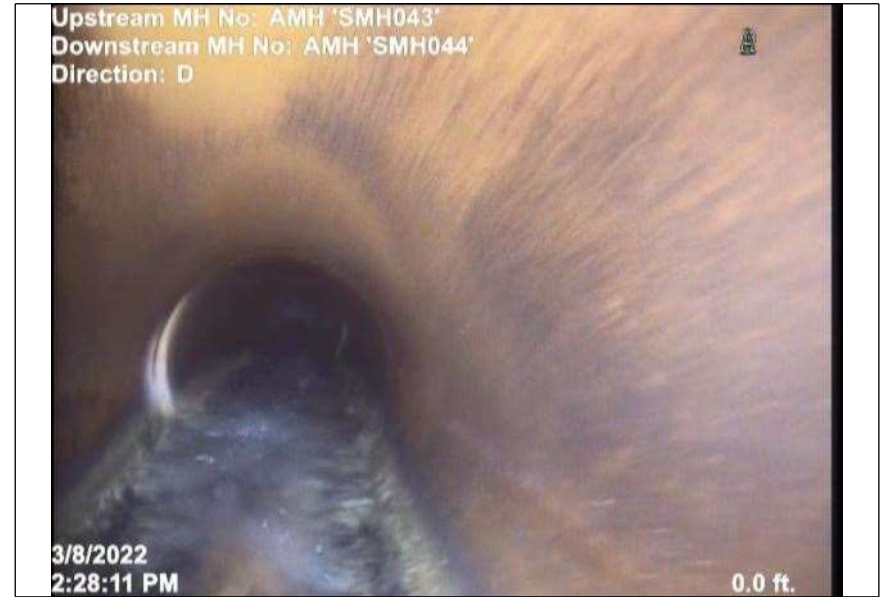
At: 0 ft. MWL - Miscellaneous Water Level
Joint: No 5%

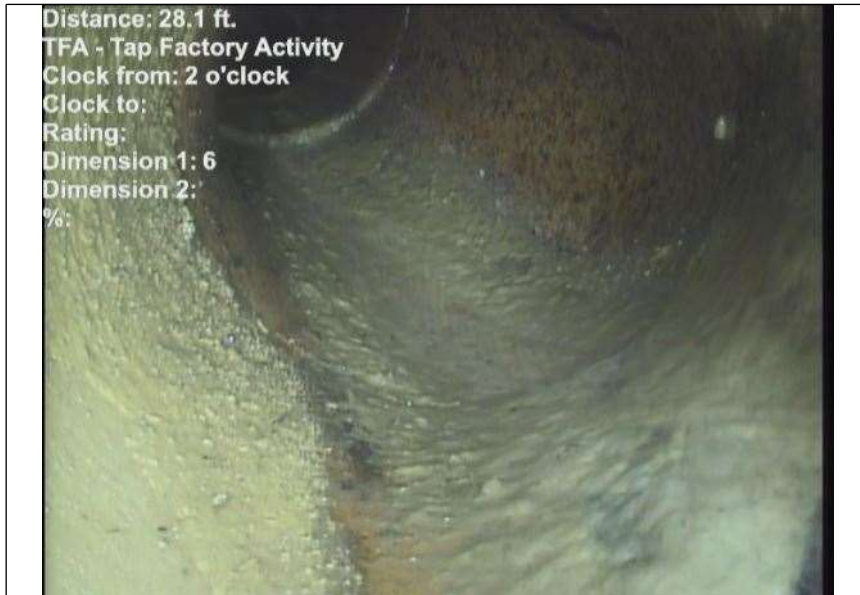
At: 28.1 ft. 2/. TFA - Tap Factory Activity
Joint: No

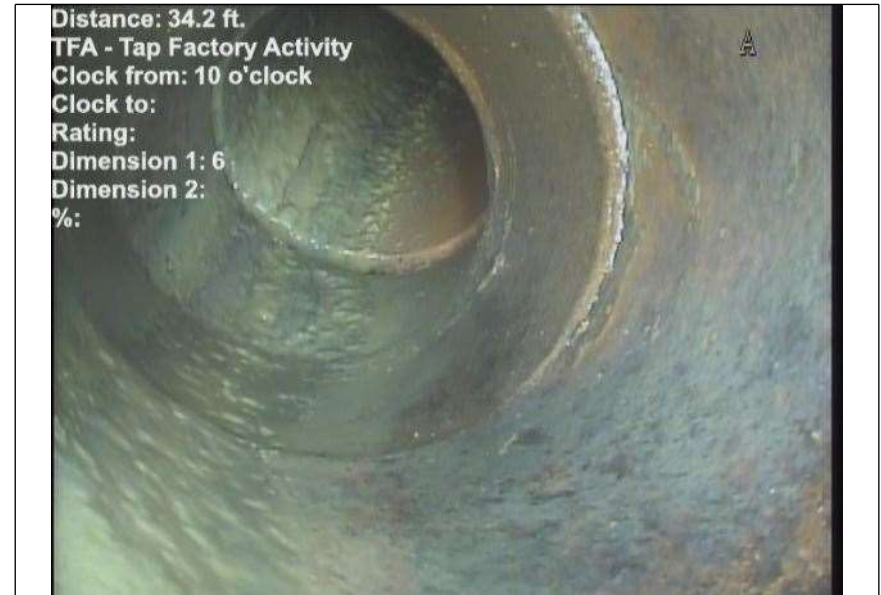
At: 34.2 ft. 10/. TFA - Tap Factory Activity
Joint: No

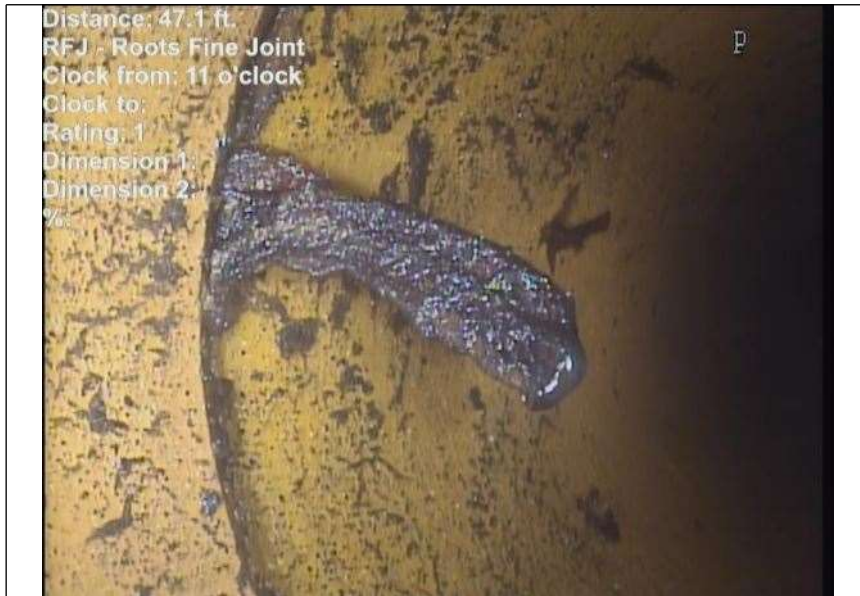
At: 47.1 ft. 11/. RFJ - Roots Fine Joint
Joint: Yes

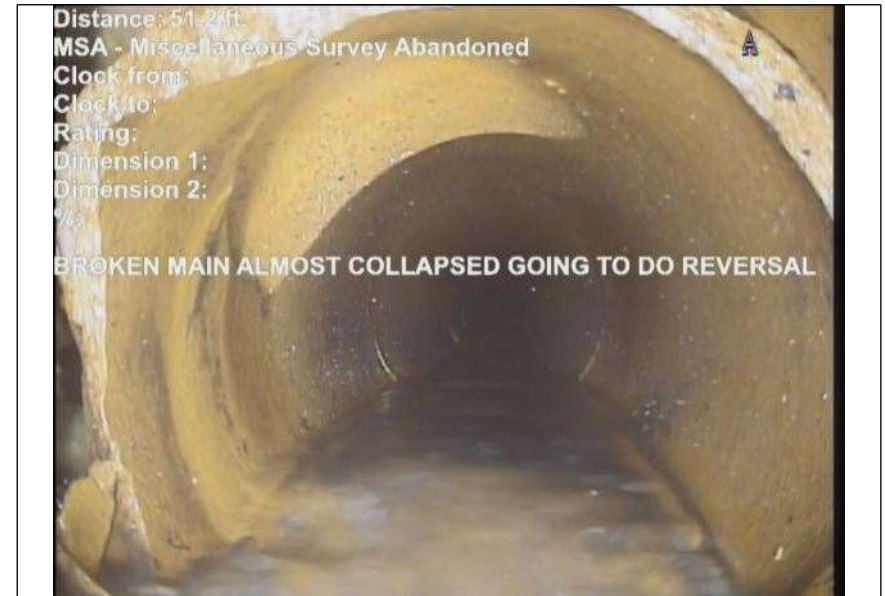
At: 51.2 ft. MSA - Miscellaneous Survey Abandoned
Joint: No **BROKEN MAIN ALMOST COLLAPSED GOING TO DO REVERSAL**

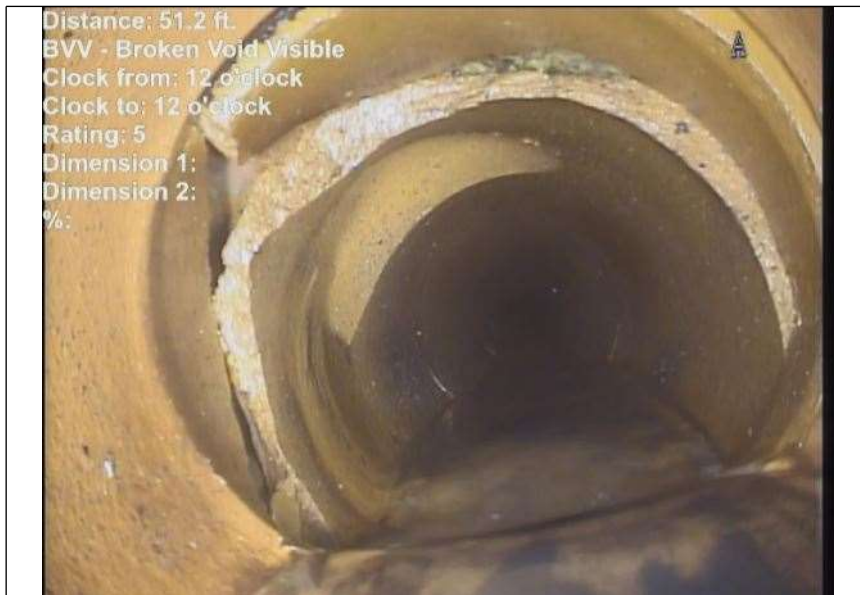
At: 51.2 ft. BVV - Broken Void Visible
12/12
Joint: No
