PACP Report with Pipe Run and Incident Snapshots

Surveyed by: DAN	Certificate number: U-716-07004752	Owner:	Customer:	Drainage area:	P/O number:	Sheet number:
Pipe segment ref.: SMH043_SMH044.	Start date/time: 20220308 15:08	Street: SUMMIT ST		City: SMITHVILLE		
Location details:		Upstream MH No: SMH043	Rim to invert:	Grade to invert:	Rim to grade:	
Pipe use: SS	Direction: U	Flow control:	Downstream MH No: SMH044	Rim to invert:	Grade to invert:	Rim to grade:
Height: 8 in.	Width:	Shape: C	Material: VCP	Lining method:	Pipe joint length:	Total length: 298.400 ft.
Media label:	PreCleaning: L	Date cleaned:	Weather: 1	Length surveyed: 247.200 ft.	Purpose:	Sewer category:
Project name: Sewer Cleaning & CCTV - Project No. 210670		Additional info:

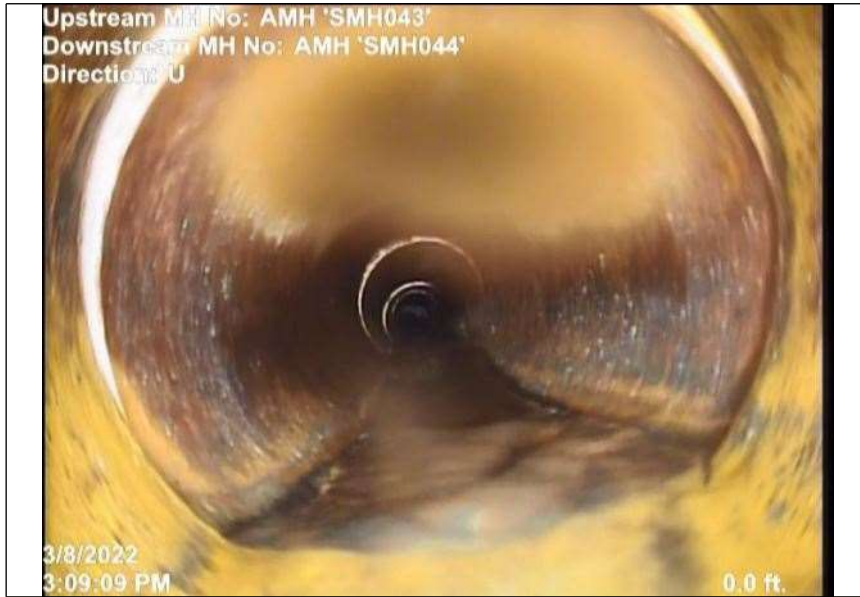
At: 0 ft. MWL - Miscellaneous Water Level
Joint: No 5 %

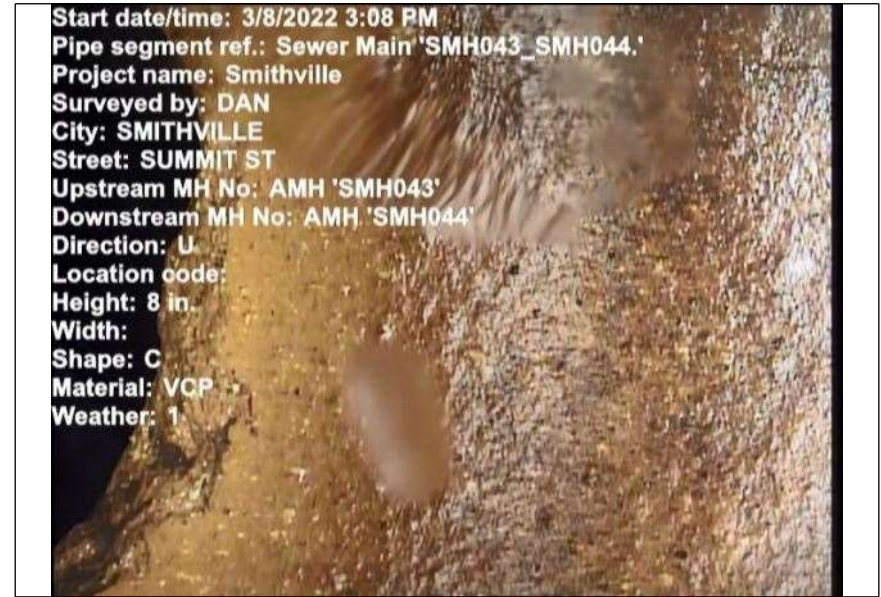
At: 0 ft. AMH - Manhole
Joint: No SMH044

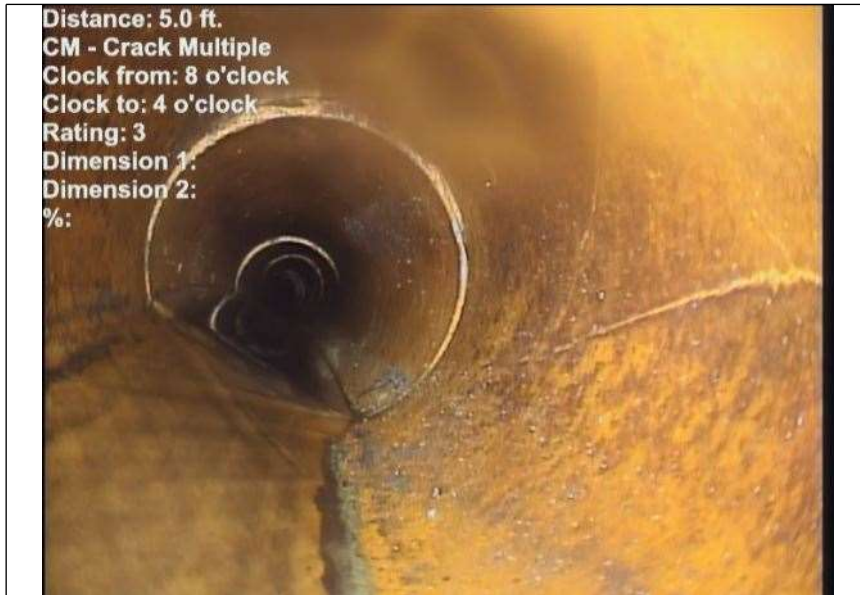
At: 5 ft. 8/4 CM - Crack Multiple
Joint: No

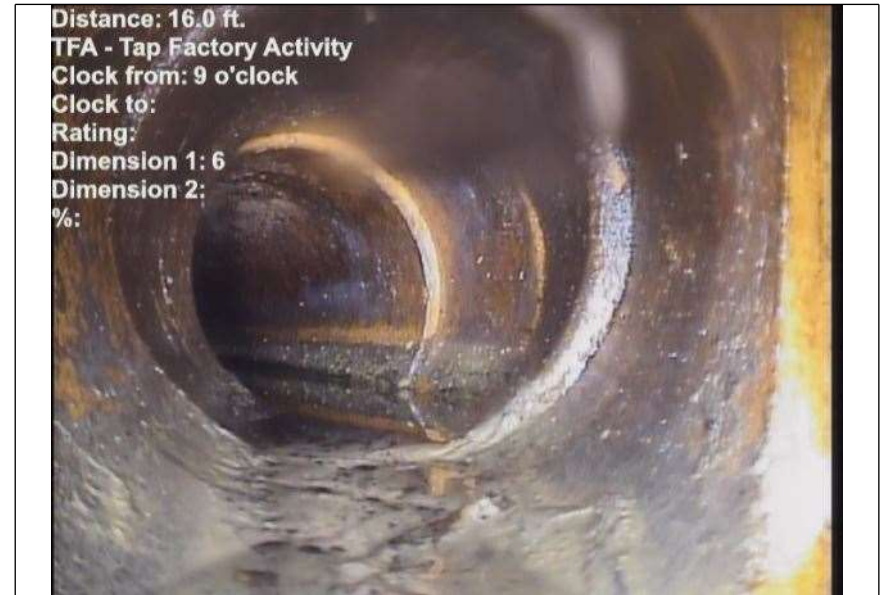
At: 16 ft. 9/. TFA - Tap Factory Activity
Joint: No

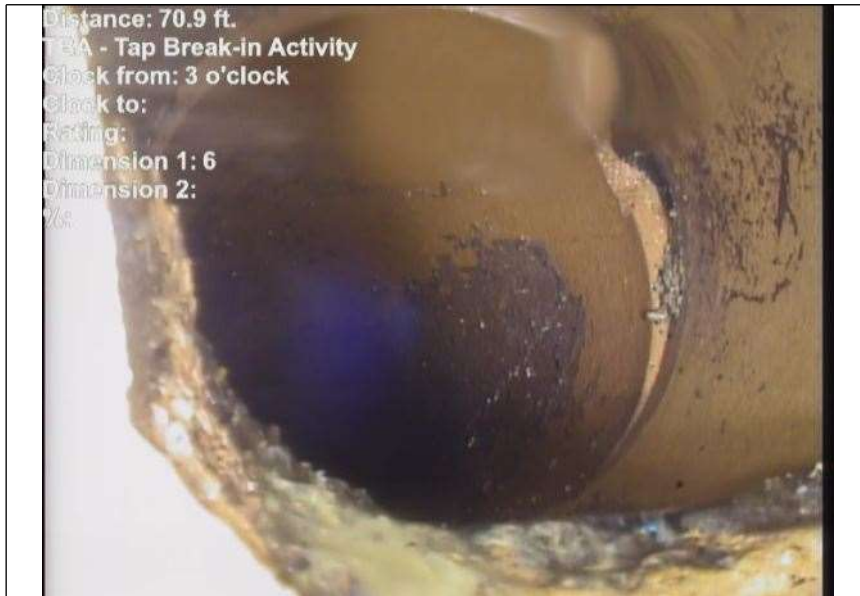
At: 70.9 ft. 3/. TBA - Tap Break-in Activity
Joint: No

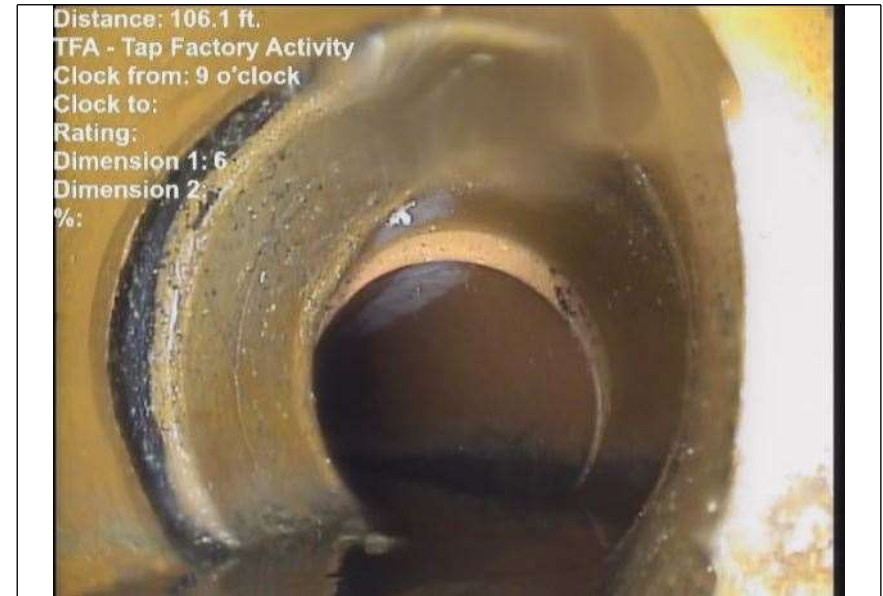
At: 106.1 ft. 9/. TFA - Tap Factory Activity
Joint: No

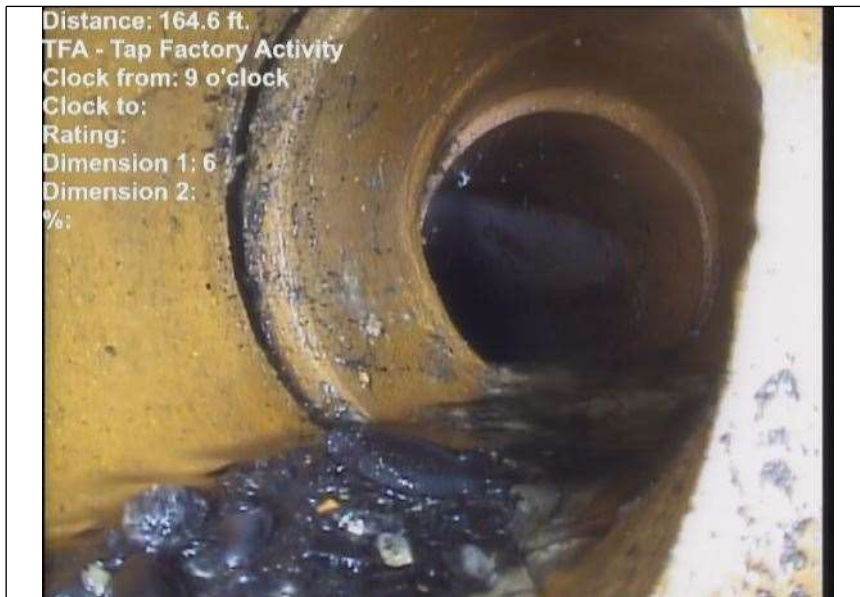
At: 164.6 ft. 9/. TFA - Tap Factory Activity
Joint: No

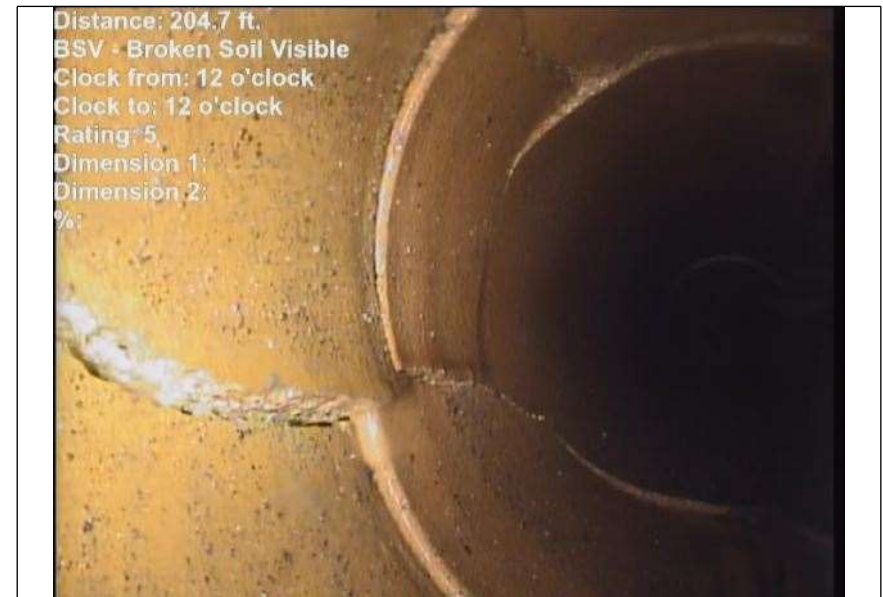
At: 204.7 ft. 12/12 BSV - Broken Soil Visible
Joint: No

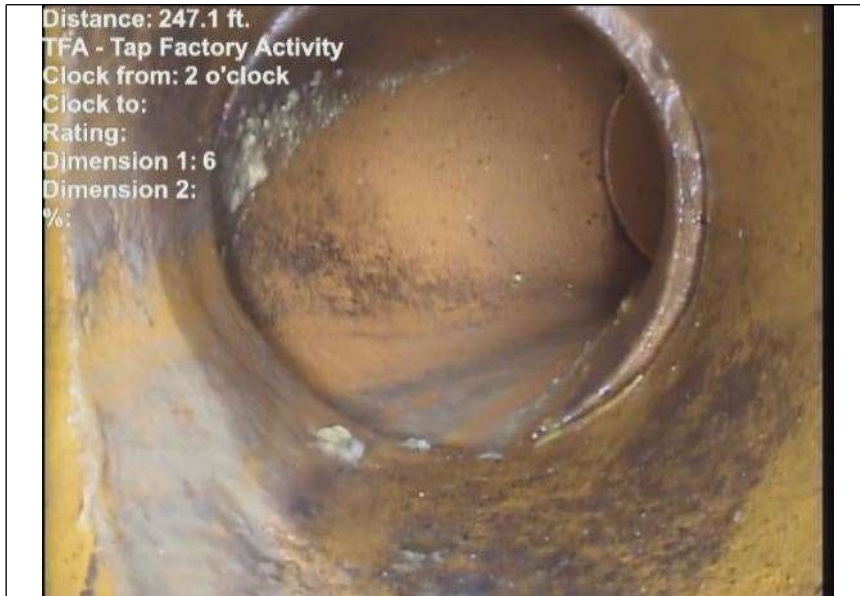
At: 247.1 ft. 2/. TFA - Tap Factory Activity
Joint: No

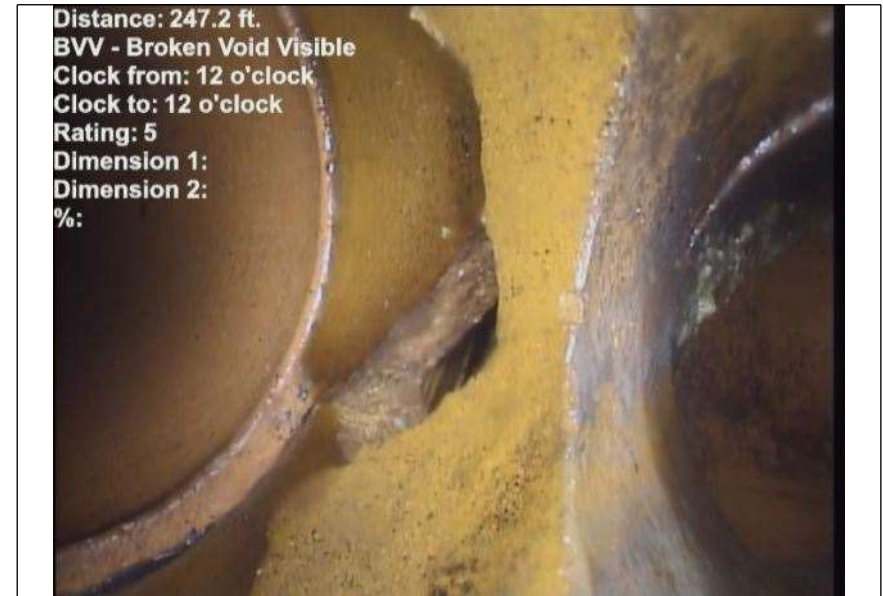
At: 247.2 ft. BVV - Broken Void Visible
12/12
Joint: No

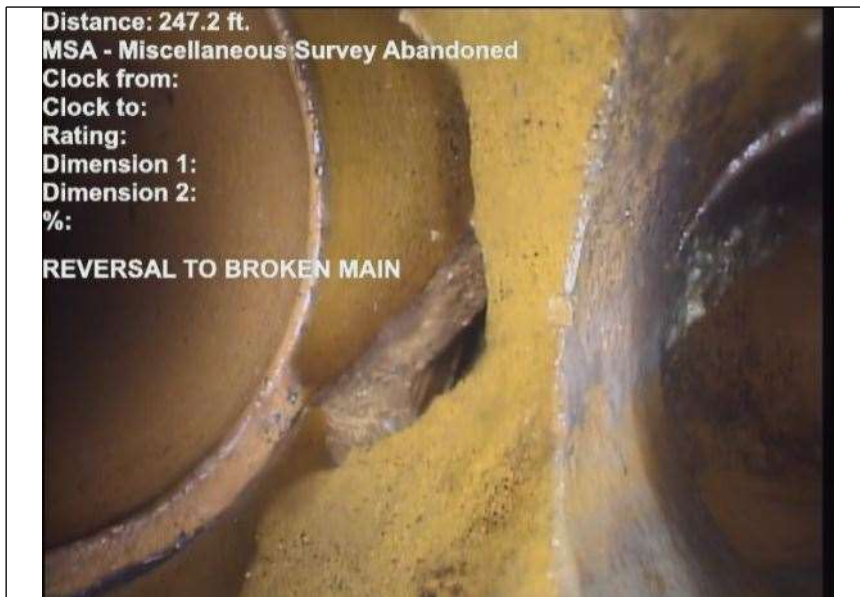
At: 247.2 ft. MSA - Miscellaneous Survey Abandoned
Joint: No REVERSAL TO BROKEN MAIN
