PACP Report with Pipe Run and Incident Snapshots

Surveyed by: DAN	Certificate number: U-716-07004752	Owner:	Customer:	Drainage area:	P/O number:	Sheet number:
Pipe segment ref.: SMH044_SMH045	Start date/time: 20220308 15:39	Street: SUMMIT ST		City: SMITHVILLE		
Location details:		Upstream MH No: SMH044	Rim to invert:	Grade to invert:	Rim to grade:	
Pipe use: SS	Direction: D	Flow control:	Downstream MH No: SMH045	Rim to invert:	Grade to invert:	Rim to grade:
Height: 8 in.	Width:	Shape: C	Material: VCP	Lining method:	Pipe joint length:	Total length: 271.100 ft.
Media label:	PreCleaning: L	Date cleaned:	Weather: 1	Length surveyed: 271.100 ft.	Purpose:	Sewer category:
Project name: Sewer Cleaning & CCTV - Project No. 210670	Additional info:

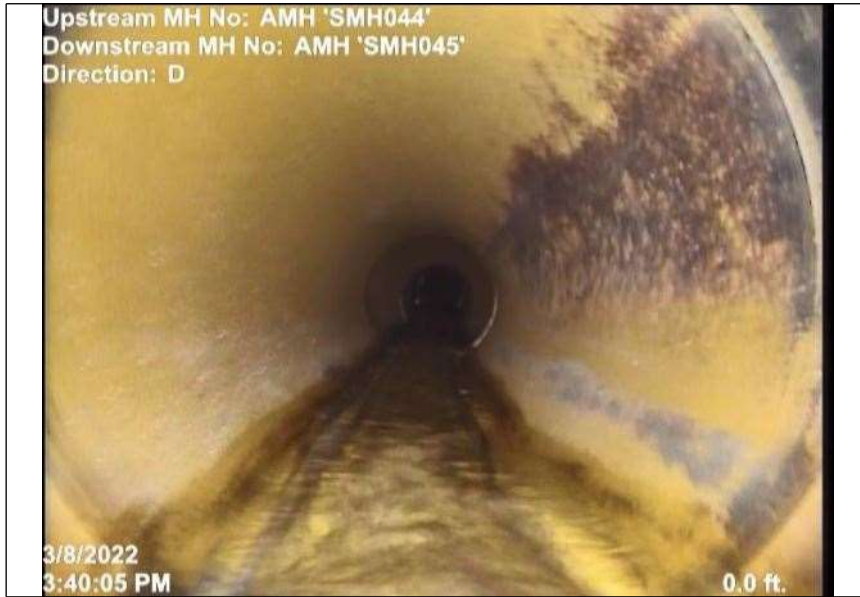
At: 0 ft. MWL - Miscellaneous Water Level
Joint: No 5%

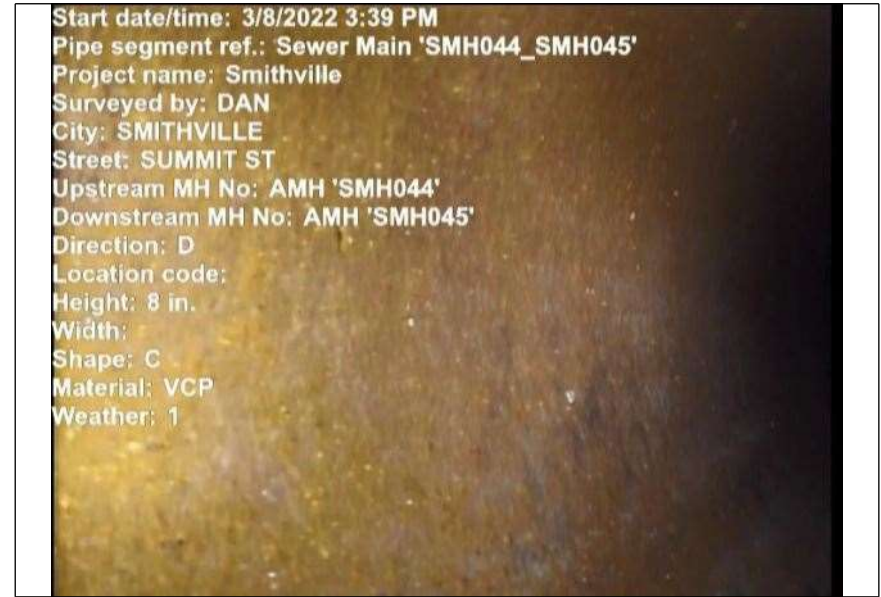
At: 0 ft. AMH - Manhole
Joint: No SMH044

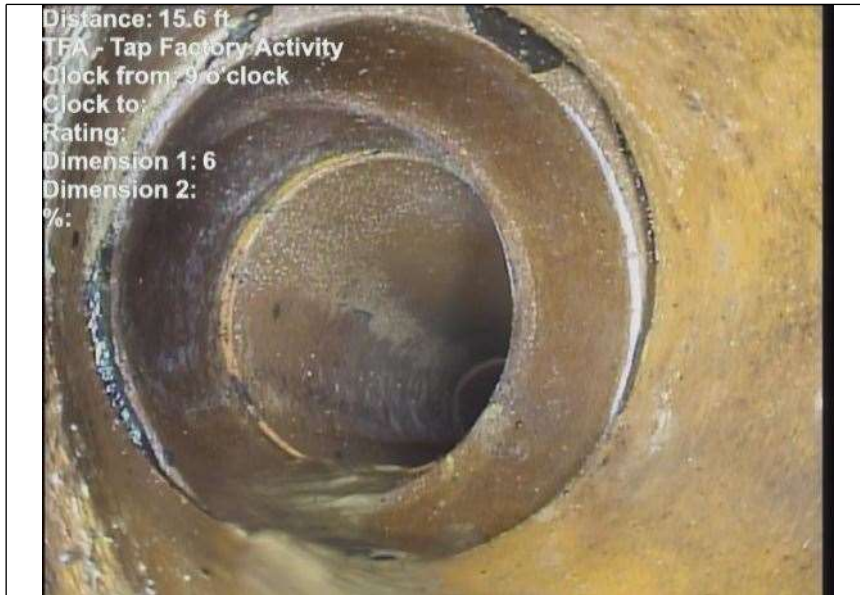
At: 15.6 ft. 9/ TFA - Tap Factory Activity
Joint: No

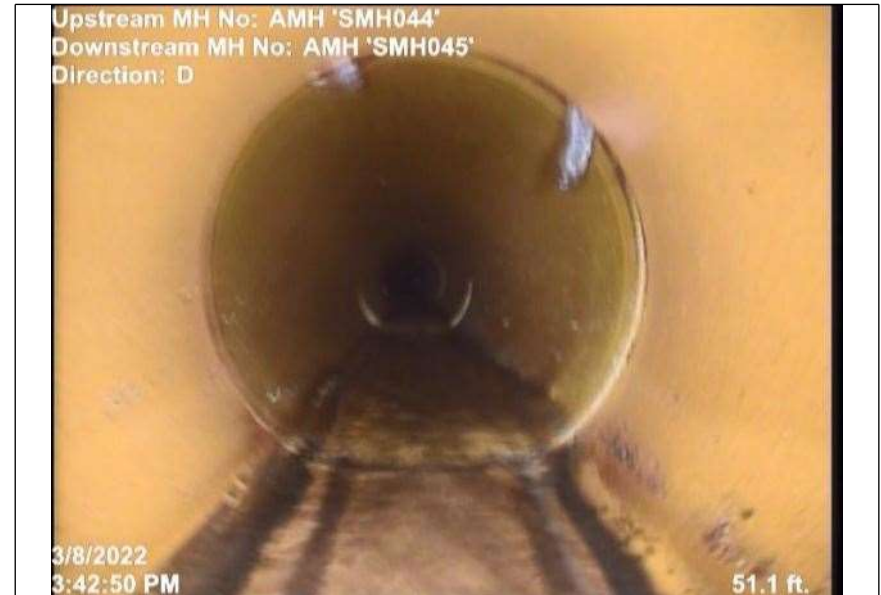
At: 53 ft. 11/2 DAE - Deposits Attached Encrustation
Joint: No 5%

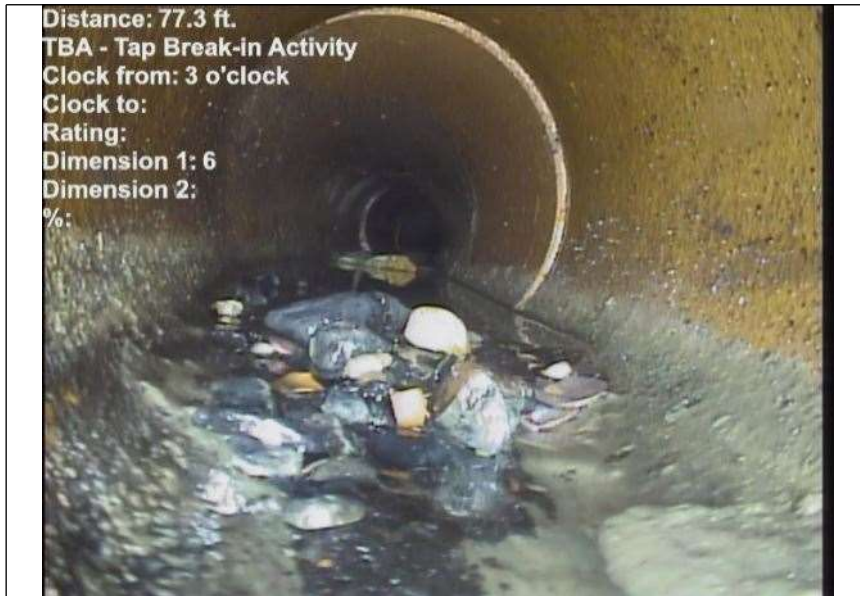
At: 77.3 ft. 3/. TBA - Tap Break-in Activity
Joint: No

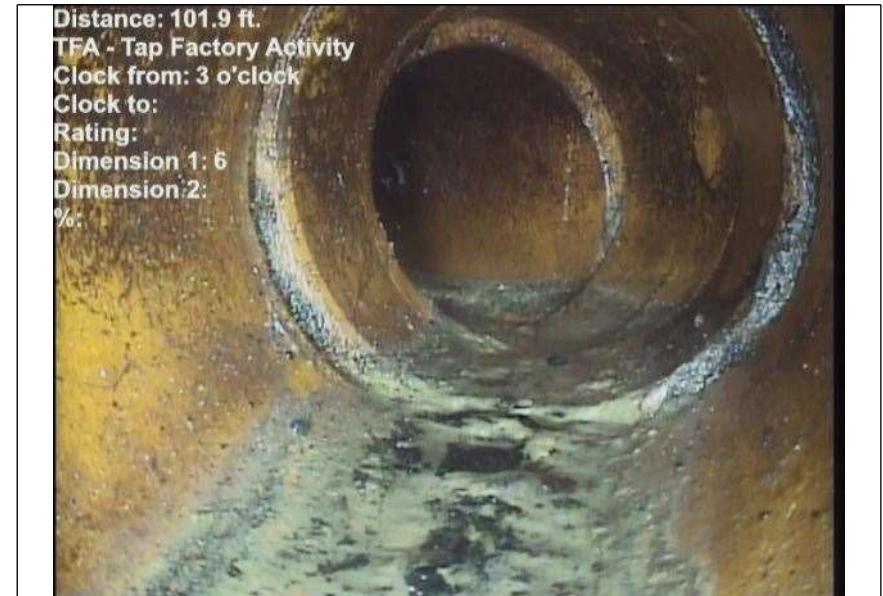
At: 101.9 ft. 3/. TFA - Tap Factory Activity
Joint: No

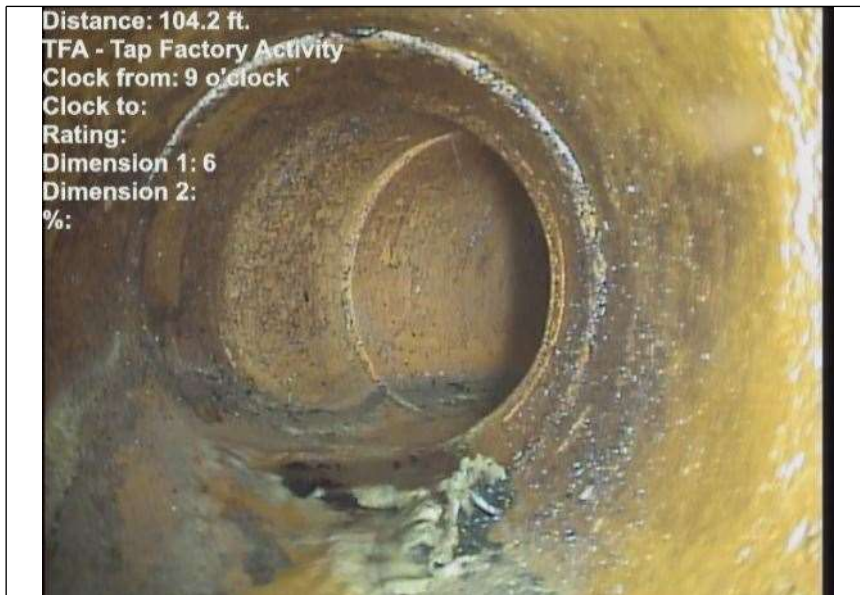
At: 104.2 ft. 9/. TFA - Tap Factory Activity
Joint: No

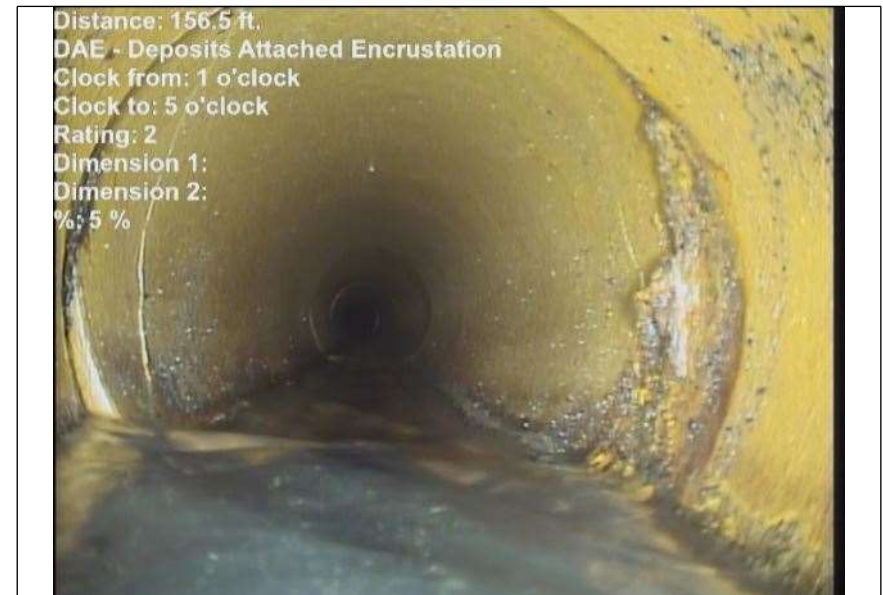
At: 156.5 ft. 1/5 DAE - Deposits Attached Encrustation
Joint: No 5 %

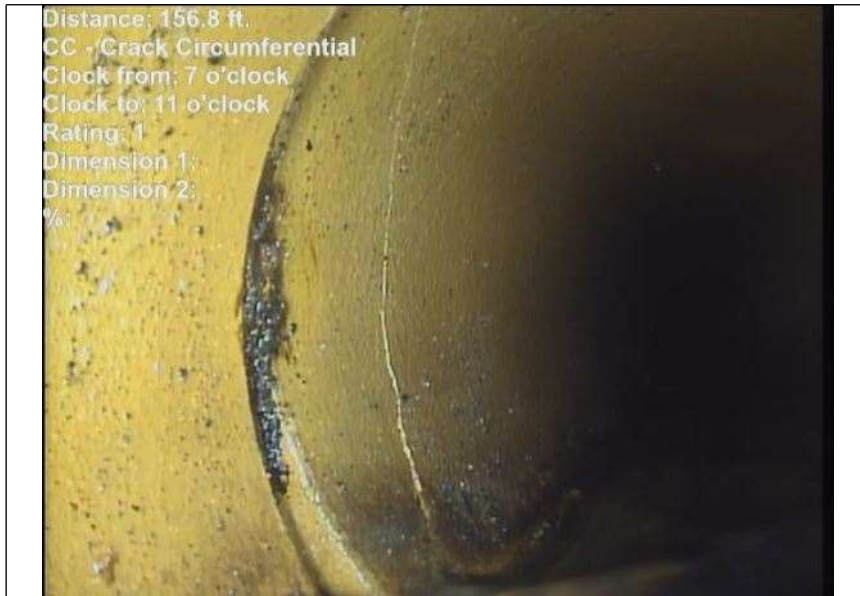
At: 156.8 ft. CC - Crack Circumferential
7/11

Joint: No

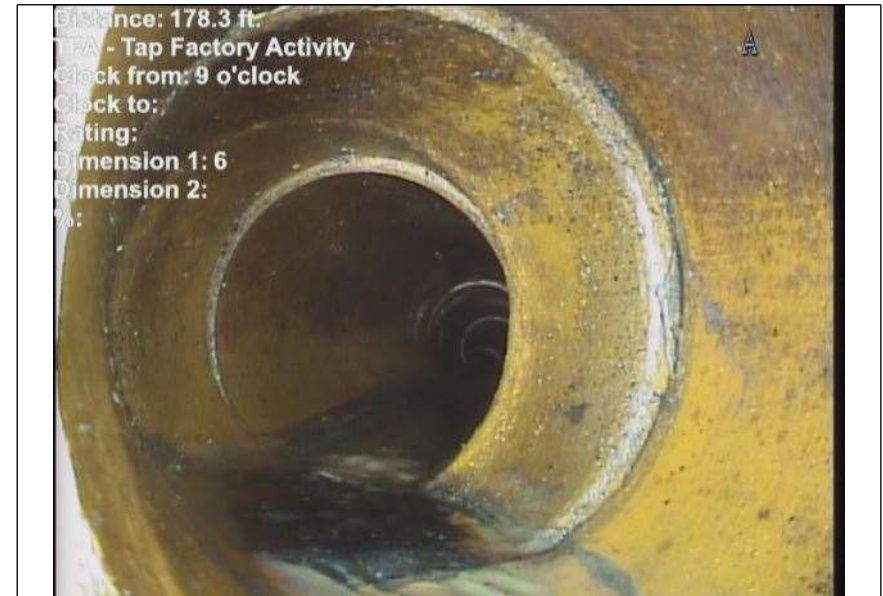
At: 178.3 ft. 9/ TFA - Tap Factory Activity

Joint: No

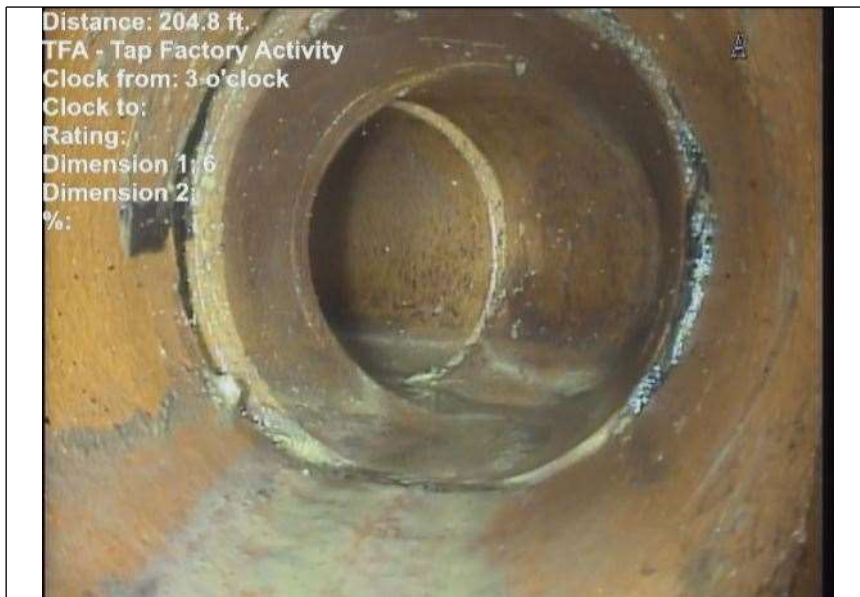
At: 204.8 ft. 3/ TFA - Tap Factory Activity

Joint: No

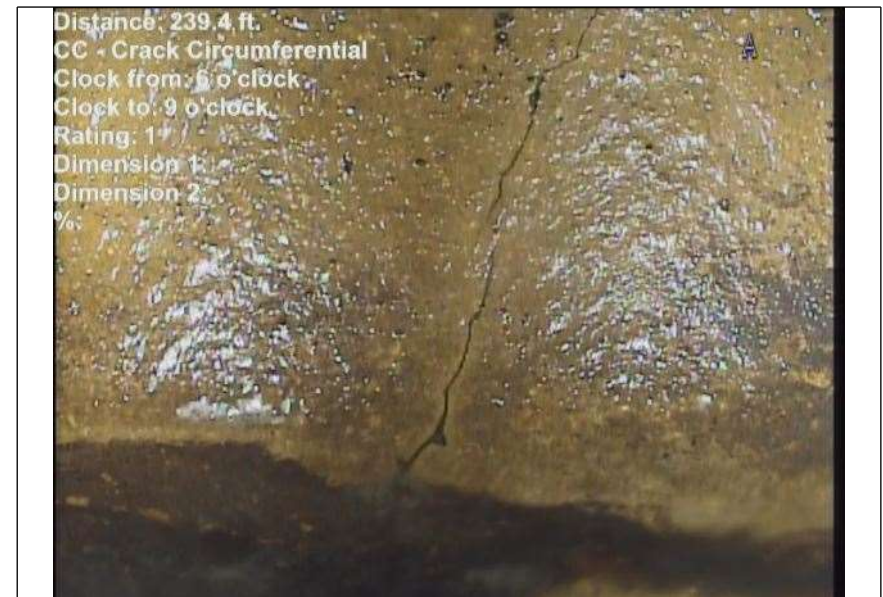
At: 239.4 ft. 6/9 CC - Crack Circumferential

Joint: No

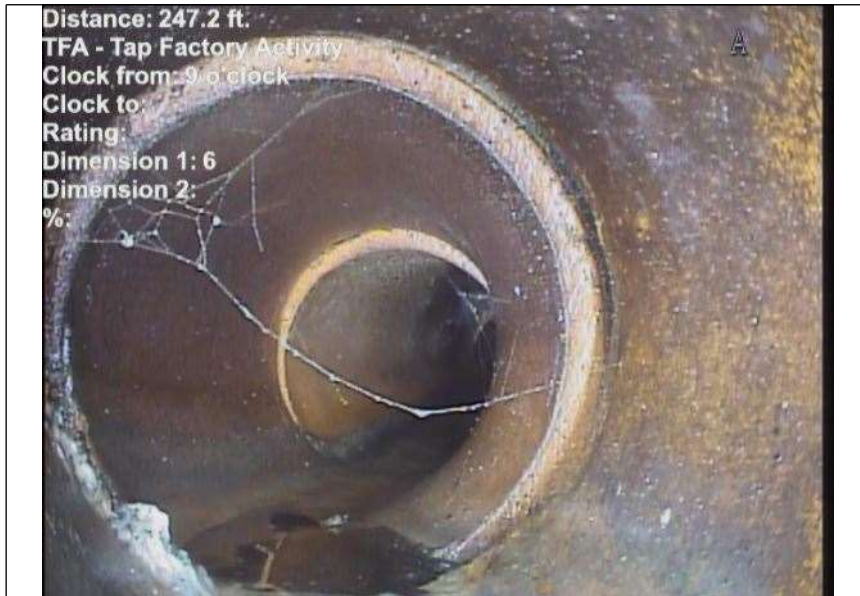
At: 247.2 ft. 9/. TFA - Tap Factory Activity
Joint: No

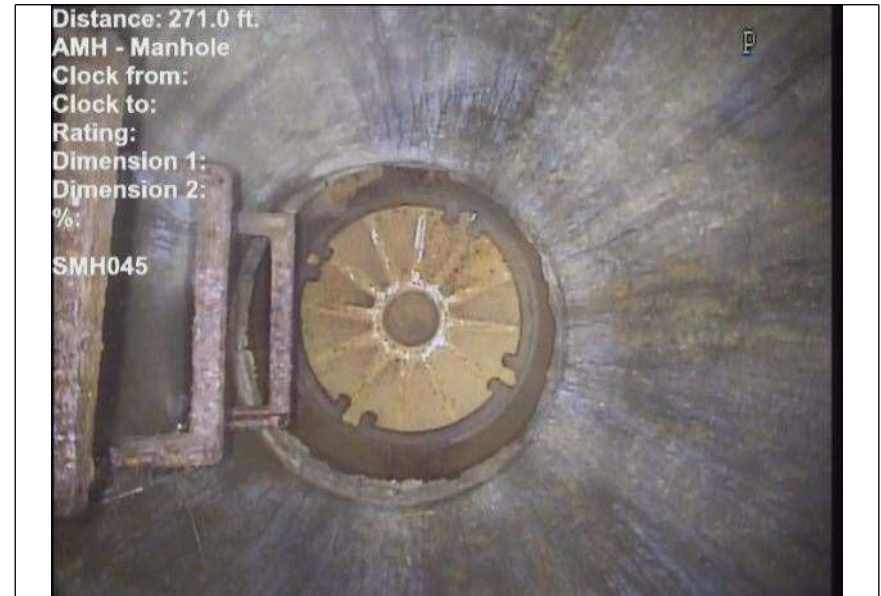
At: 271.1 ft. AMH - Manhole
Joint: No SMH045
