PACP Report with Pipe Run and Incident Snapshots

Surveyed by: DAN	Certificate number: U-716-07004752	Owner:	Customer:	Drainage area:	P/O number:	Sheet number:			
Pipe segment ref.: SMH045_SMH046	Start date/time: 20220309 09:43	Street: SUMMIT	City: SMITHVILLE						
Location details:	Upstream MH No: SMH045	Rim to invert:	Grade to invert:	Rim to grade:					
Pipe use: SS	Direction: D	Flow control:	Downstream MH No: SMH046	Rim to invert:	Grade to invert:	Rim to grade:			
Height: 8 in.	Width:	Shape: C	Material: VCP	Lining method:	Pipe joint length:	Total length: 387.800 ft.	Length surveyed: 387.800 ft.	Purpose:	Sewer category:
Media label:	PreCleaning: L	Date cleaned:	Weather: 1	Location code:	Pressure value:				
Project name: Sewer Cleaning & CCTV - Project No. 210670	Additional info:

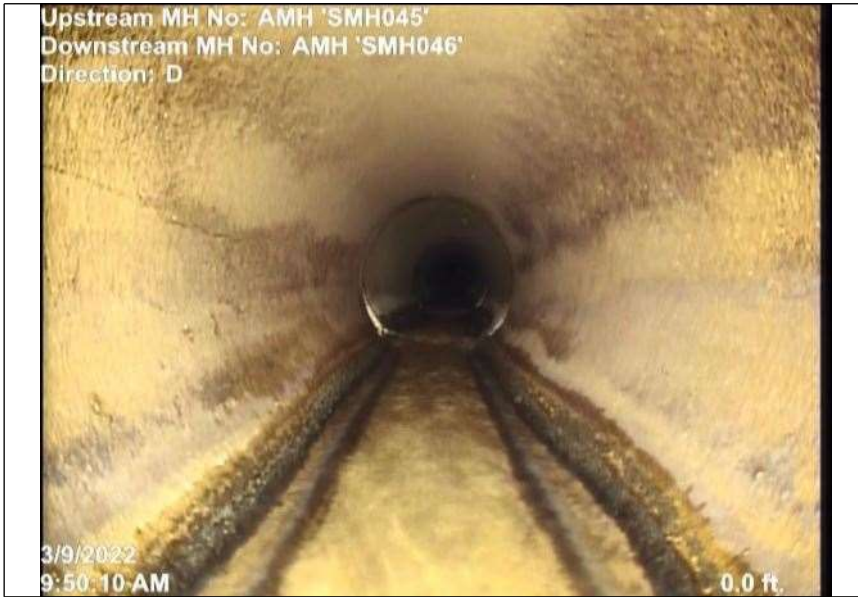
At: 0 ft. MWL - Miscellaneous Water Level
Joint: No 5 %

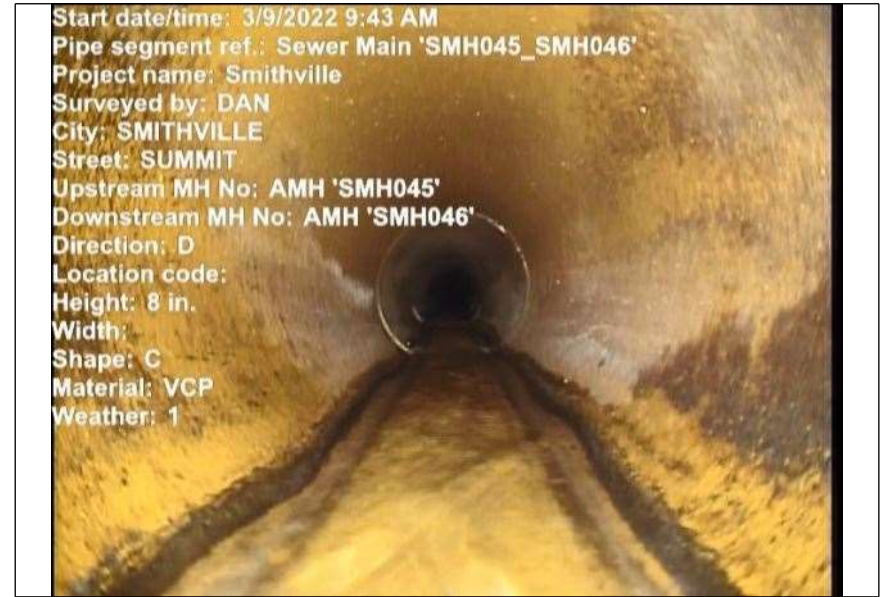
At: 0 ft. AMH - Manhole
Joint: No SMH045

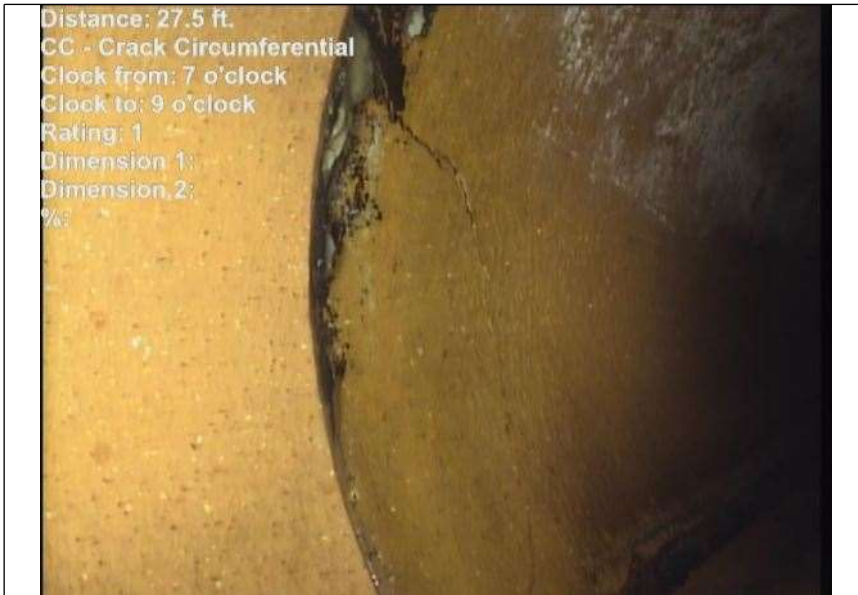
At: 27.5 ft. 7/9 CC - Crack Circumferential
Joint: No

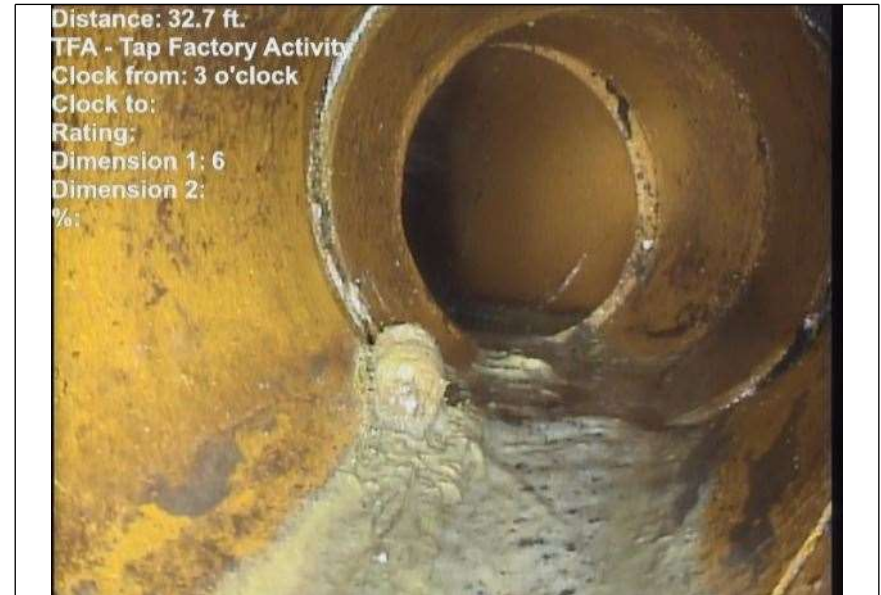
At: 32.7 ft. 3/ TFA - Tap Factory Activity
Joint: No

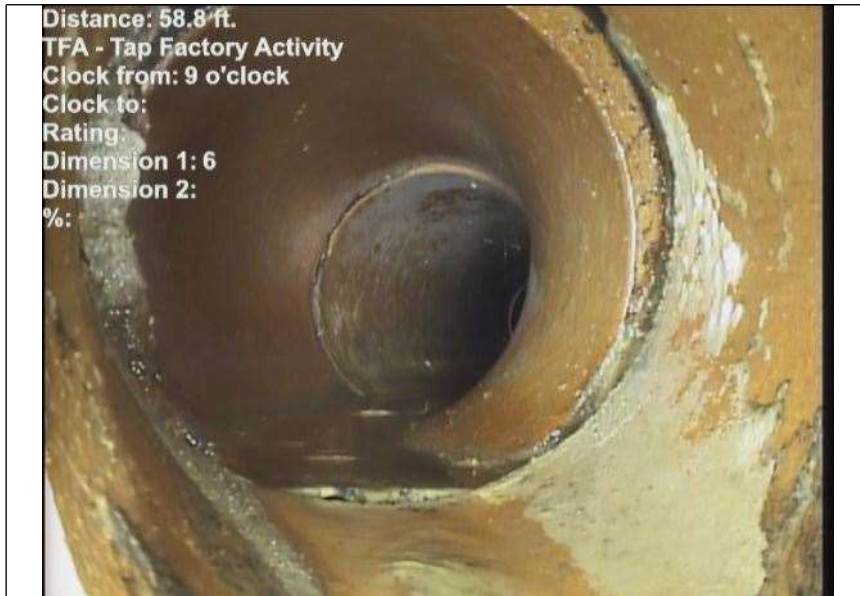
At: 58.8 ft. 9/ TFA - Tap Factory Activity
Joint: No

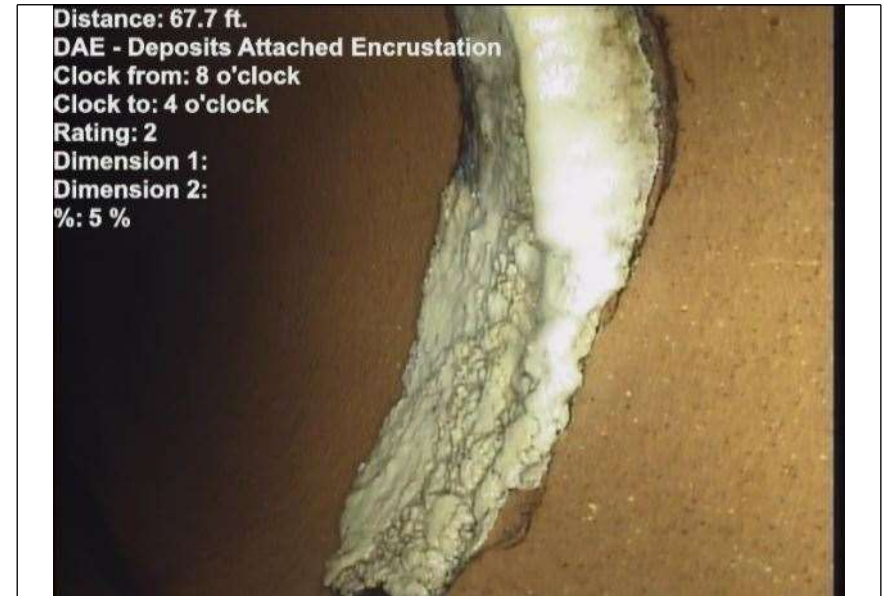
At: 67.7 ft. 8/4 DAE - Deposits Attached Encrustation
Joint: No 5 %

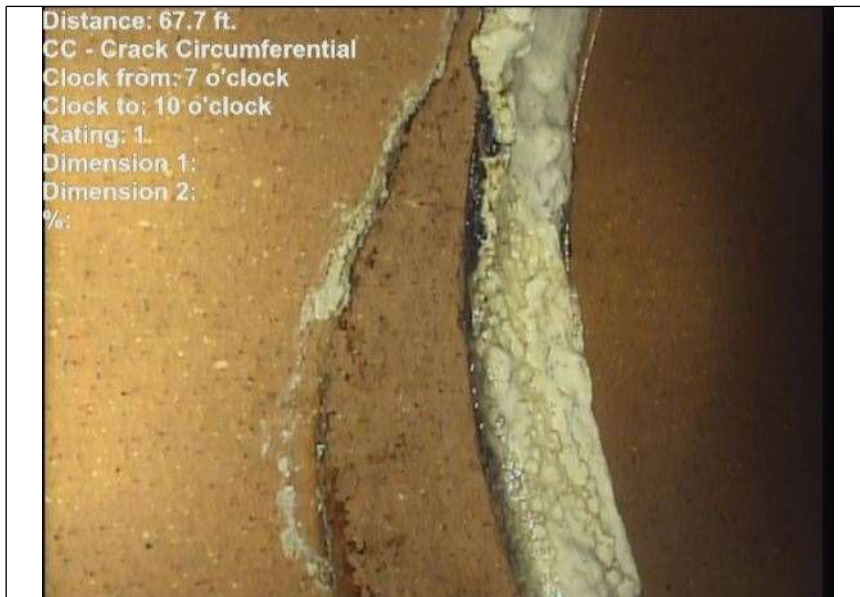
At: 67.7 ft. 7/10 CC - Crack Circumferential
Joint: No

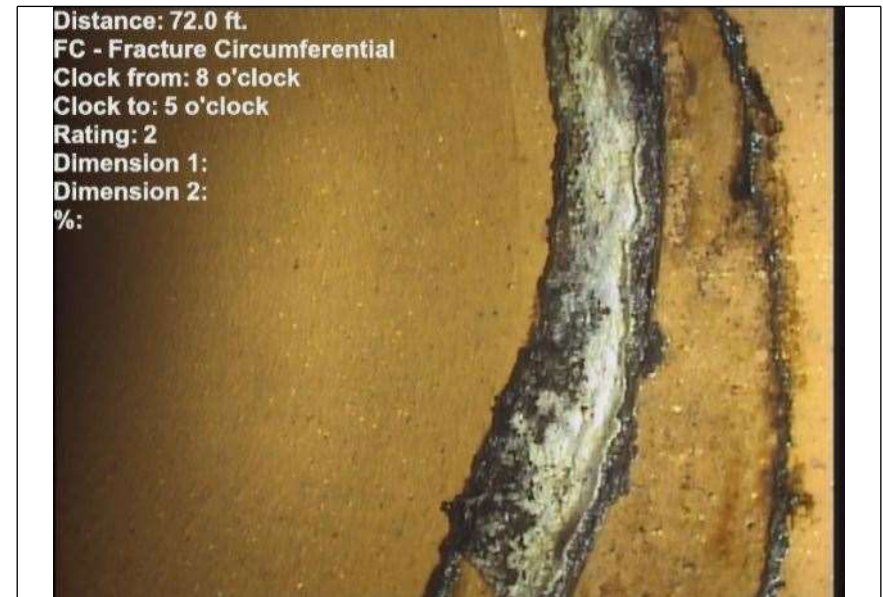
At: 72 ft. 8/5 FC - Fracture Circumferential
Joint: No

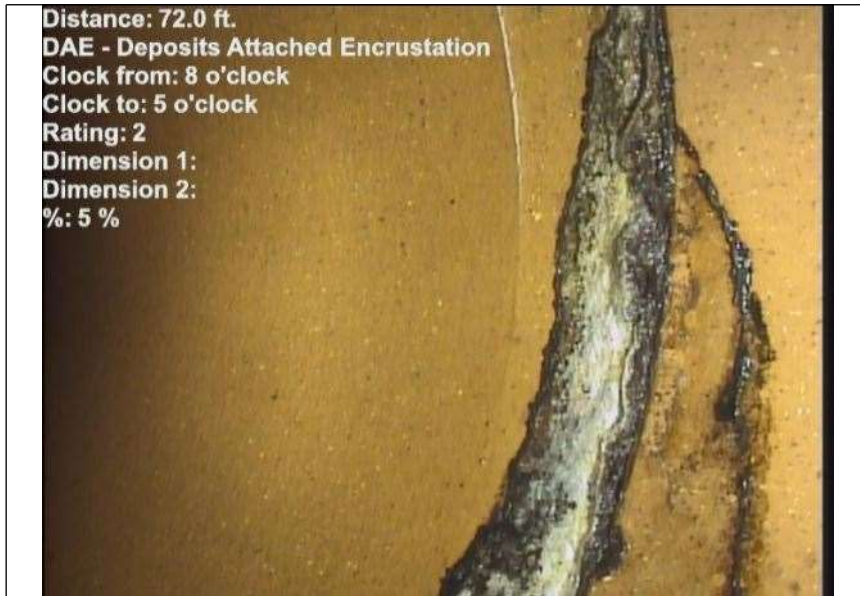
At: 72 ft. 8/5 DAE - Deposits Attached Encrustation
Joint: No 5 %

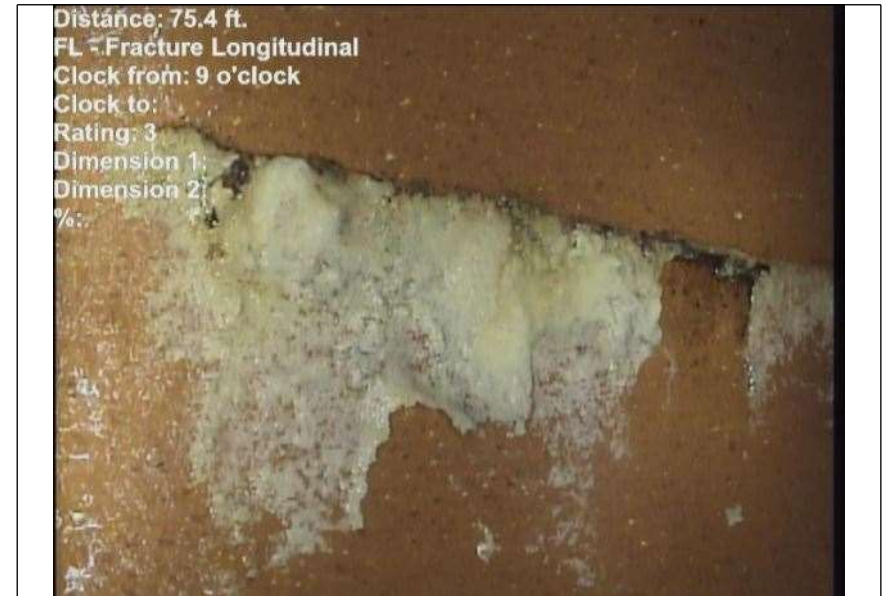
At: 75.4 ft. 9/ FL - Fracture Longitudinal
Joint: No

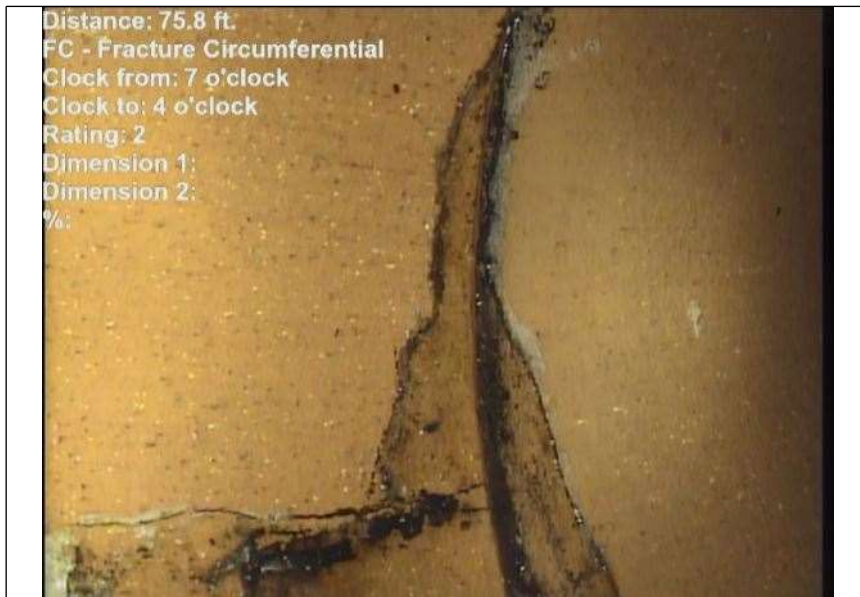
At: 75.8 ft. 7/4 FC - Fracture Circumferential
Joint: No

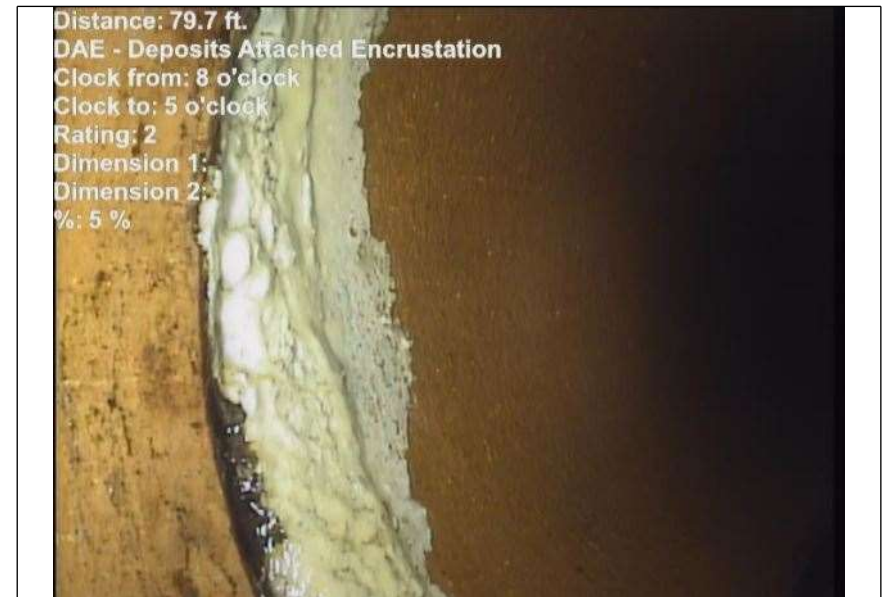
At: 79.7 ft. 8/5 DAE - Deposits Attached Encrustation
Joint: No 5 %

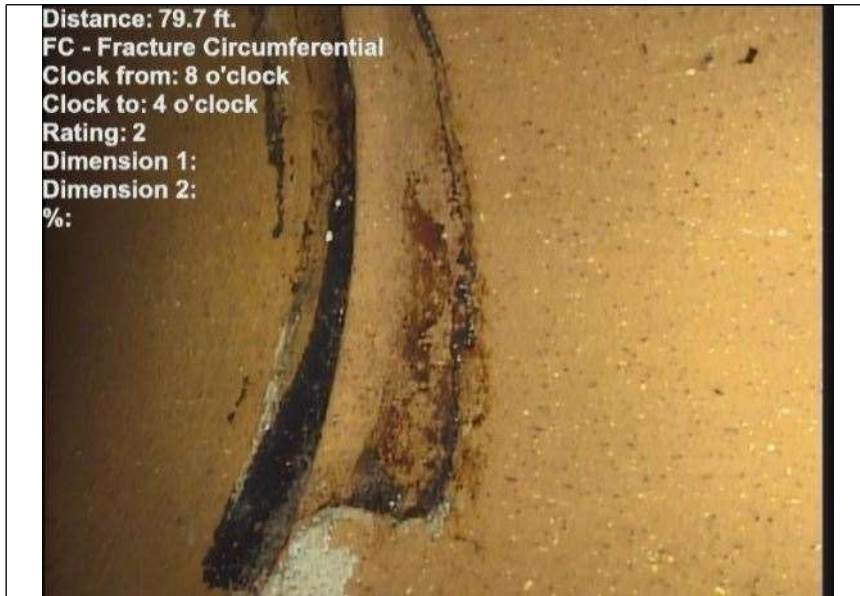
At: 79.7 ft. 8/4 FC - Fracture Circumferential
Joint: No

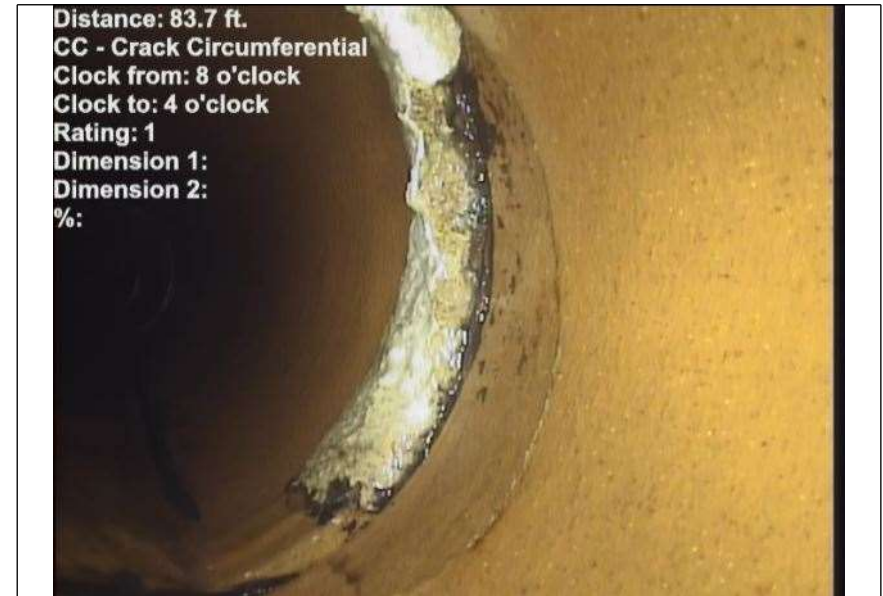
At: 83.7 ft. 8/4 CC - Crack Circumferential
Joint: No

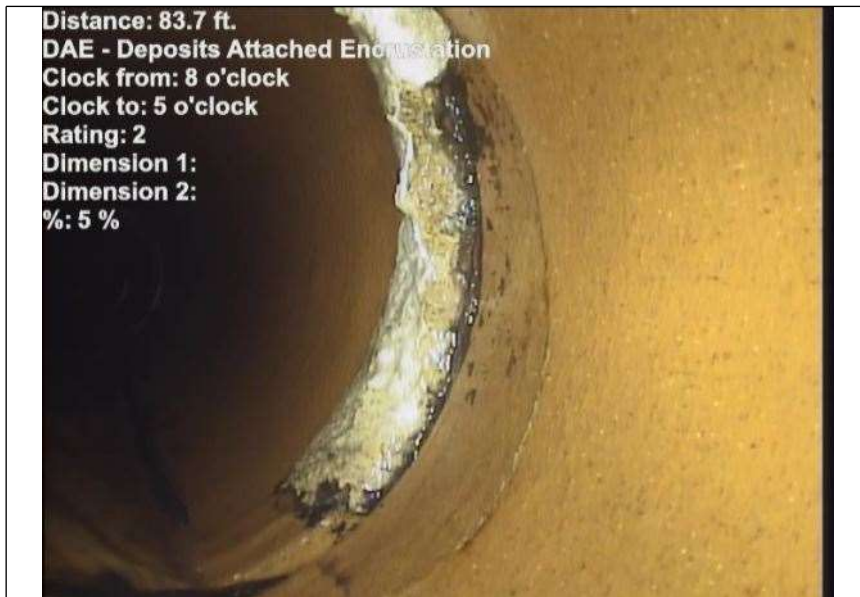
At: 83.7 ft. 8/5 DAE - Deposits Attached Encrustation
Joint: No 5 %

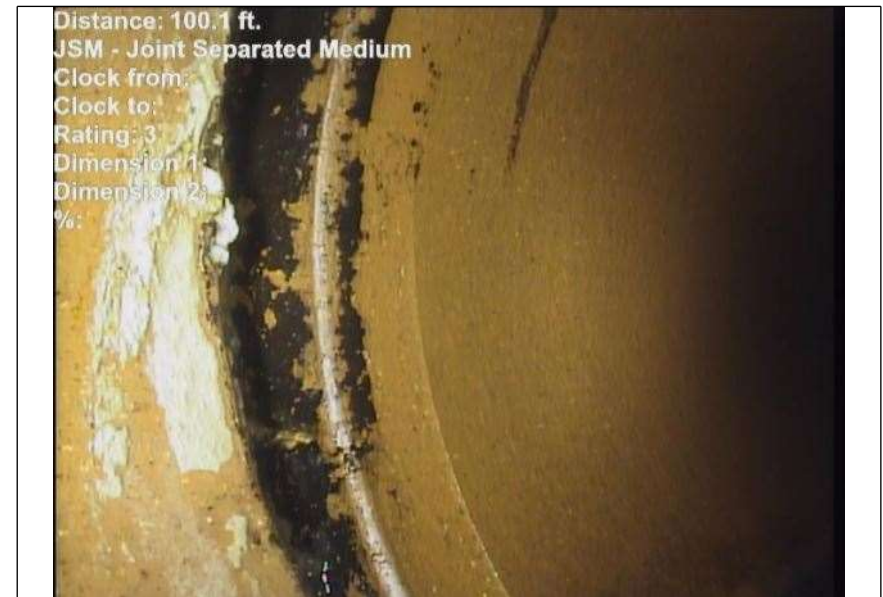
At: 100.1 ft. JSM - Joint Separated Medium
Joint: No

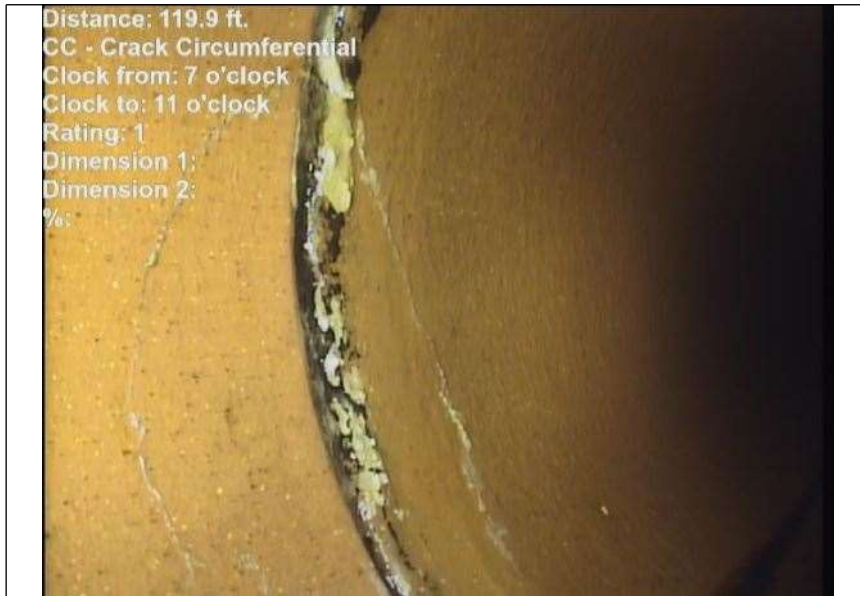
At: 119.9 ft. CC - Crack Circumferential
7/11

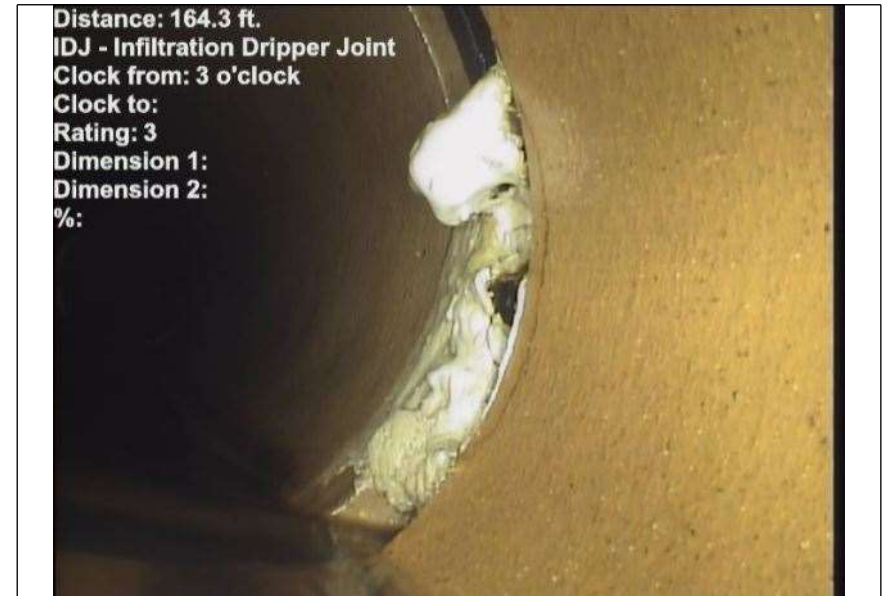
At: 164.3 ft. 3/. IDJ - Infiltration Dripper Joint

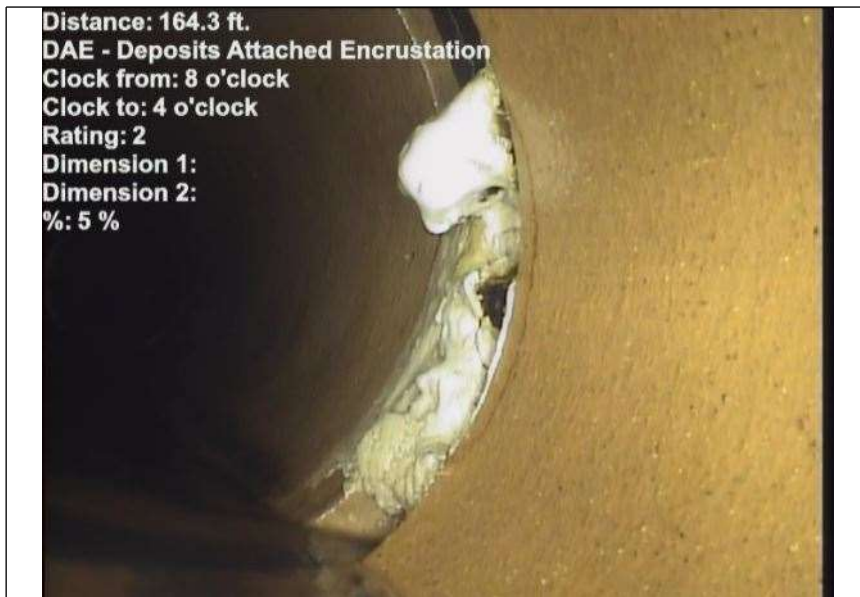
At: 164.3 ft. 8/4 DAE - Deposits Attached Encrustation

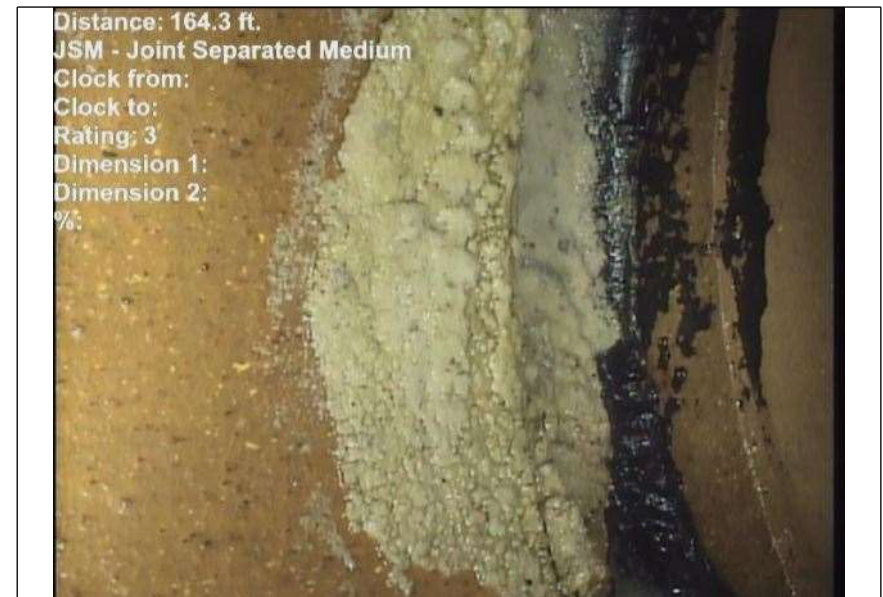
At: 164.3 ft. JSM - Joint Separated Medium

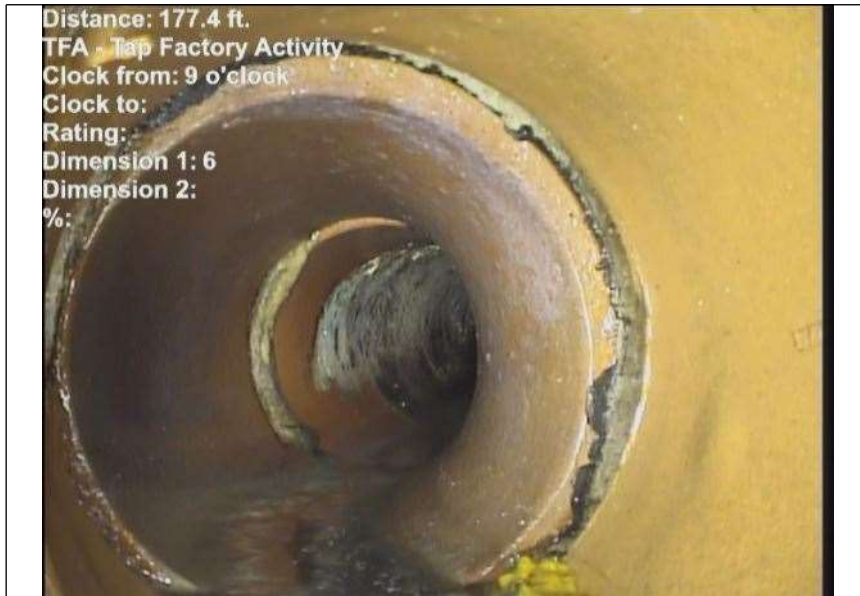
At: 177.4 ft. 9/ TFA - Tap Factory Activity
Joint: No

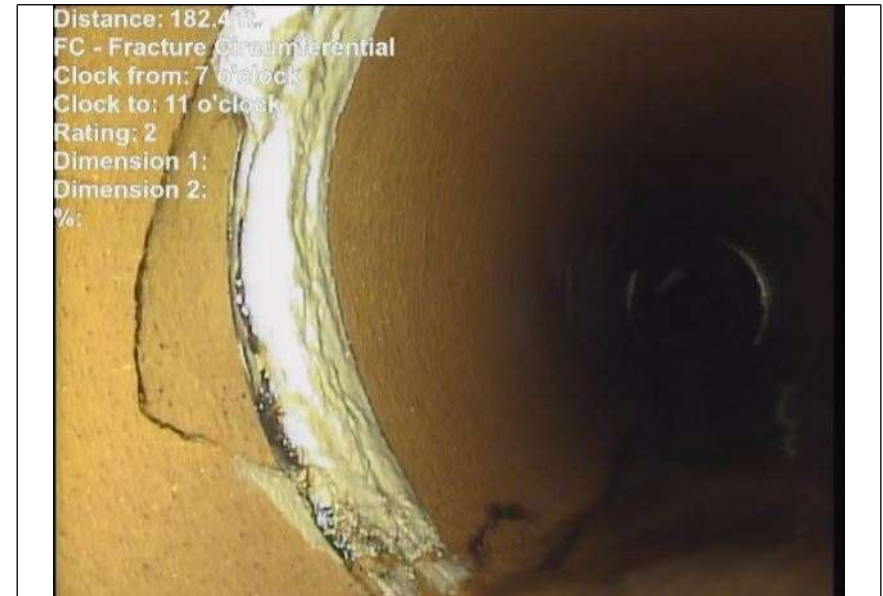
At: 182.4 ft. FC - Fracture Circumferential
7/11
Joint: No

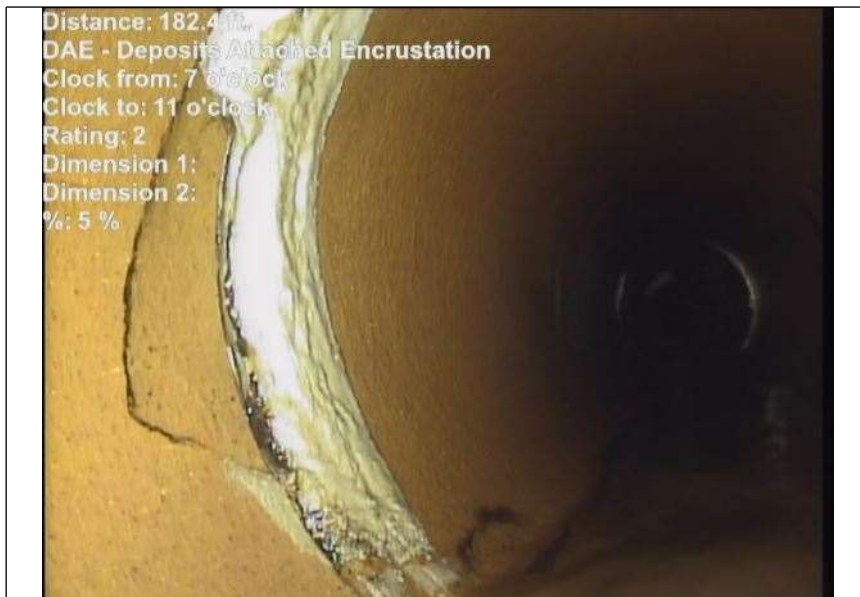
At: 182.4 ft. DAE - Deposits Attached Encrustation
7/11
Joint: No 5 %

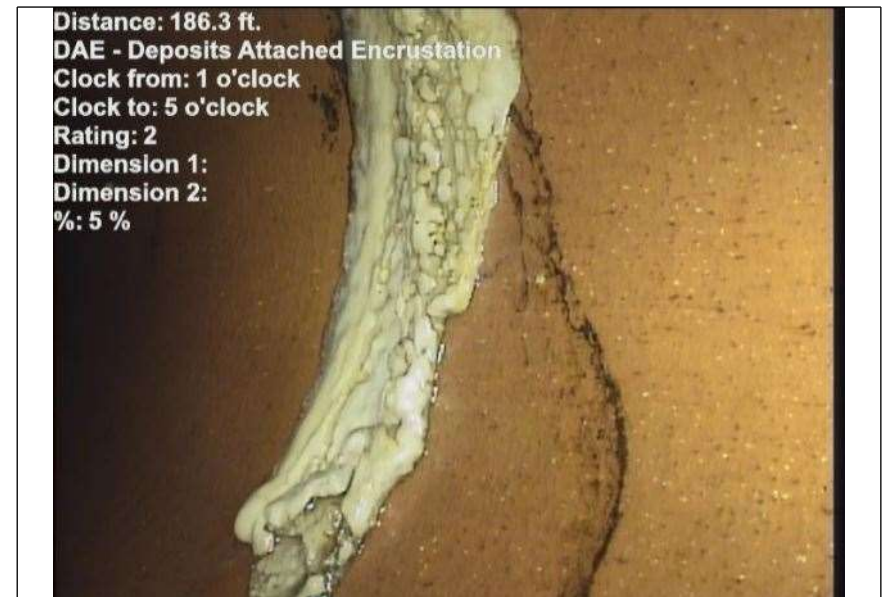
At: 186.3 ft. 1/5 DAE - Deposits Attached Encrustation
Joint: No 5 %

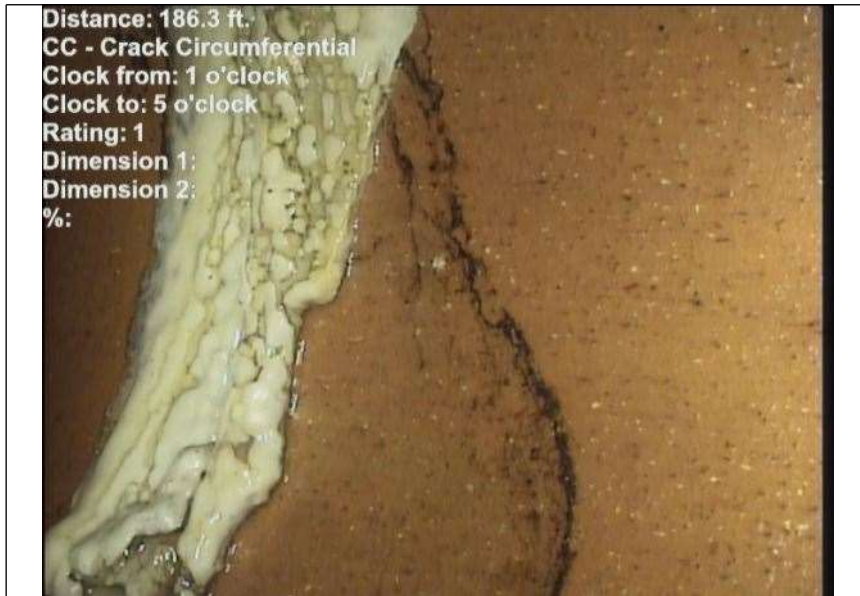
At: 186.3 ft. 1/5 CC - Crack Circumferential
Joint: No

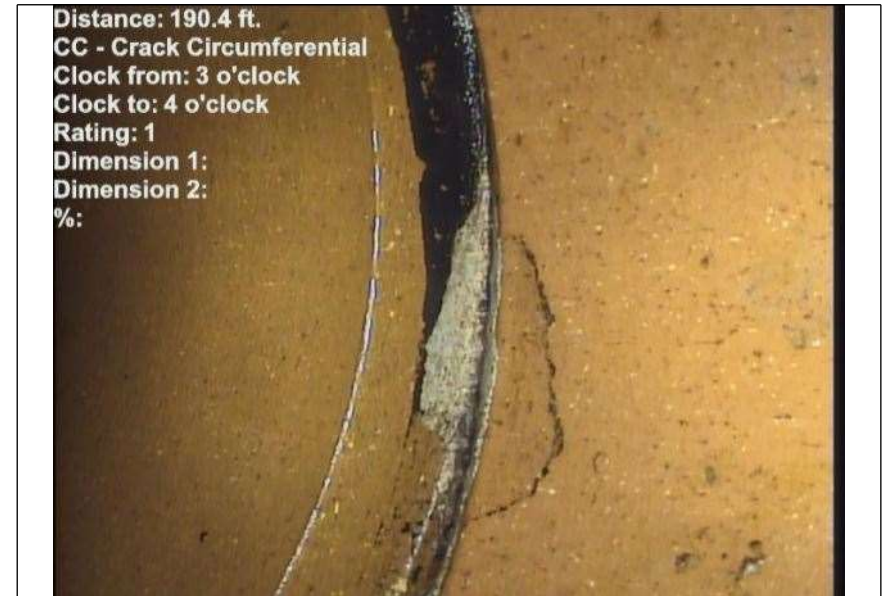
At: 190.4 ft. 3/4 CC - Crack Circumferential
Joint: No

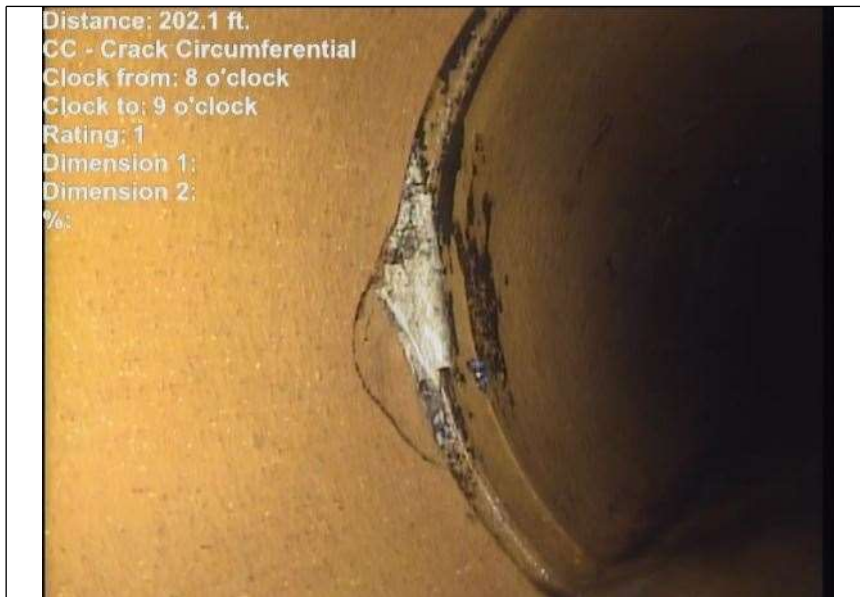
At: 202.1 ft. 8/9 CC - Crack Circumferential
Joint: No

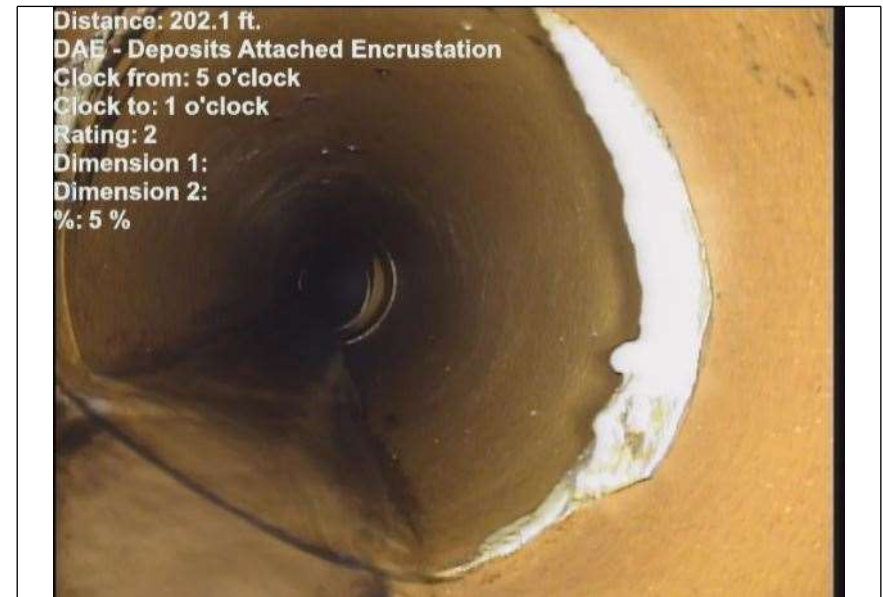
At: 202.1 ft. 5/1 DAE - Deposits Attached Encrustation
Joint: No 5 %

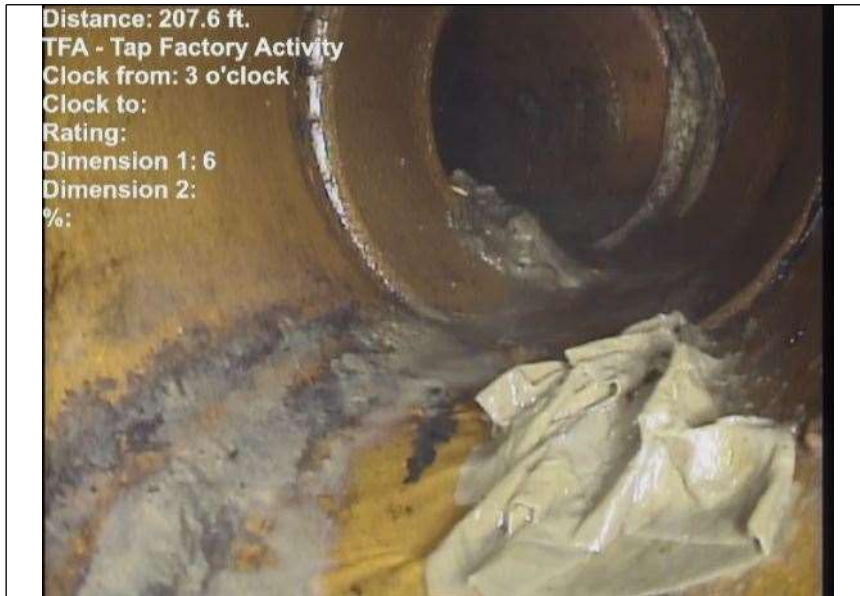
At: 207.6 ft. 3/. TFA - Tap Factory Activity
Joint: No

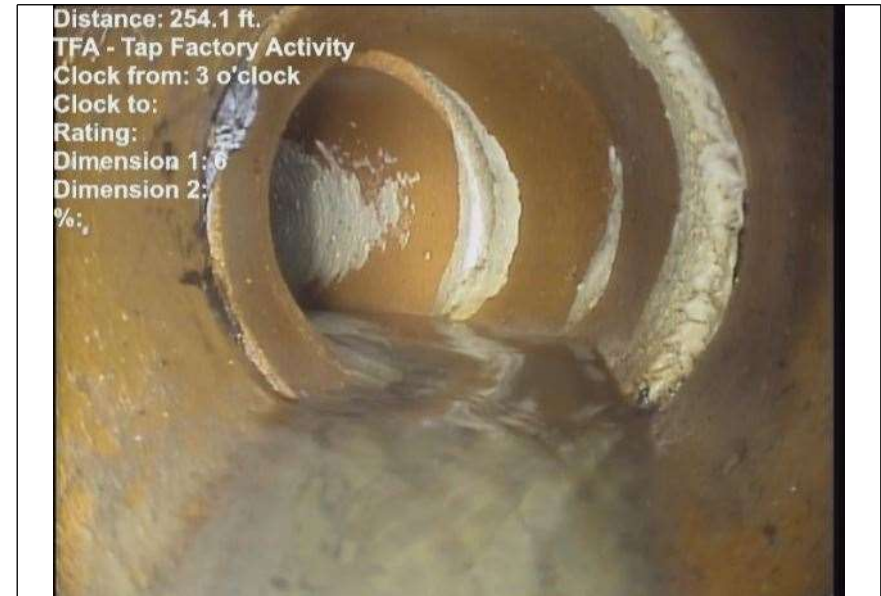
At: 254.1 ft. 3/. TFA - Tap Factory Activity
Joint: No

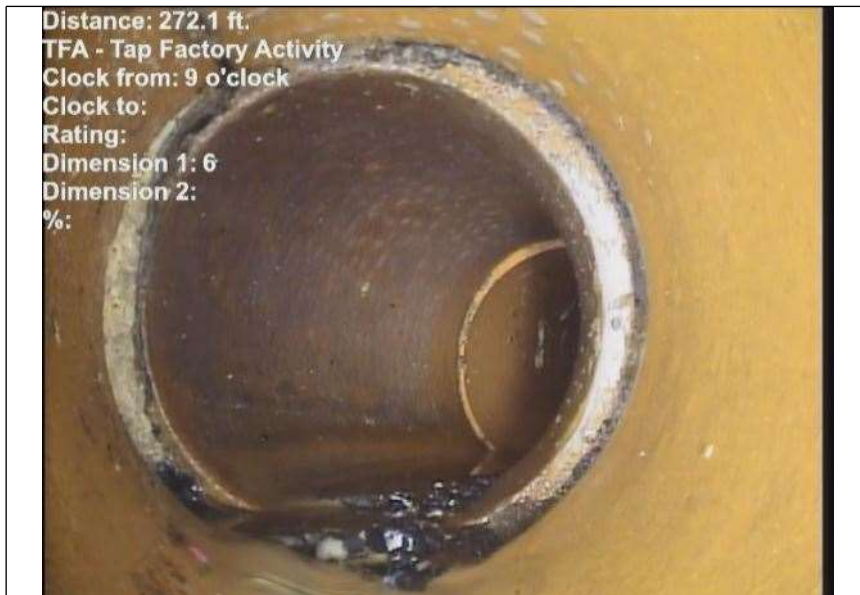
At: 272.1 ft. 9/. TFA - Tap Factory Activity
Joint: No

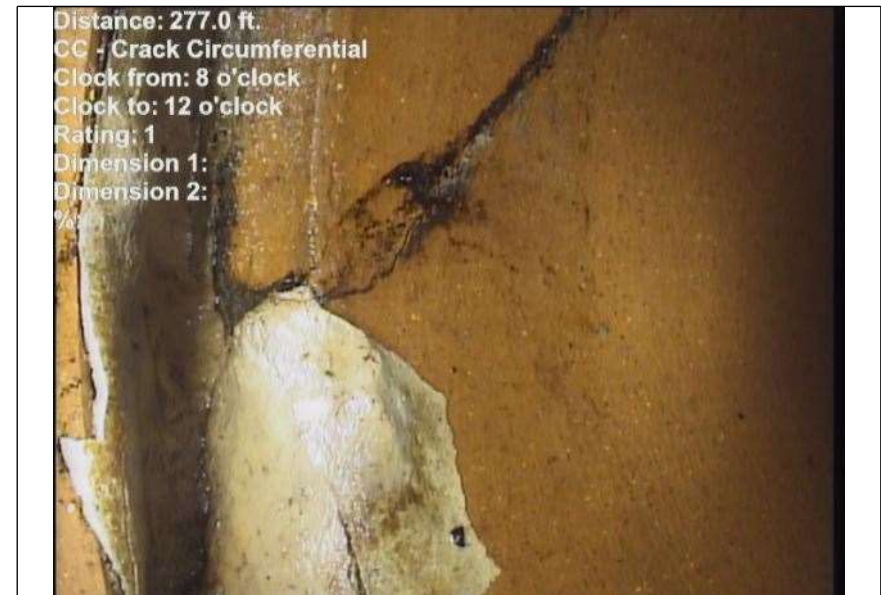
At: 277 ft. 8/4 CC - Crack Circumferential
Joint: No

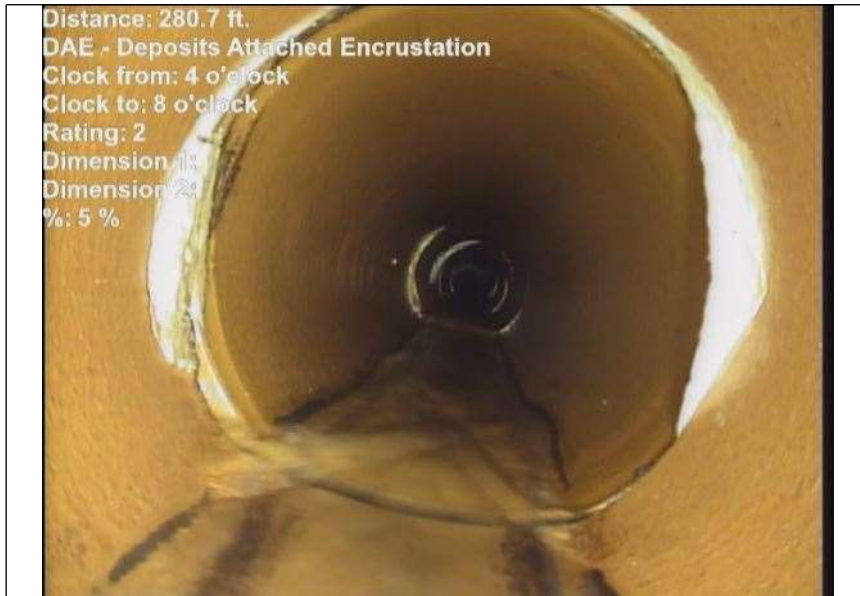
At: 280.7 ft. 4/8 DAE - Deposits Attached Encrustation
Joint: No 5 %

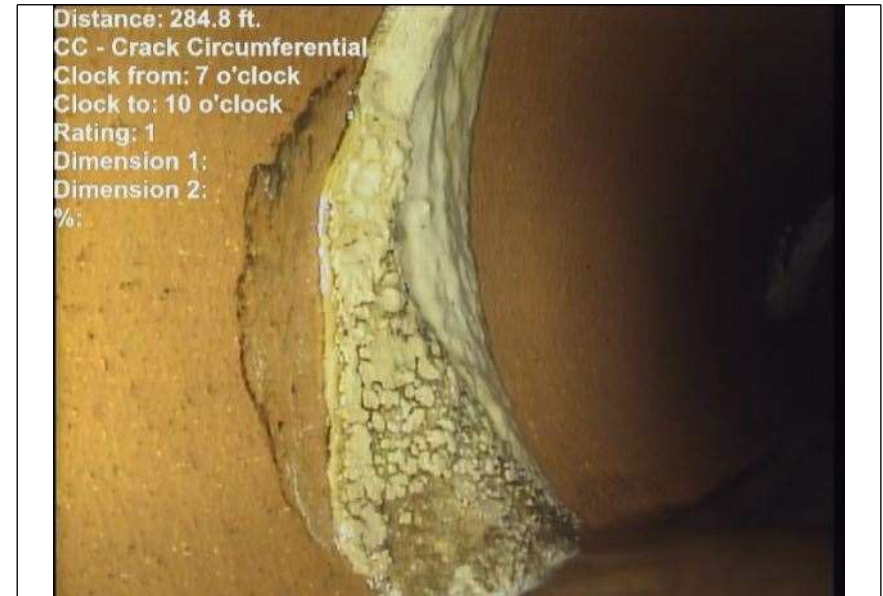
At: 284.8 ft. 7/10 CC - Crack Circumferential
Joint: No

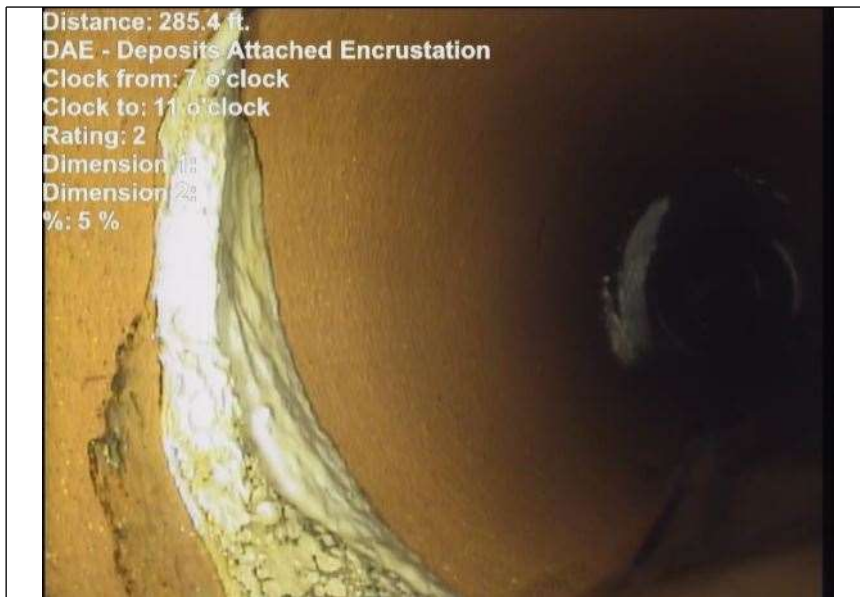
At: 285.4 ft. 7/11 DAE - Deposits Attached Encrustation
Joint: No 5 %

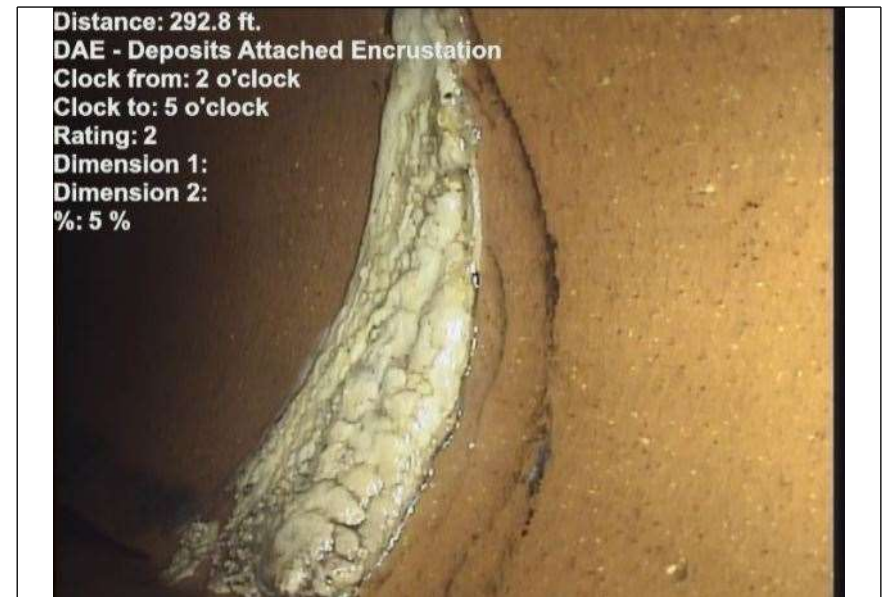
At: 292.8 ft. 2/5 DAE - Deposits Attached Encrustation
Joint: No 5 %

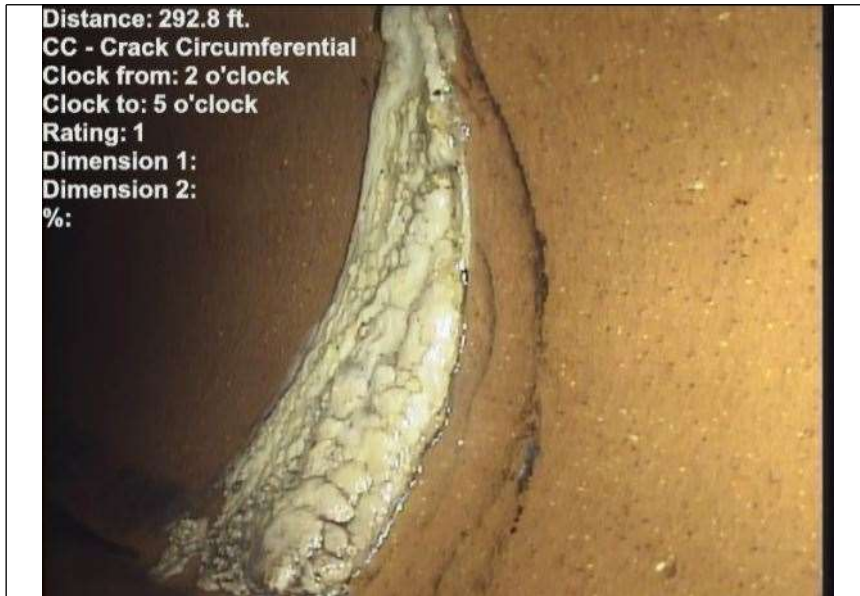
At: 292.8 ft. 2/5 CC - Crack Circumferential
Joint: No

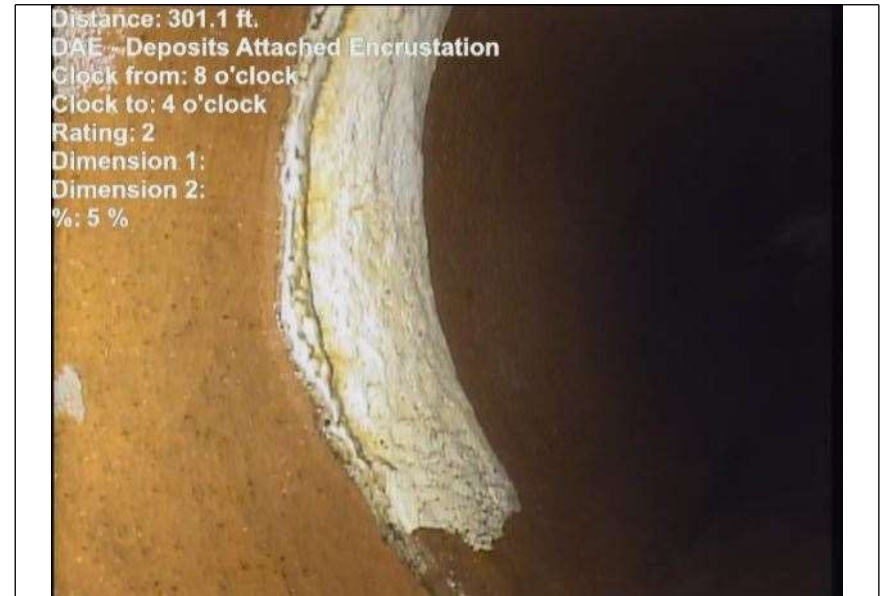
At: 301.1 ft. 8/4 DAE - Deposits Attached Encrustation
Joint: No 5 %

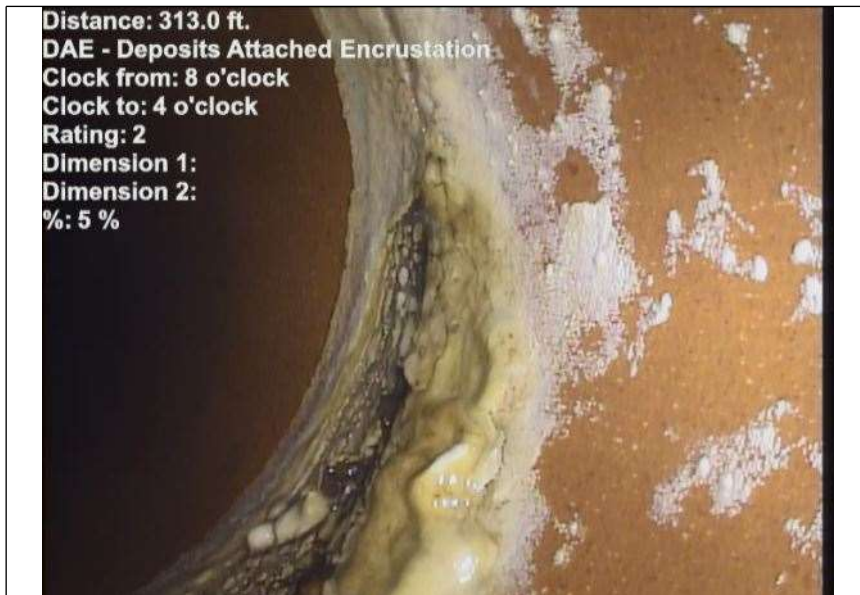
At: 313 ft. 8/4 DAE - Deposits Attached Encrustation
Joint: No 5 %

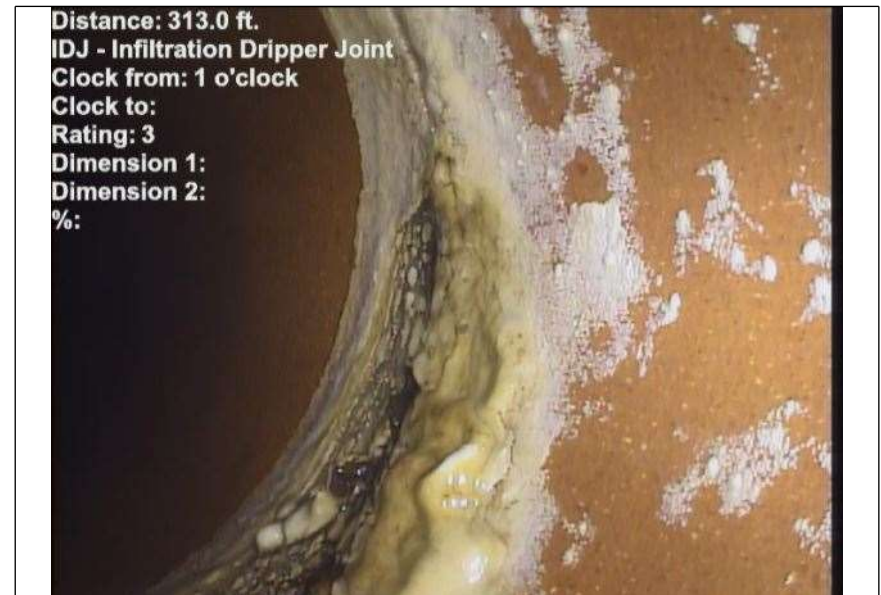
At: 313 ft. 1/. IDJ - Infiltration Dripper Joint
Joint: Yes

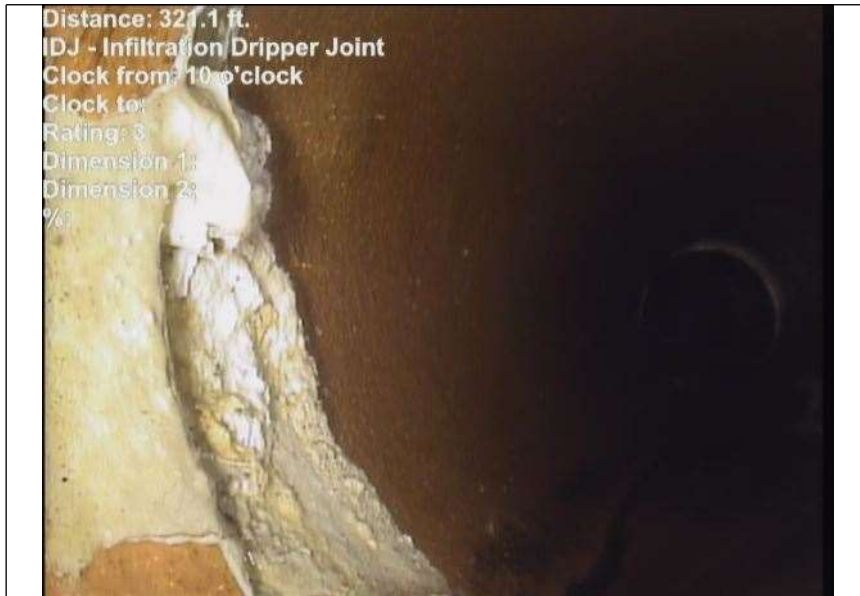
At: 321.1 ft. 10/ IDJ - Infiltration Dripper Joint
Joint: Yes

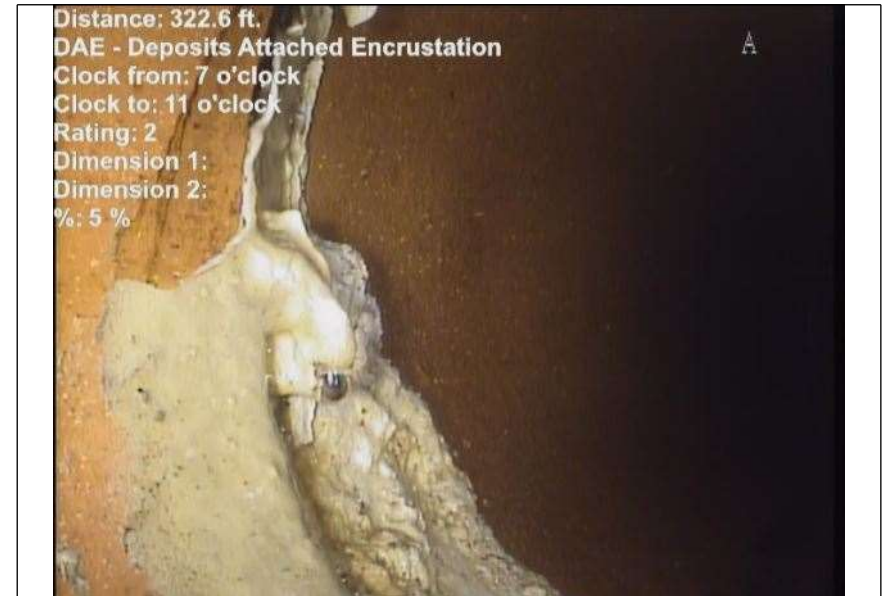
At: 322.6 ft. DAE - Deposits Attached Encrustation
7/11
Joint: No 5 %

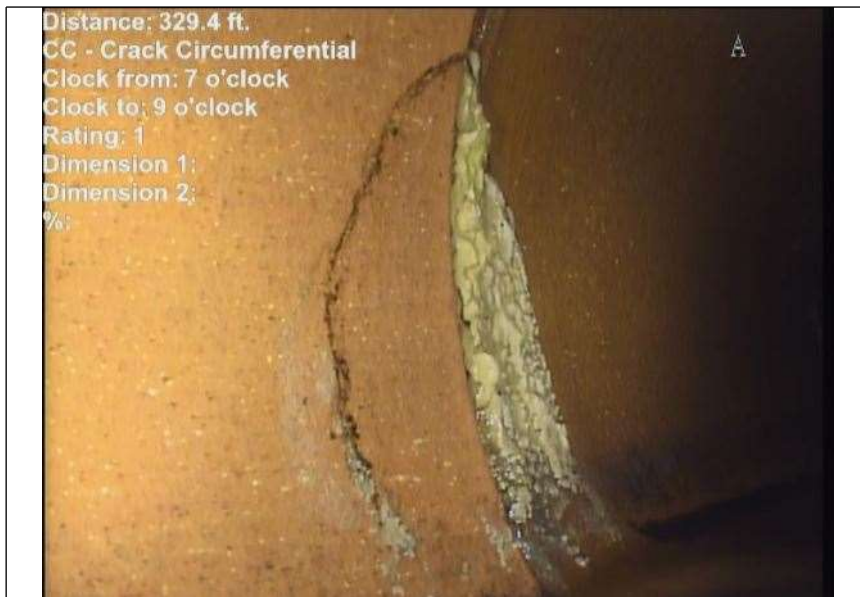
At: 329.4 ft. 7/9 CC - Crack Circumferential
Joint: No
