PACP Report with Pipe Run and Incident Snapshots

Surveyed by: DAN	Certificate number: U-716-07004752	Owner:	Customer:	Drainage area:	P/O number:	Sheet number:			
Pipe segment ref.: SMH045_SMH046	Start date/time: 20220309 09:43	Street: SUMMIT	City: SMITHVILLE						
Location details:	Upstream MH No: SMH045	Rim to invert:	Grade to invert:	Rim to grade:					
Pipe use: SS	Direction: D	Flow control:	Downstream MH No: SMH046	Rim to invert:	Grade to invert:	Rim to grade:			
Height: 8 in.	Width:	Shape: C	Material: VCP	Lining method:	Pipe joint length:	Total length: 387.800 ft.	Length surveyed: 387.800 ft.	Purpose:	Sewer category:
Media label:	PreCleaning: L	Date cleaned:	Weather: 1	Location code:	Pressure value:				
Project name: Sewer Cleaning & CCTV - Project No. 210670	Additional info:

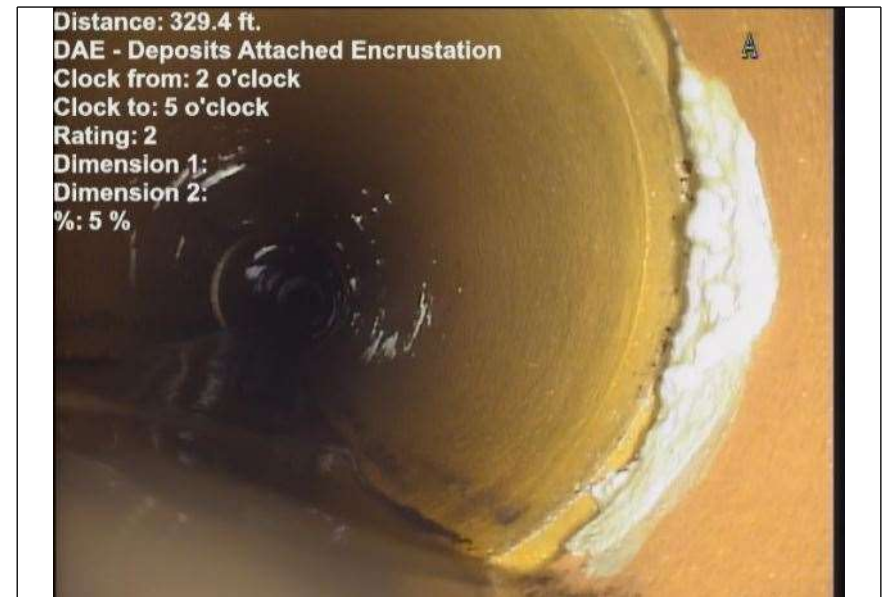
At: 329.4 ft. 2/5 DAE - Deposits Attached Encrustation
Joint: No 5 %

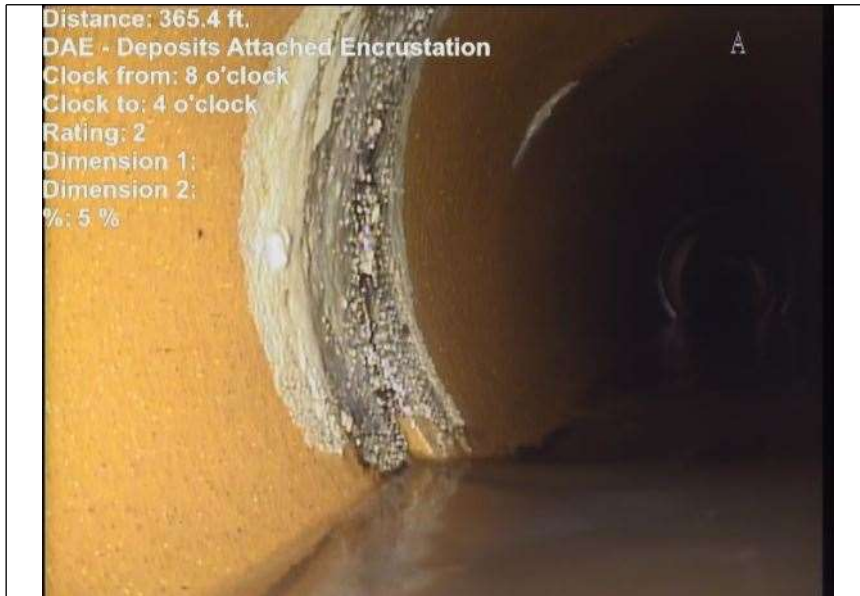
At: 365.4 ft. 8/4 DAE - Deposits Attached Encrustation
Joint: No 5 %

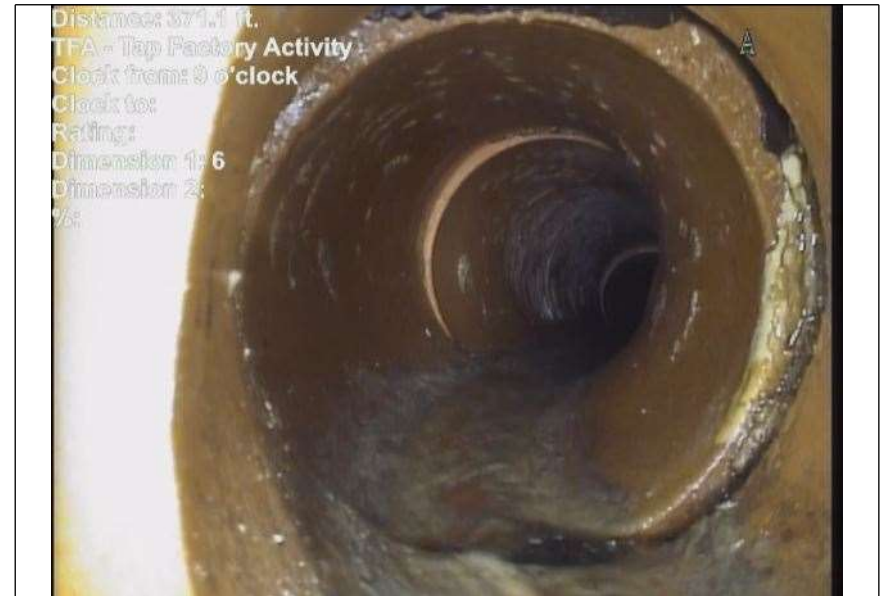
At: 371.1 ft. 9/. TFA - Tap Factory Activity
Joint: No

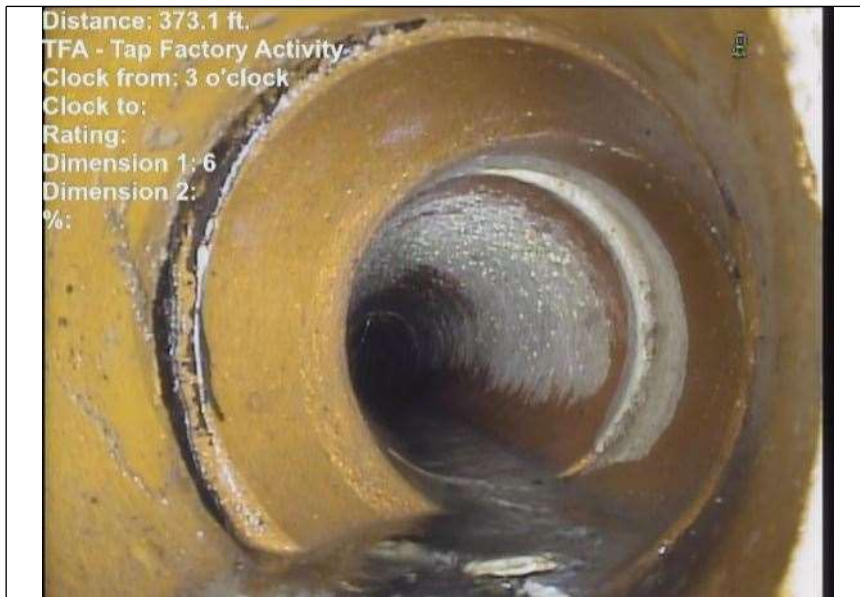
At: 373.1 ft. 3/. TFA - Tap Factory Activity
Joint: No

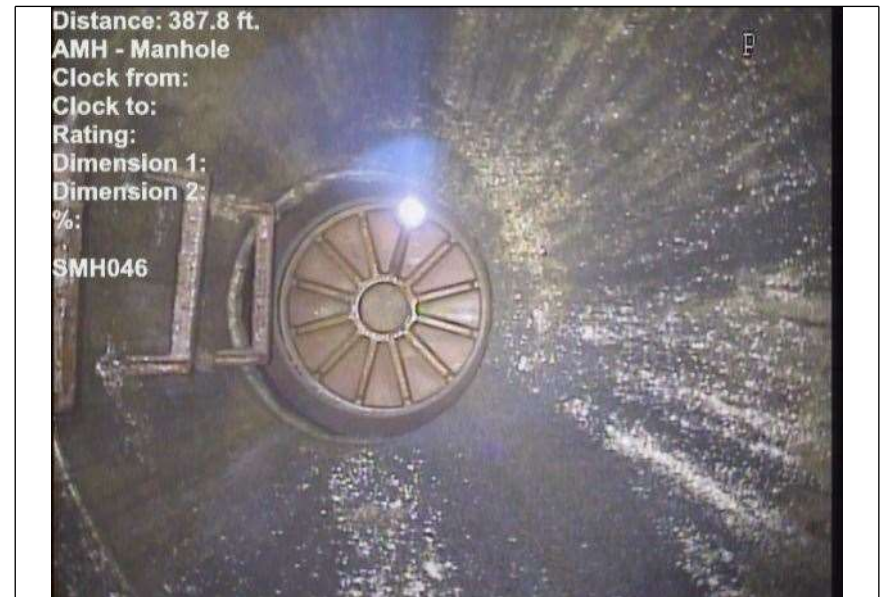
At: 387.8 ft. AMH - Manhole
Joint: No SMH046
