PACP Report with Pipe Run and Incident Snapshots

Surveyed by: Dan Shrodes	Certificate number: u-716-07004752	Owner:	Customer:	Drainage area:	P/O number:	Sheet number:
Pipe segment ref.: SMH088_SMH089	Start date/time: 20220221 10:21	Street: EBERLY		City: SMITHVILLE		
Location details: STREET		Upstream MH No: SMH088	Rim to invert:	Grade to invert:	Rim to grade:	
Pipe use: SS	Direction: U	Flow control:	Downstream MH No: SMH089	Rim to invert:	Grade to invert:	Rim to grade:
Height: 6 in.	Width:	Shape: C	Material: VCP	Lining method:	Pipe joint length:	Total length: 62.300 ft.
Media label:	PreCleaning: L	Date cleaned:	Weather: 1	Length surveyed: 62.300 ft.	Purpose:	Sewer category:
Project name: Sewer Cleaning & CCTV - Project No. 210670		Additional info:

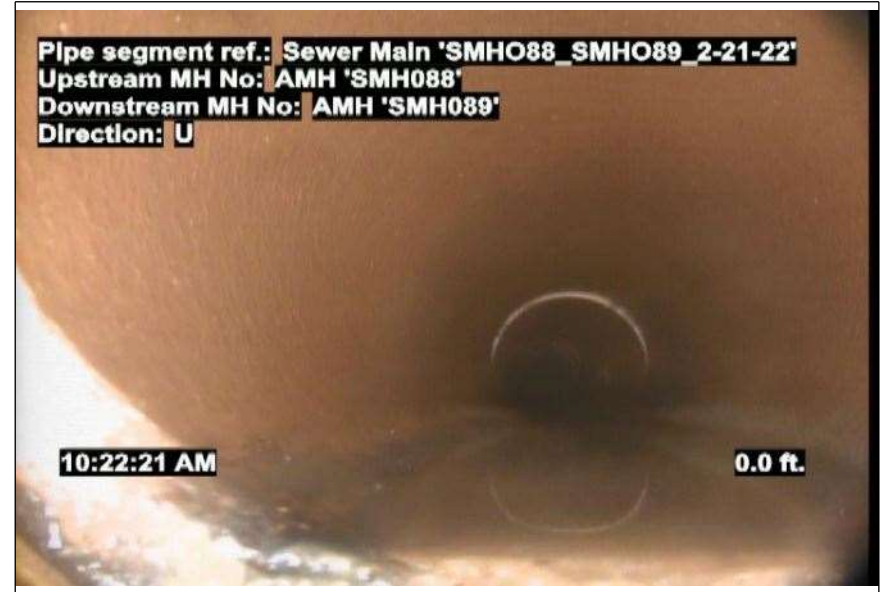
At: 0 ft. MWL - Miscellaneous Water Level
Joint: No 5 %

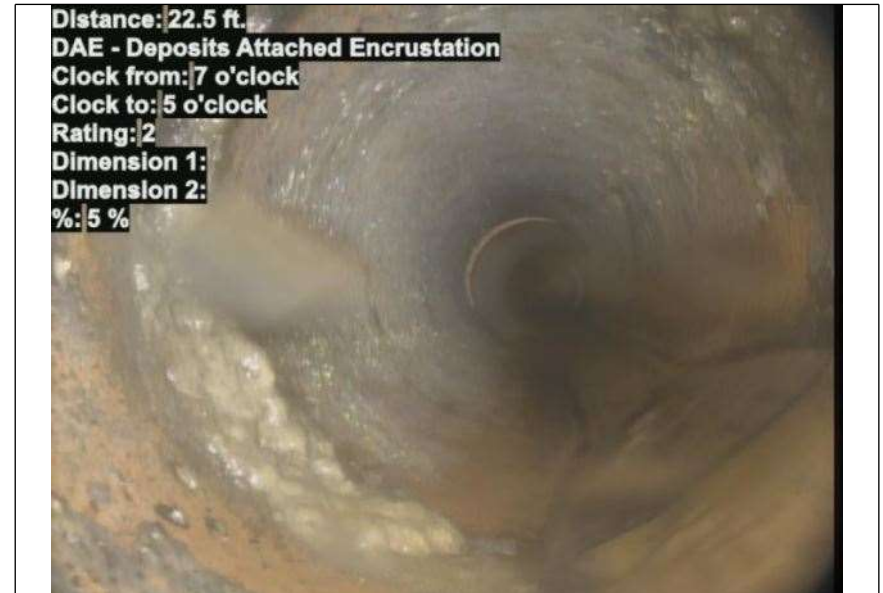
7.0 ft.	00:02:02	MGO						<input type="checkbox"/>	/			SMH088_SMH089_MG O_7.0 ft.JPG	7.0 FT SET DISTANCE
22.5 ft.	00:03:35	DAE					5	<input checked="" type="checkbox"/>	7 / 5		2	SMH088_SMH089_DA E_22.5 ft.JPG

At: 22.5 ft. 7/5 DAE - Deposits Attached Encrustation
Joint: Yes 5 %

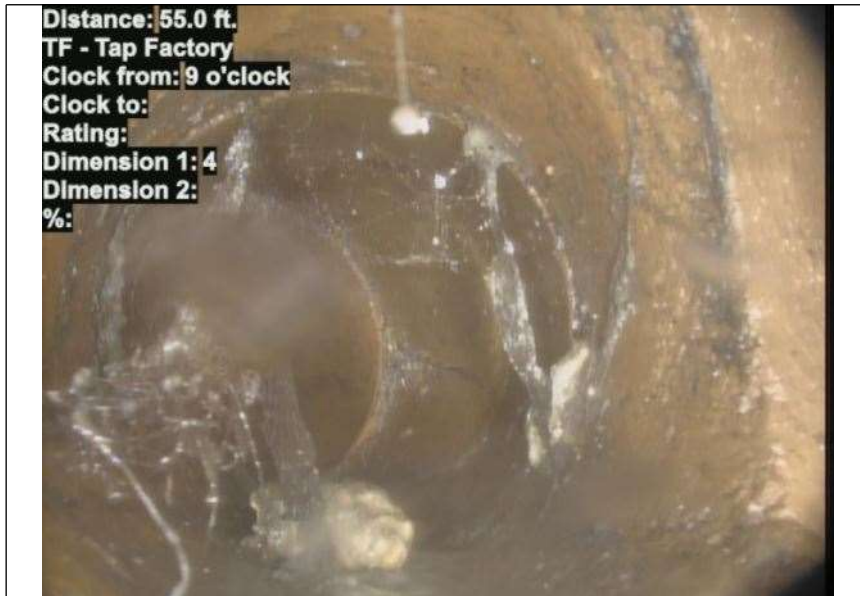
At: 55 ft. 9/. TF - Tap Factory
Joint: No

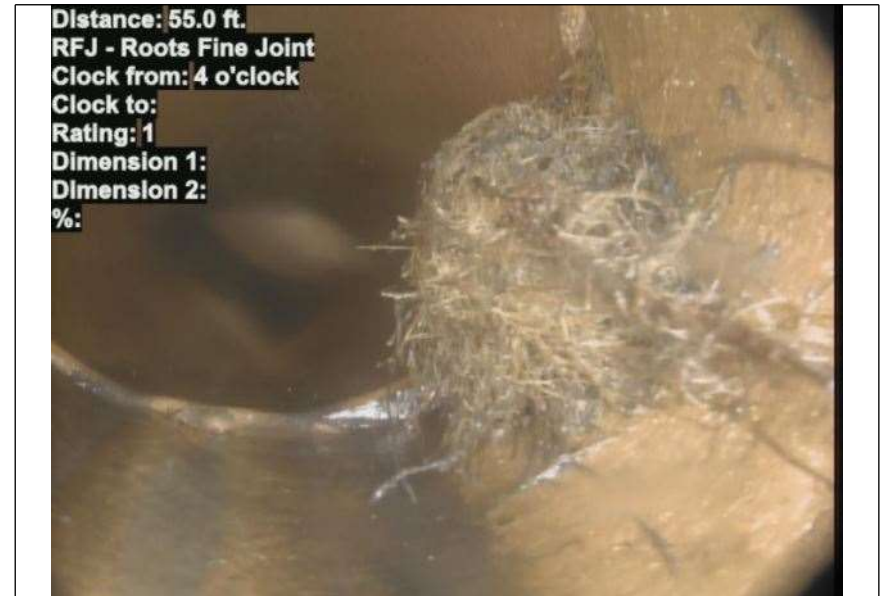
55.0 ft.	00:05:35	TF			4.000			<input type="checkbox"/>	9 /			SMH088_SMH089_TF _55.0 ft.JPG	
55.0 ft.	00:06:51	RFJ						<input checked="" type="checkbox"/>	4 /		1	SMH088_SMH089_RF J_55.0 ft.JPG

At: 55 ft. 4/. RFJ - Roots Fine Joint
Joint: Yes

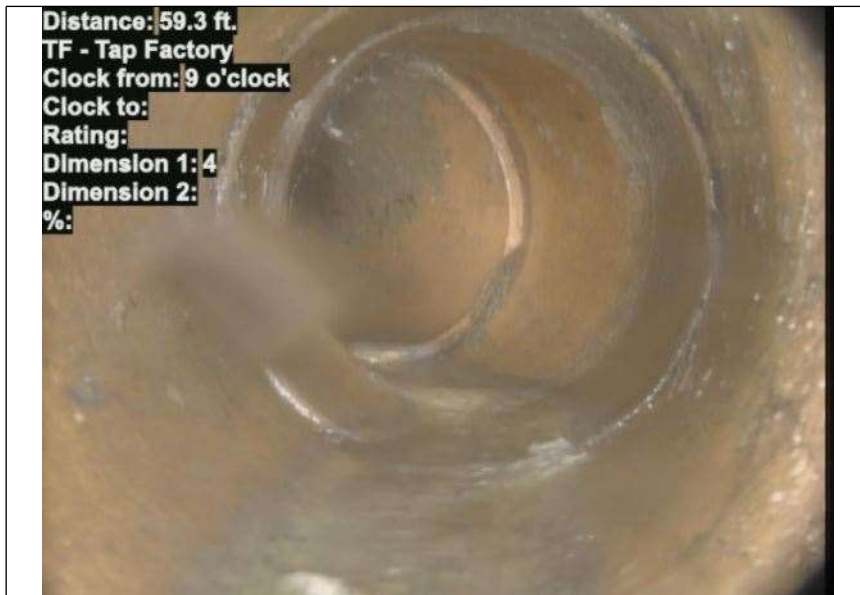
At: 59.3 ft. 9/. TF - Tap Factory
Joint: No

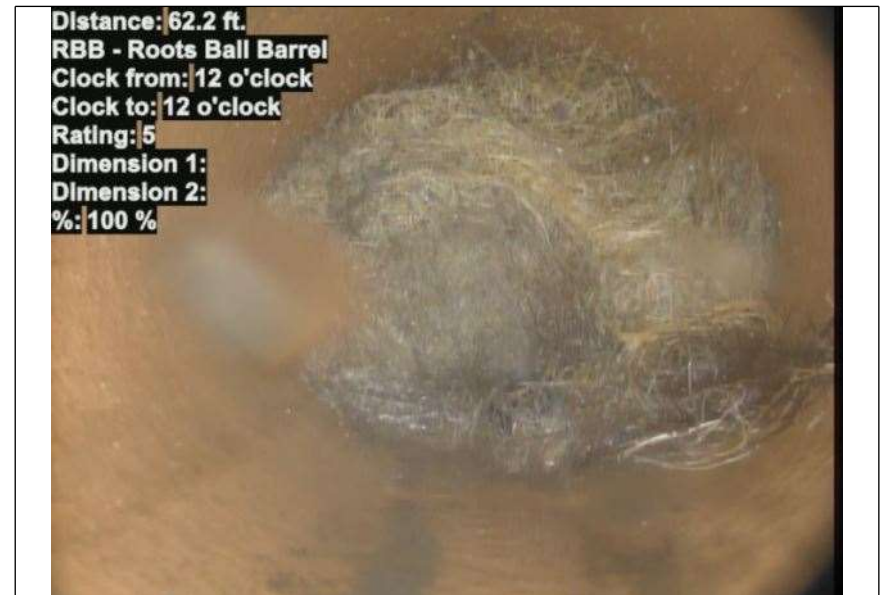
59.3 ft.	00:07:45	TF			4.000			<input type="checkbox"/>	9 /			SMH088_SMH089_TF _59.3 ft.JPG	
62.2 ft.	00:08:34	RBB					100	<input type="checkbox"/>	12 / 12		5	SMH088_SMH089_RB B_62.2 ft.JPG

At: 62.2 ft. RBB - Roots Ball Barrel
12/12
Joint: No 100 %

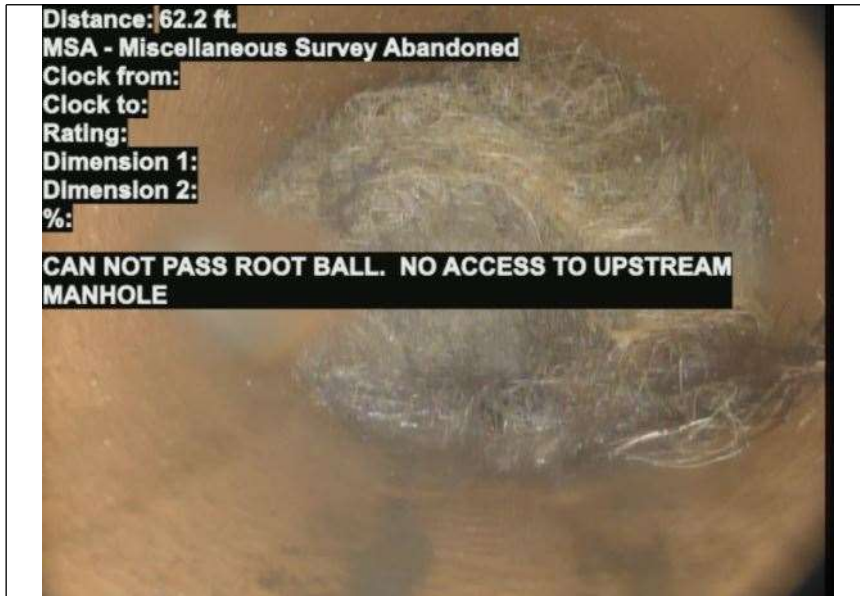
62.3 ft.	00:09:21	MSA						<input type="checkbox"/>	/			SMH088_SMH089_MS A_62.3 ft.JPG	CAN NOT PASS ROOT BALL. NO ACCESS TO UPSTREAM MANHOLE

At: 62.3 ft. MSA - Miscellaneous Survey Abandoned
Joint: No CAN NOT PASS ROOT BALL. NO ACCESS TO UPSTREAM MANHOLE
