PACP Report with Pipe Run and Incident Snapshots

Surveyed by: Mike Brooks	Certificate number: Mike Brooks	Owner:	Customer:	Drainage area:	P/O number:	Sheet number:
Pipe segment ref.: SMH089_SMH090	Start date/time: 20220221 11:32	Street: EBERLY		City: SMITHVILLE		
Location details: STREET		Upstream MH No: SMH090	Rim to invert:	Grade to invert:	Rim to grade:	
Pipe use: SW	Direction: D	Flow control:	Downstream MH No: SMH089	Rim to invert:	Grade to invert:	Rim to grade:
Height: 6 in.	Width:	Shape: C	Material: VCP	Lining method:	Pipe joint length:	Total length: 196.100 ft.
Media label:	PreCleaning: L	Date cleaned:	Weather: 1	Length surveyed: 196.100 ft.	Purpose:	Sewer category:
Project name: Sewer Cleaning & CCTV - Project No. 210670		Additional info:

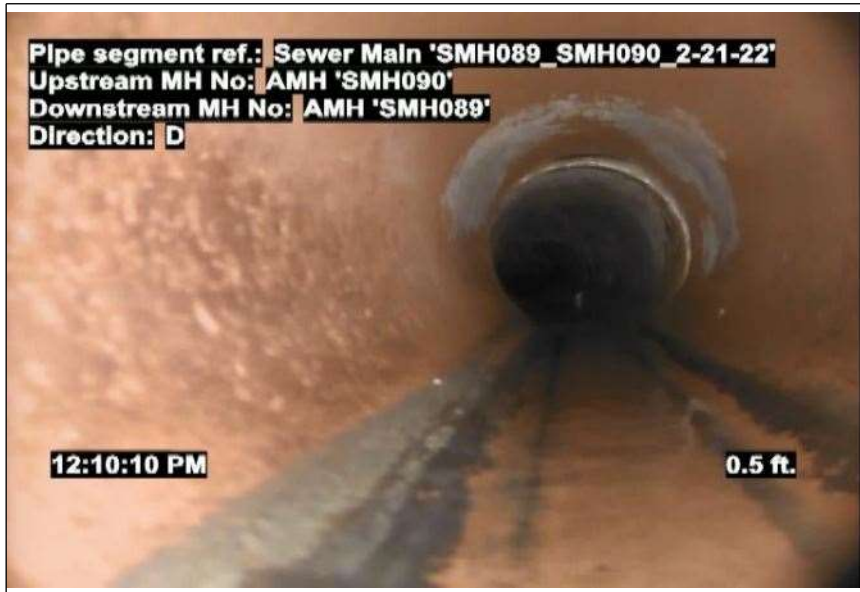
At: 0 ft. MWL - Miscellaneous Water Level
Joint: No 5 %

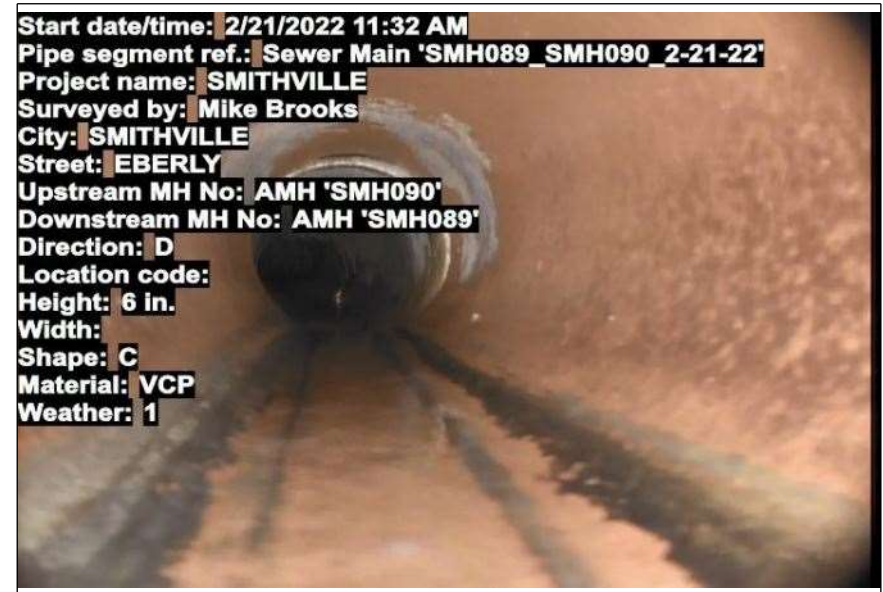
At: 0 ft. AMH - Manhole
Joint: No SMH090

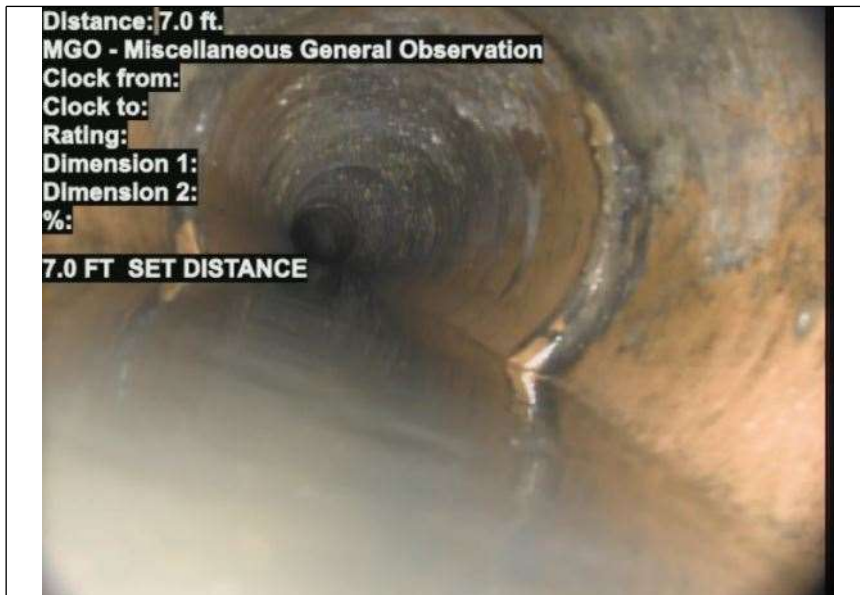
At: 7 ft. MGO - Miscellaneous General Observation
Joint: No 7.0 FT SET DISTANCE

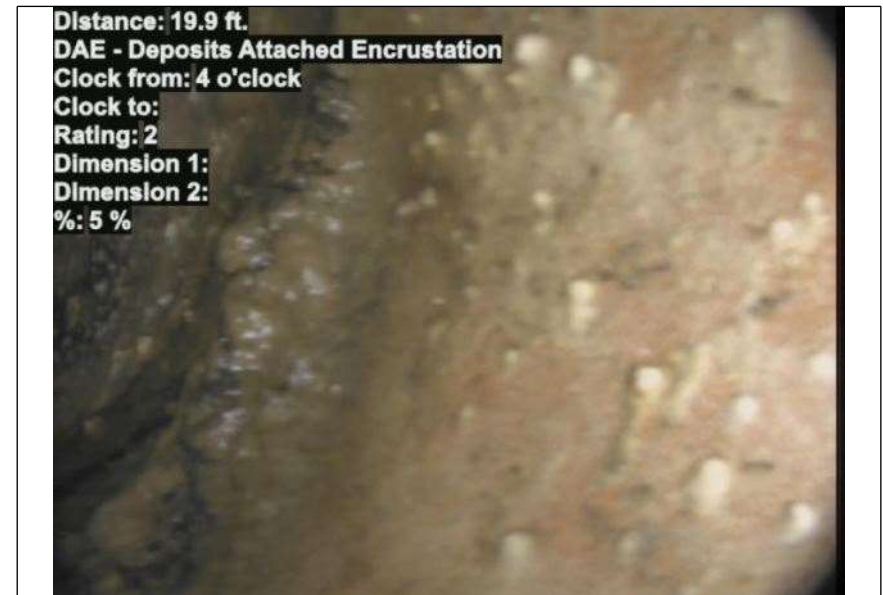
At: 19.9 ft. 4/ DAE - Deposits Attached Encrustation
Joint: Yes 5 %

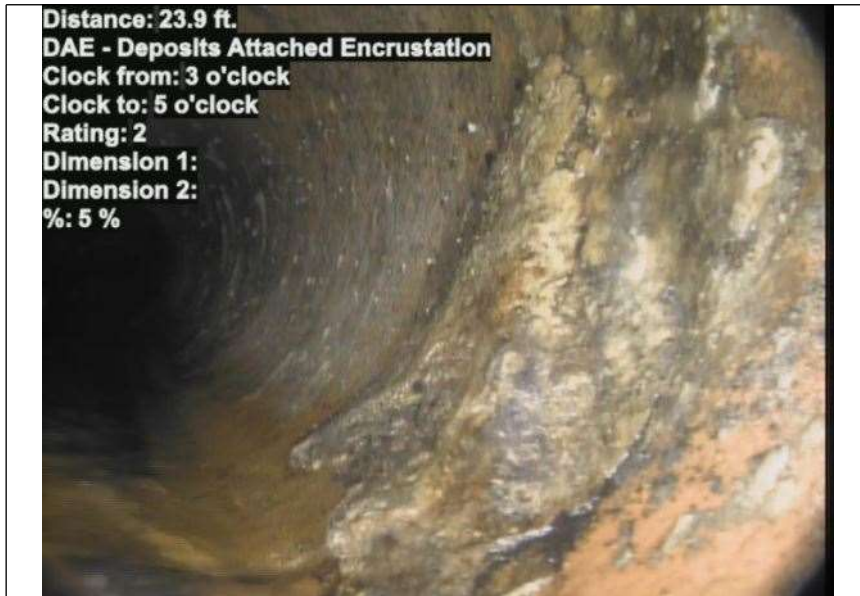
At: 23.9 ft. 3/5 DAE - Deposits Attached Encrustation
Joint: Yes 5 %

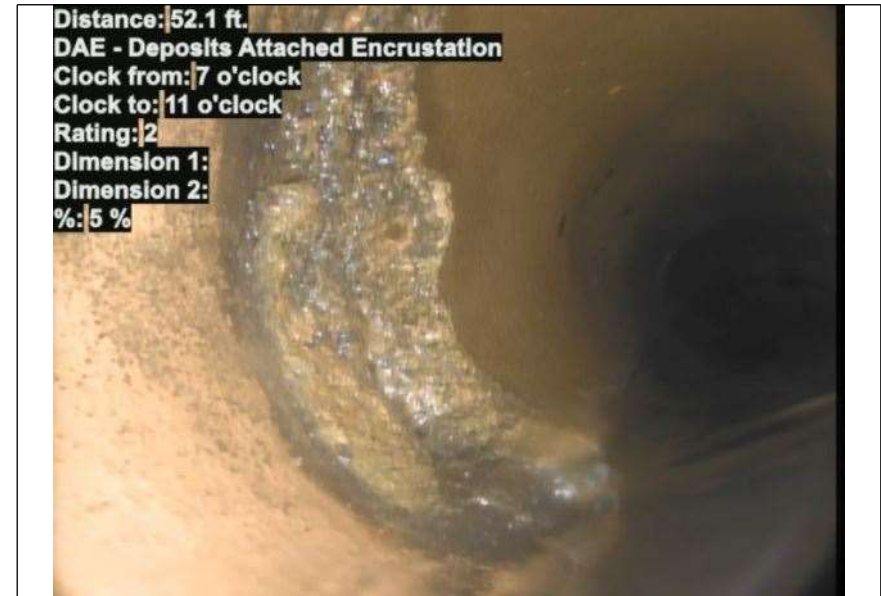
At: 52.1 ft. 7/11 DAE - Deposits Attached Encrustation
Joint: No 5 %

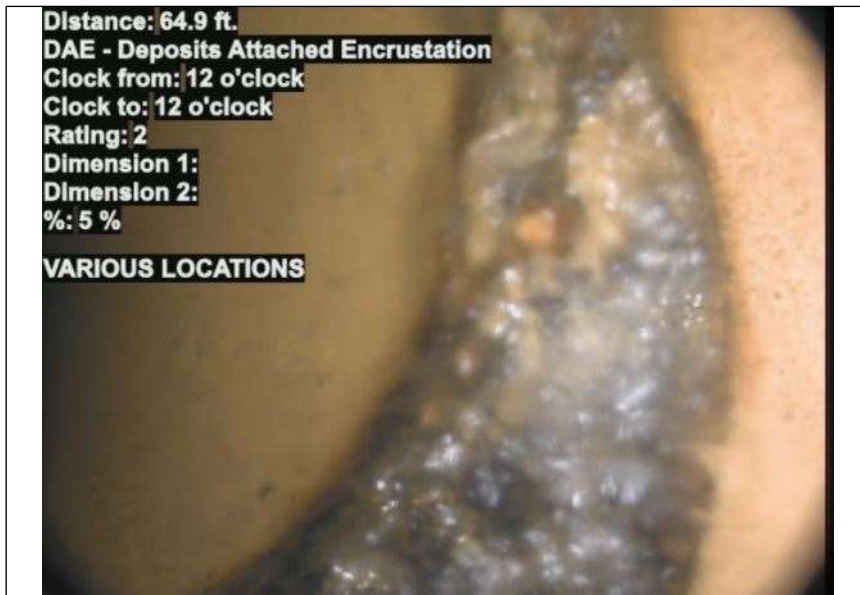
At: 64.9 ft. 7/5 DAE - Deposits Attached Encrustation
Joint: No 5 % VARIOUS LOCATIONS

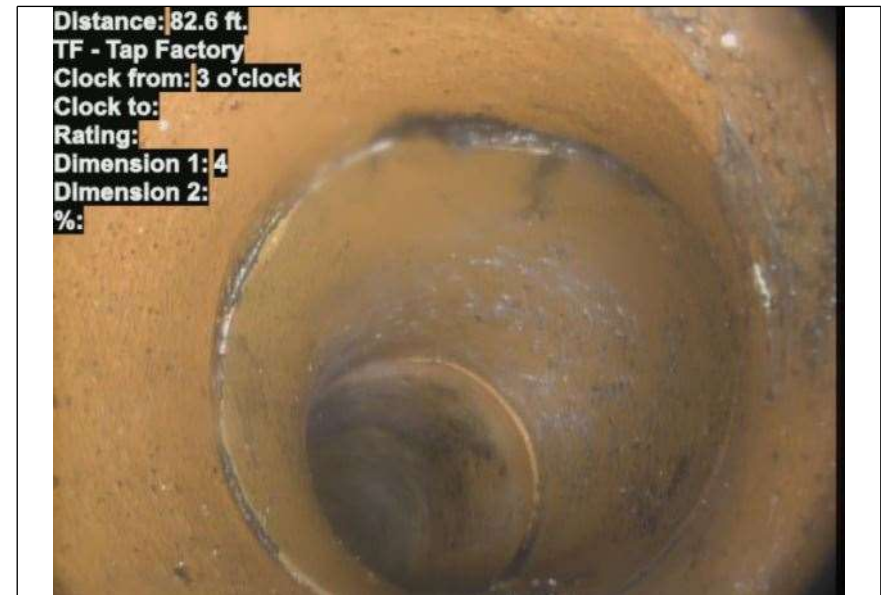
At: 82.6 ft. 3/. TF - Tap Factory
Joint: No

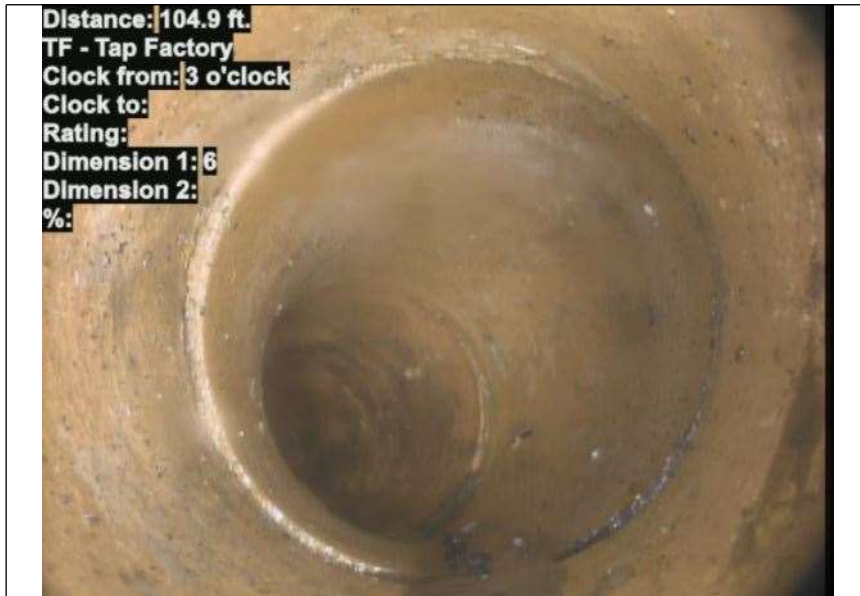
At: 104.9 ft. 3/. TF - Tap Factory

Joint: No

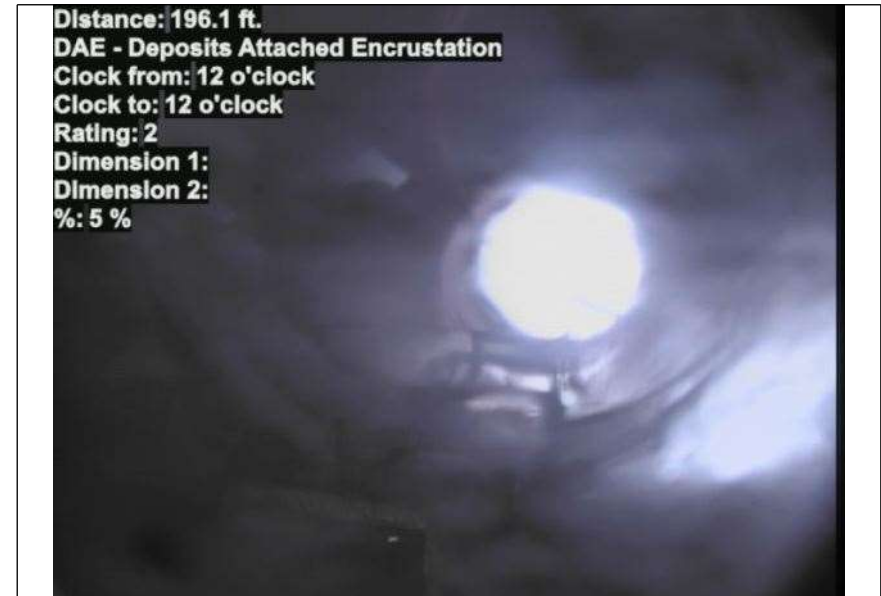
At: 196.1 ft. 7/5 DAE - Deposits Attached Encrustation

Joint: No 5 %

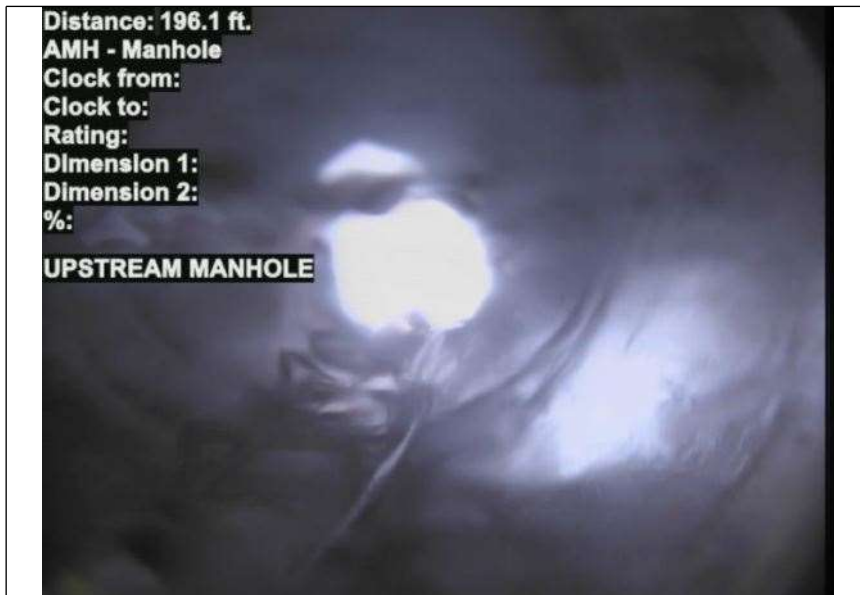
At: 196.1 ft. AMH - Manhole

Joint: No UPSTREAM MANHOLE
