PACP Report with Pipe Run and Incident Snapshots

Surveyed by: Mike Brooks	Certificate number: Mike Brooks	Owner:	Customer:	Drainage area:	P/O number:	Sheet number:
Pipe segment ref.: SMH090_SMH091	Start date/time: 20220221 14:29	Street: EBERLY		City: SMITHVILLE		
Location details: STREET		Upstream MH No: SMH090	Rim to invert:	Grade to invert:	Rim to grade:	
Pipe use: SS	Direction: U	Flow control:	Downstream MH No: SMH091	Rim to invert:	Grade to invert:	Rim to grade:
Height: 6 in.	Width:	Shape: C	Material: VCP	Lining method:	Pipe joint length:	Total length: 398.300 ft.
Media label:	PreCleaning: L	Date cleaned:	Weather: 1	Length surveyed: 398.300 ft.	Purpose:	Sewer category:
Project name: Sewer Cleaning & CCTV - Project No. 210670		Additional info:

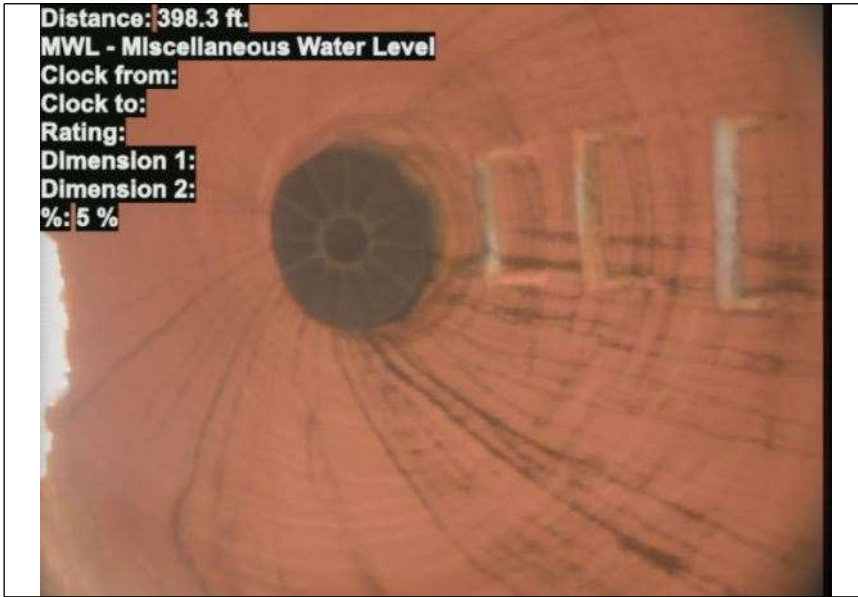
At: 0 ft. MWL - Miscellaneous Water Level
Joint: No 5 %

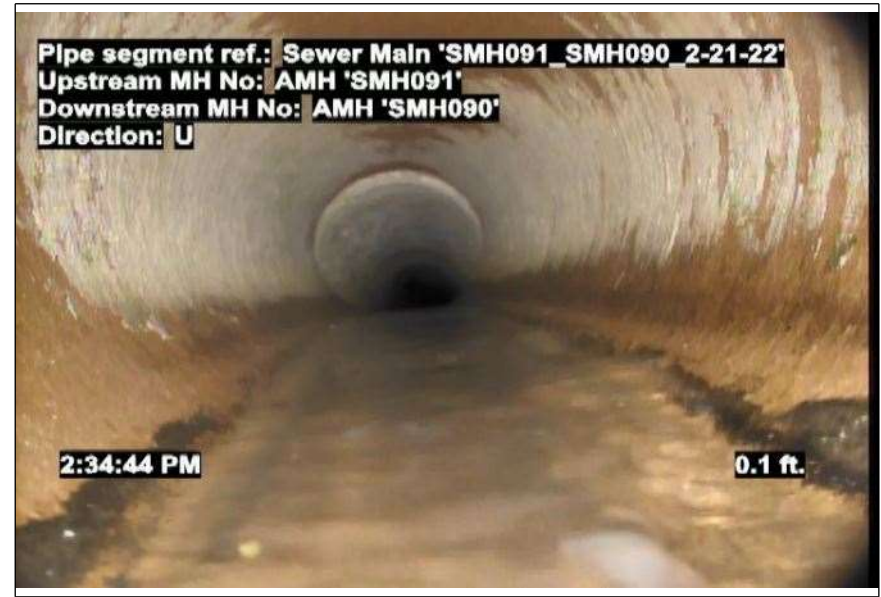
At: 0 ft. MWL - Miscellaneous Water Level
Joint: No 5 %

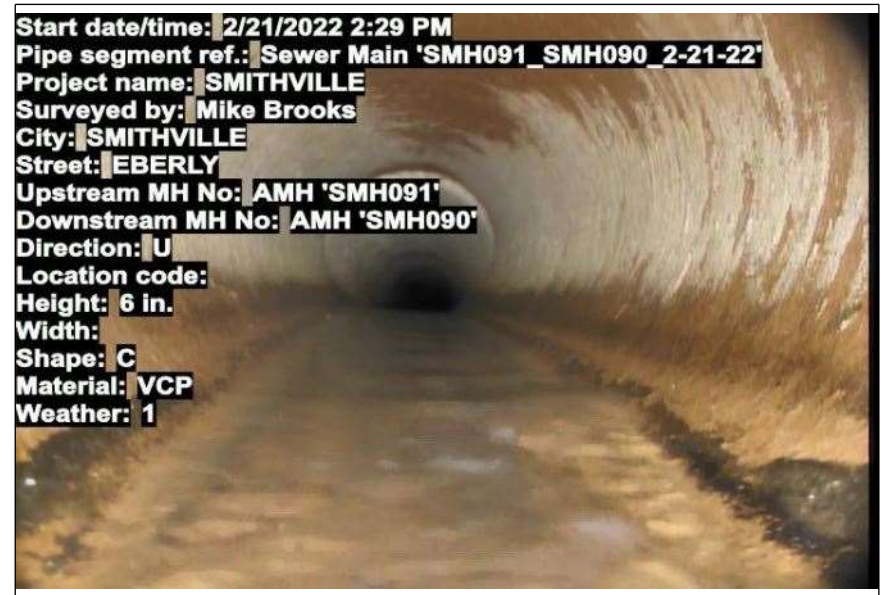
At: 0 ft. AMH - Manhole
Joint: No SMH091

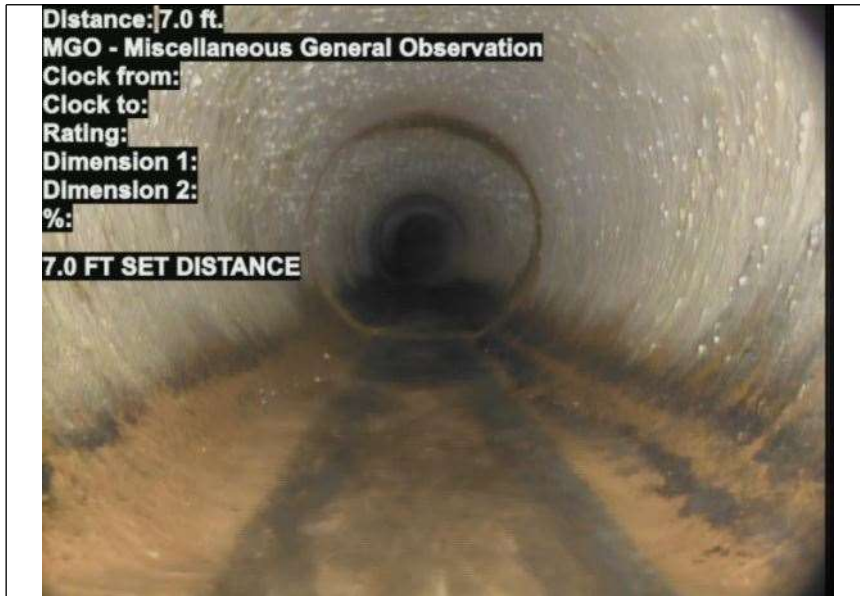
At: 7 ft. MGO - Miscellaneous General Observation
Joint: No 7.0 FT SET DISTANCE

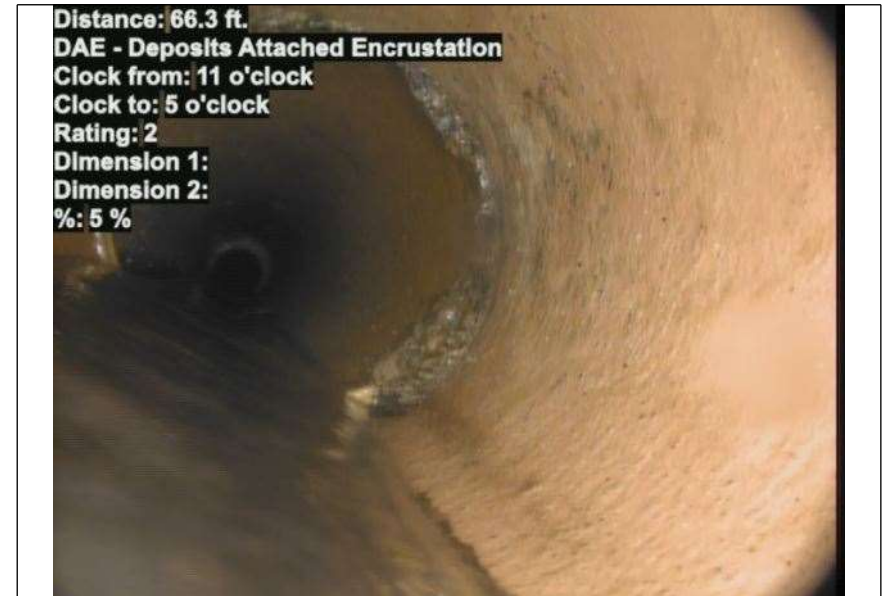
At: 66.3 ft. 11/5 DAE - Deposits Attached Encrustation
Joint: No 5 %

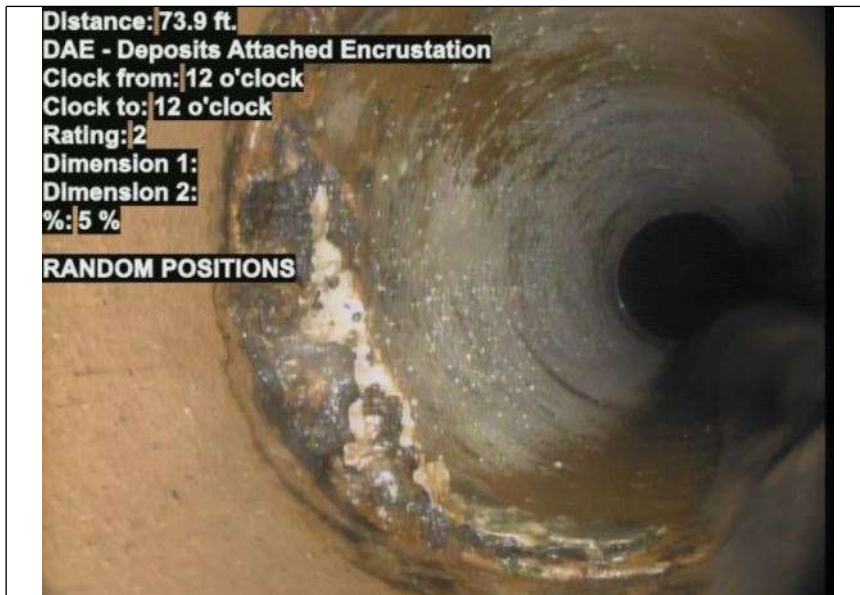
At: 73.9 ft. 7/5 DAE - Deposits Attached Encrustation
Joint: No 5 % RANDOM POSITIONS

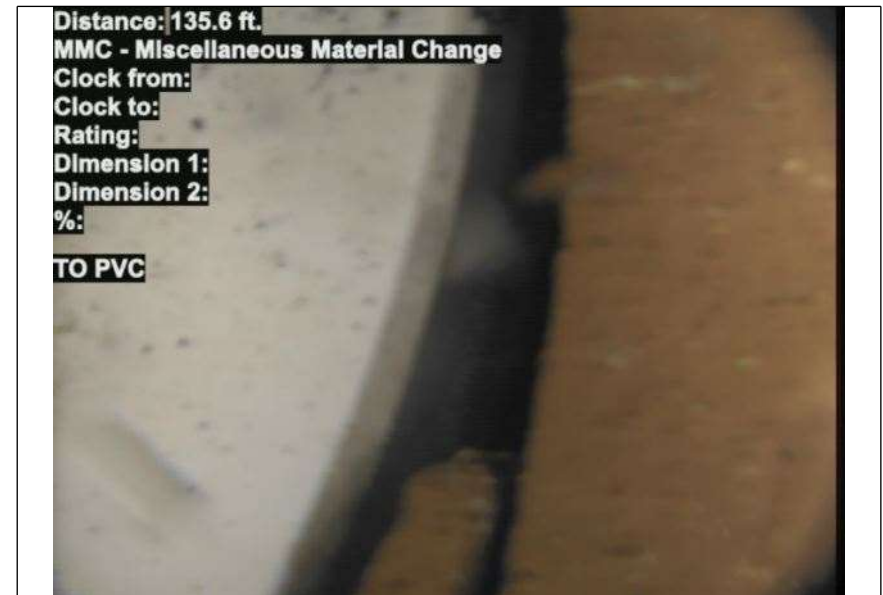
At: 135.6 ft. RPR - Point Repair Replacement
Joint: No TO PVC

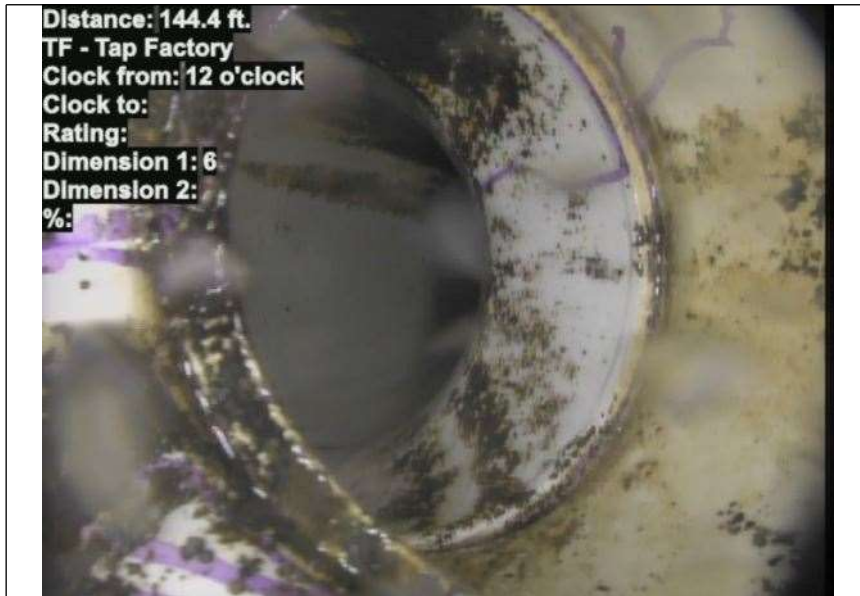
At: 144.4 ft. 12/. TF - Tap Factory

Joint: No

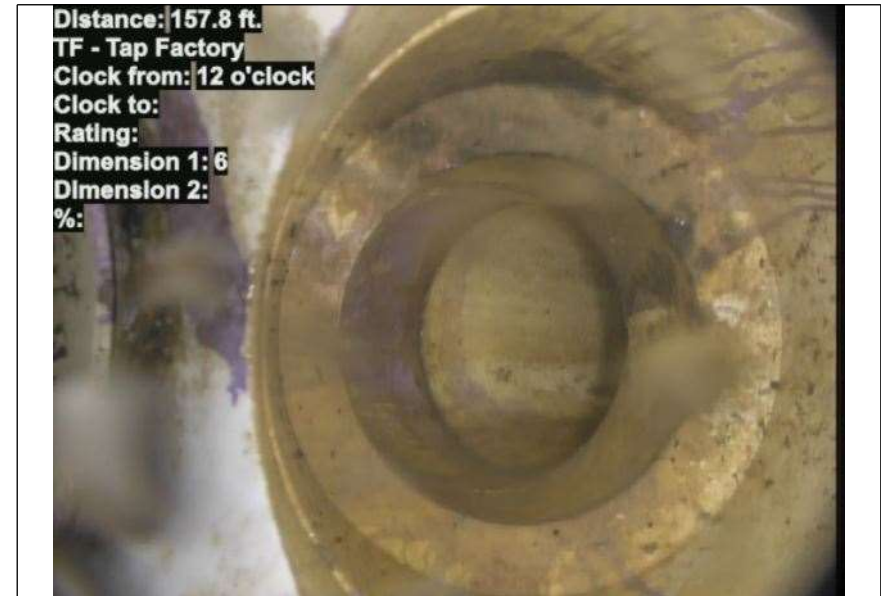
At: 157.8 ft. 12/. TF - Tap Factory

Joint: No

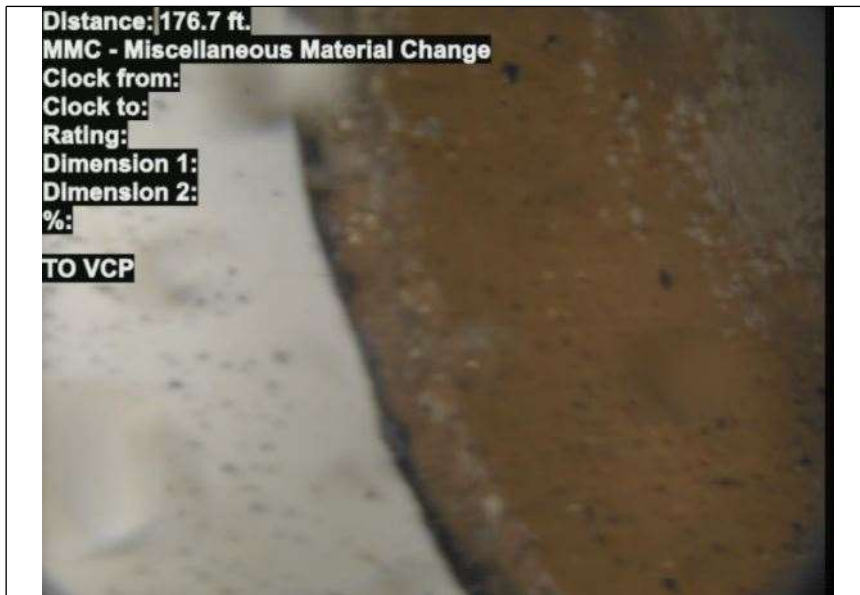
At: 176.7 ft. RPR - Point Repair Replacement

Joint: No TO VCP

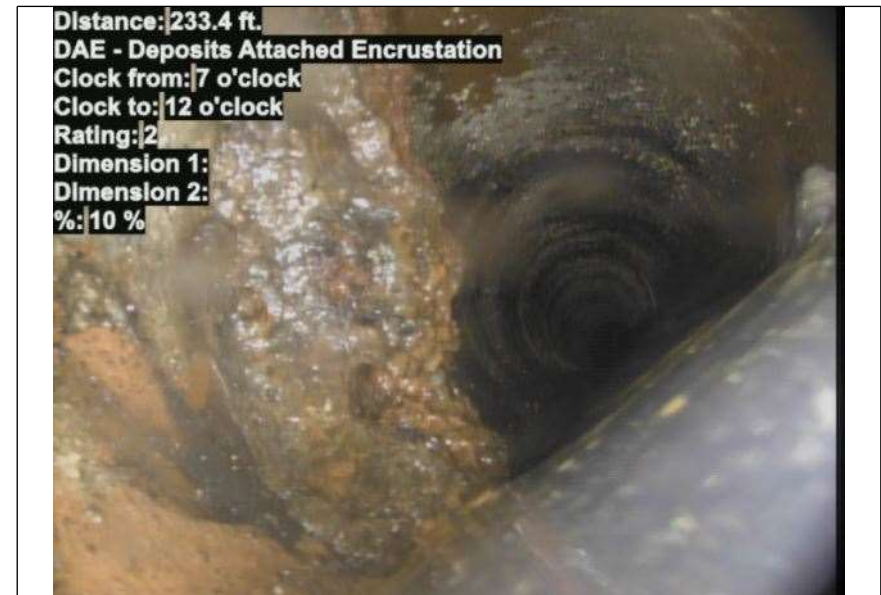
At: 233.4 ft. DAE - Deposits Attached Encrustation

7/12
Joint: No 10 %

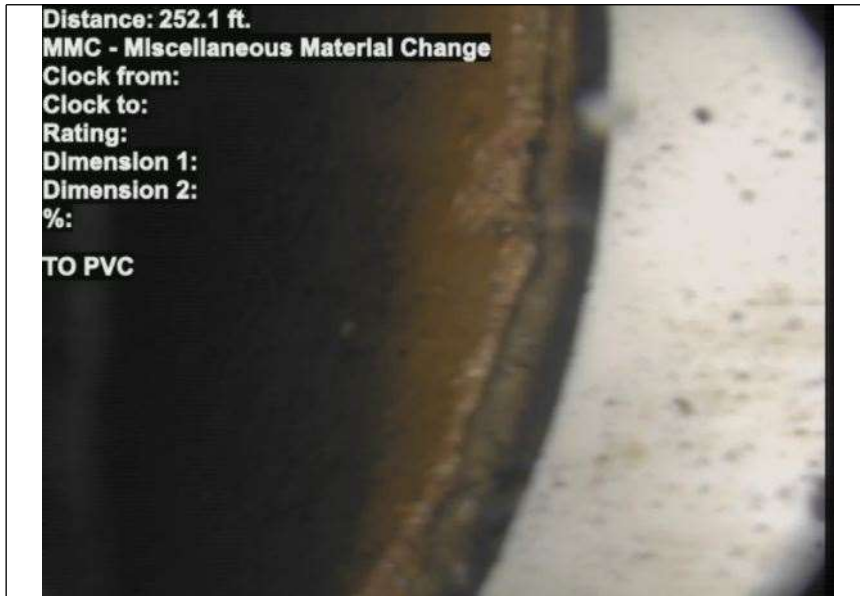
At: 252.1 ft. RPR - Point Repair Replacement
Joint: No TO PVC

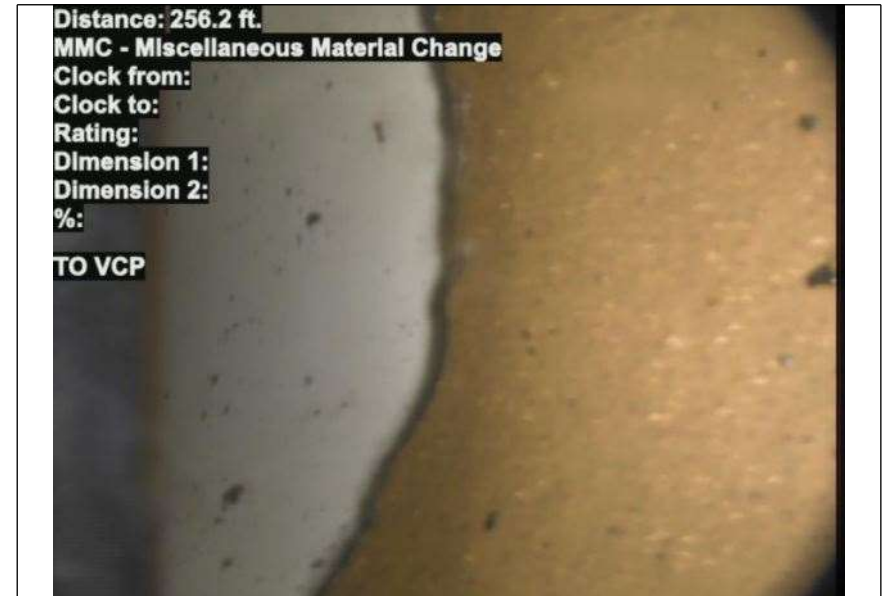
At: 256.2 ft. RPR - Point Repair Replacement
Joint: No TO VCP

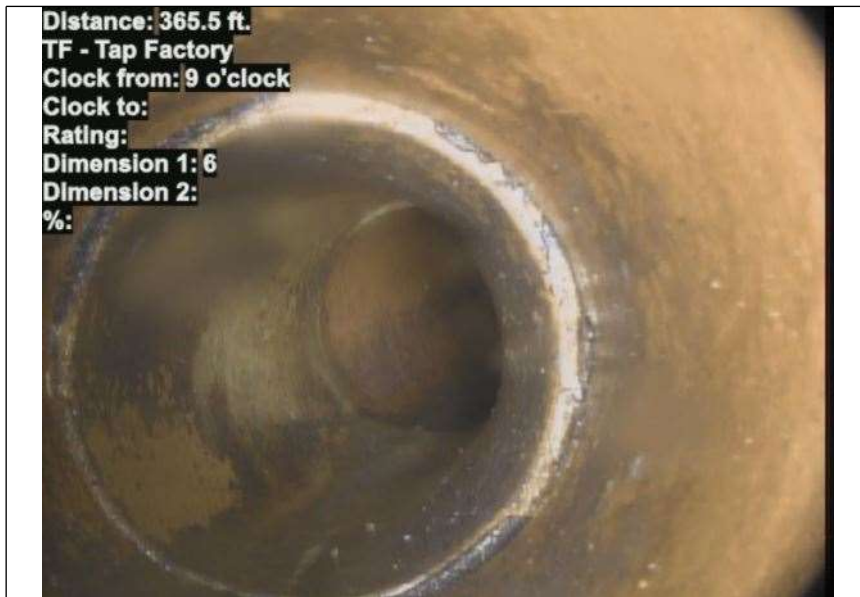
At: 365.5 ft. 9/. TF - Tap Factory
Joint: No

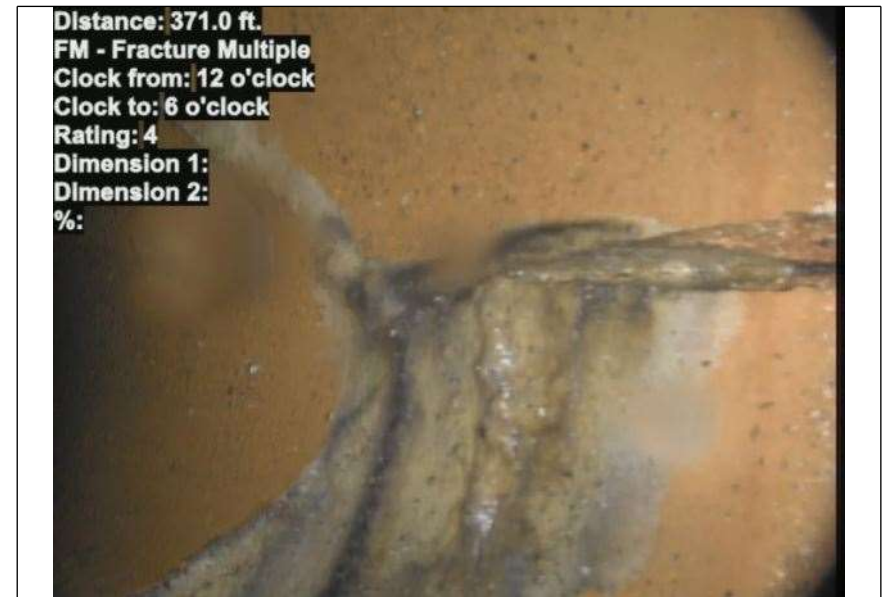
365.5 ft.	00:02:35	TF				6.000		<input type="checkbox"/>	9 /			SMH090_SMH091_TF_365.5 ft.JPG	
371.0 ft.	00:04:33	FM						<input type="checkbox"/>	12 / 12		4	SMH090_SMH091_FM_371.0 ft.JPG

At: 371 ft. 12/12 FM - Fracture Multiple
Joint: No

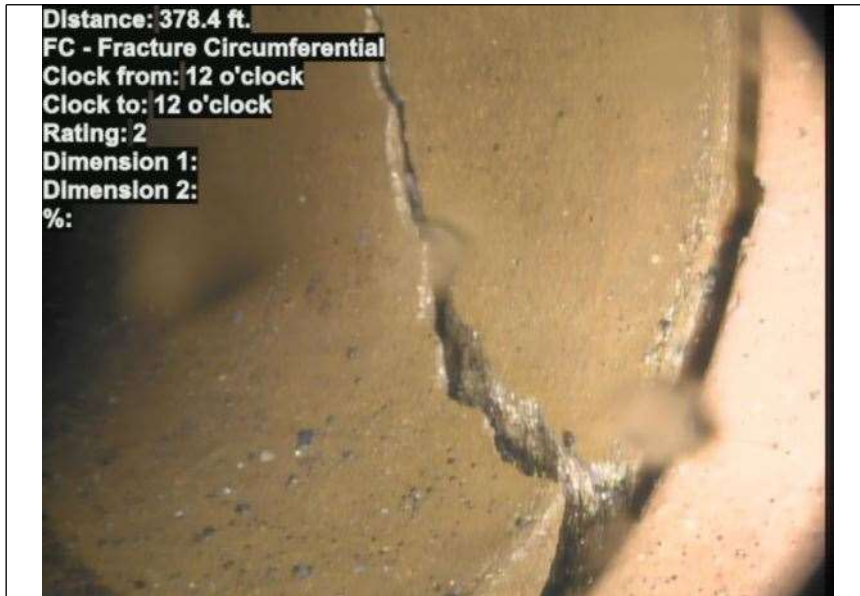
378.4 ft.	00:07:10	FC						<input type="checkbox"/>	12 / 12		2	SMH090_SMH091_FC_378.4 ft.JPG

At: 378.4 ft. FC - Fracture Circumferential
12/12

Joint: No

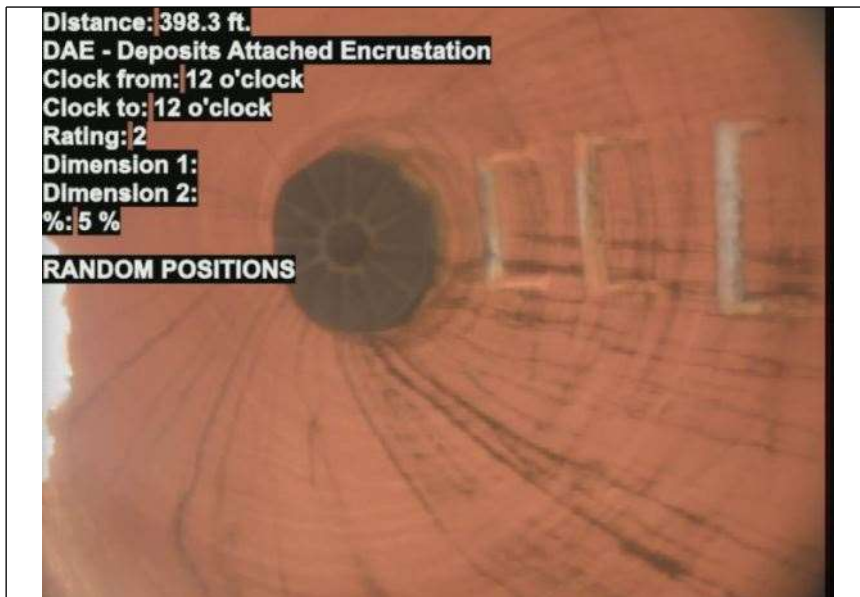
At: 398.3 ft. 7/5 DAE - Deposits Attached Encrustation

Joint: No 5 % RANDOM POSITIONS

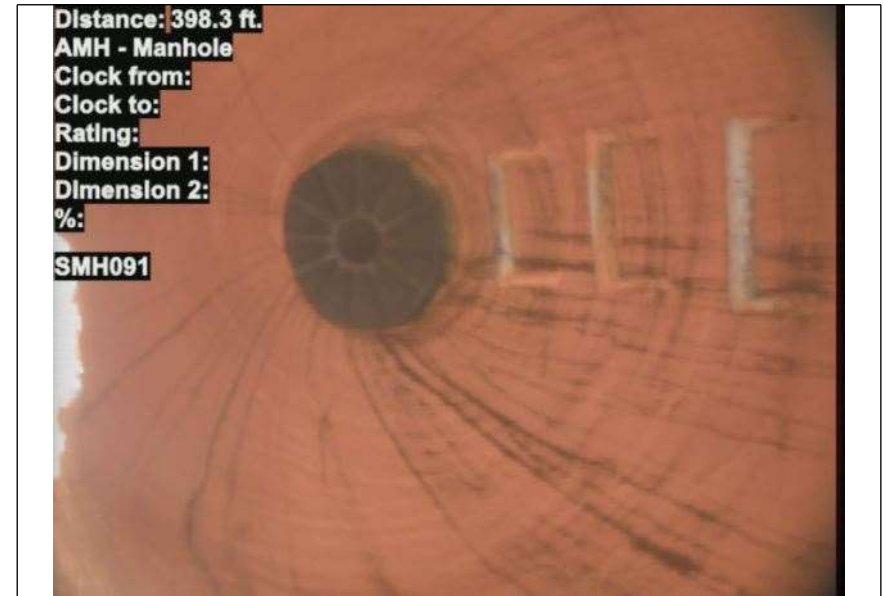
At: 398.3 ft. AMH - Manhole

Joint: No SMH090
