## PACP Report with Pipe Run and Incident Snapshots

Surveyed by: <b>Mike Brooks</b>		Certificate number: <b>Mike Brooks</b>		Owner:		Customer:		Drainage area:		P/O number:		Sheet number:							
Pipe segment ref.: <b>SMH098_SMH089</b>				Start date/time: <b>20220221 10:45</b>		Street: <b>EBERLY</b>				City: <b>SMITHVILLE</b>									
Location details: <b>STREET</b>				Upstream MH No: <b>SMH098</b>				Rim to invert:		Grade to invert:		Rim to grade:							
Pipe use: <b>SS</b>		Direction: <b>U</b>		Flow control:		Downstream MH No: <b>SMH089</b>				Rim to invert:		Grade to invert:		Rim to grade:					
Height: <b>6 in.</b>		Width:		Shape: <b>C</b>		Material: <b>VCP</b>		Lining method:		Pipe joint length:		Total length: <b>252.100 ft.</b>		Length surveyed: <b>252.100 ft.</b>		Purpose:		Sewer category:	
Media label:				PreCleaning: <b>L</b>		Date cleaned:		Weather: <b>1</b>		Location code:		Pressure value:							
Project name: <b>Sewer Cleaning &amp; CCTV - Project No. 210670</b>				Additional info:

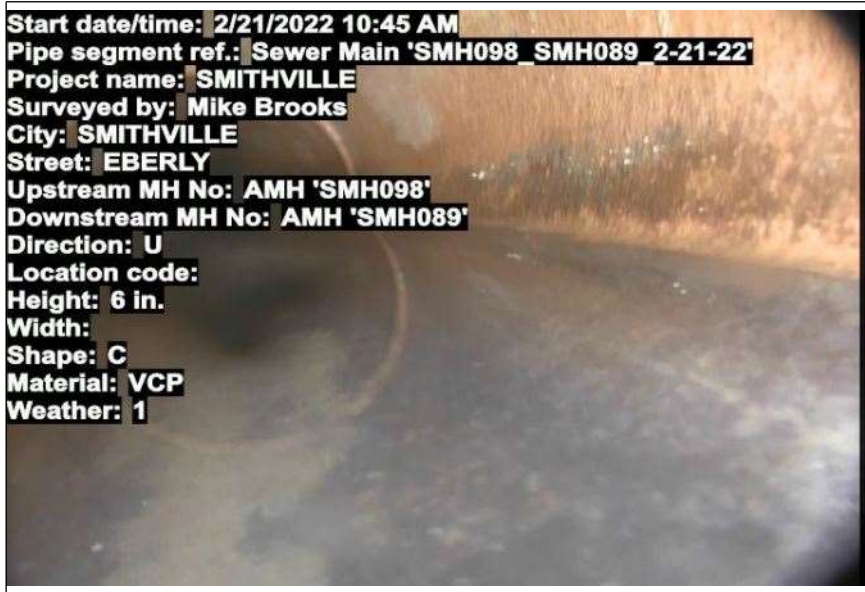
At: 0 ft. AMH - Manhole  
Joint: No SMH089

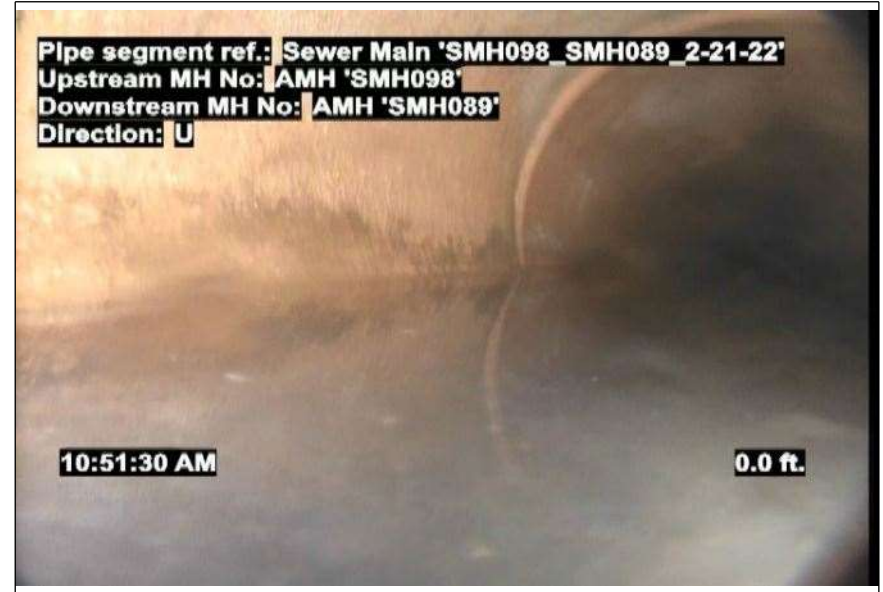
At: 0 ft. MWL - Miscellaneous Water Level  
Joint: No 5 %

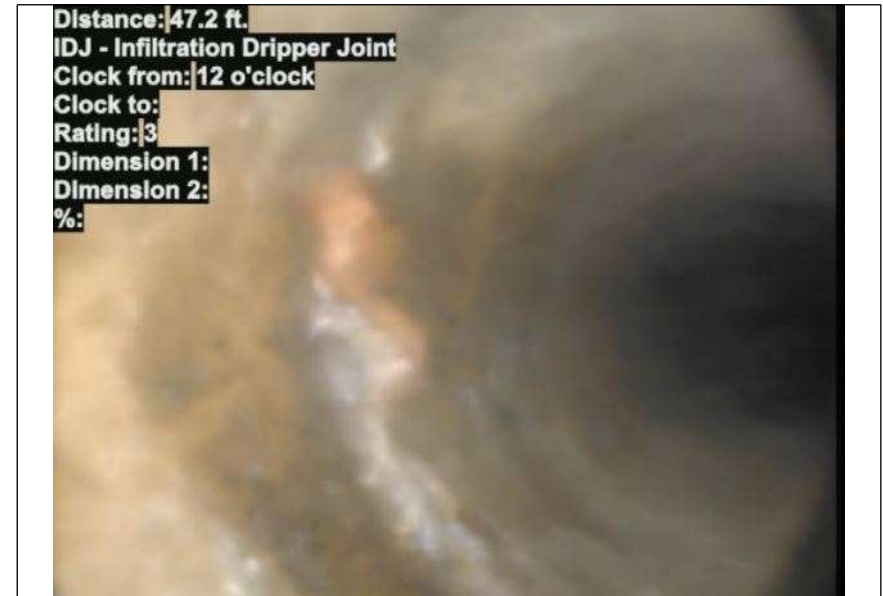
At: 47.2 ft. 12/. IDJ - Infiltration Dripper Joint  
Joint: Yes

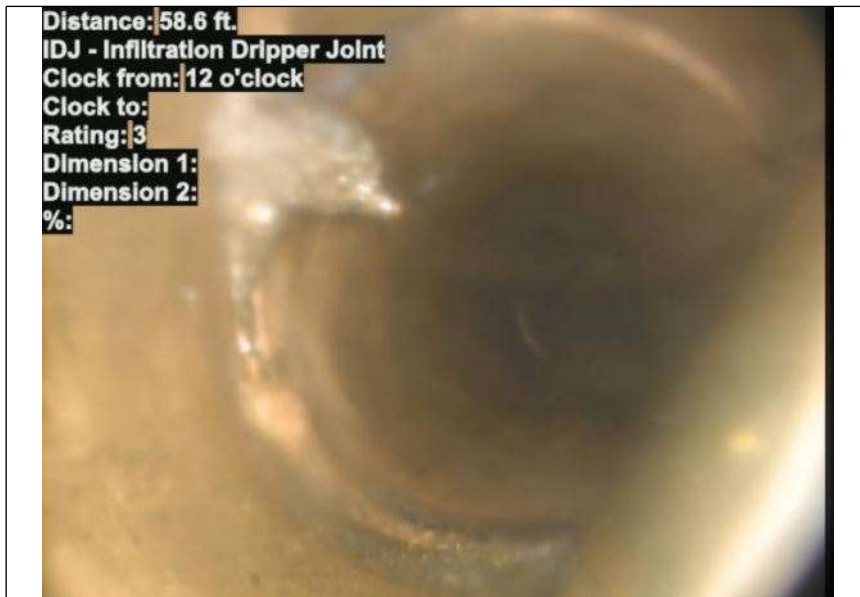
At: 58.6 ft. 12/. IDJ - Infiltration Dripper Joint  
Joint: Yes

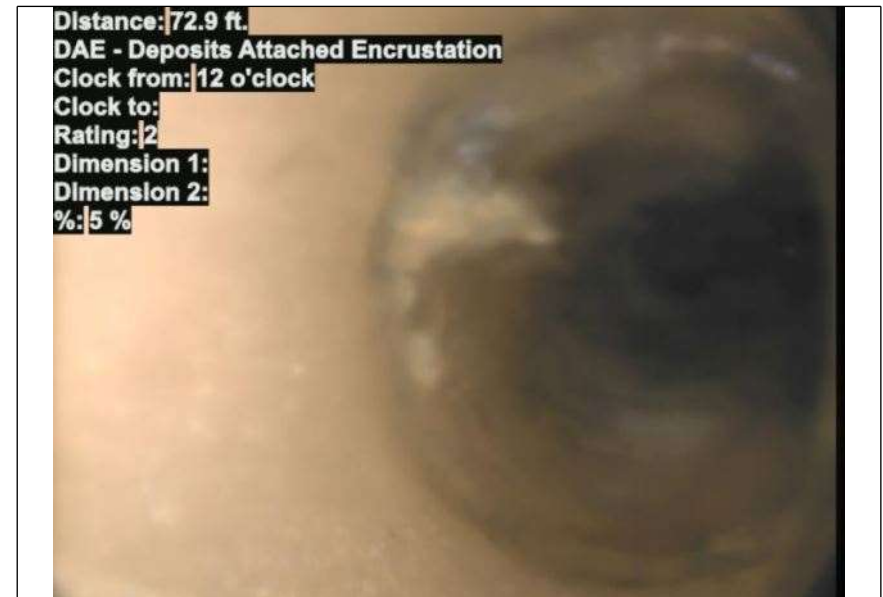
At: 72.9 ft. 12/. DAE - Deposits Attached Encrustation  
Joint: Yes 5 %

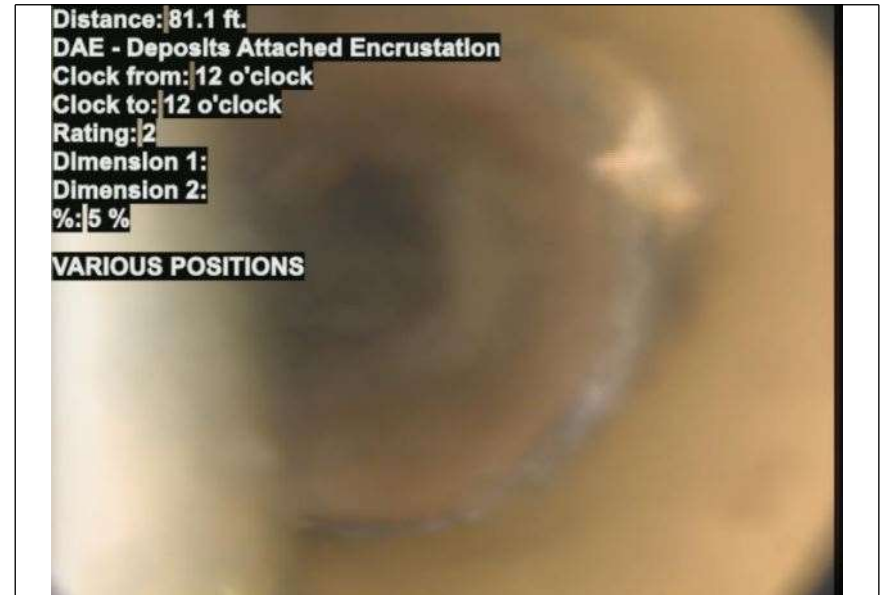
At: 81.1 ft. 7/5 DAE - Deposits Attached Encrustation  
Joint: Yes 5 % VARIOUS POSITIONS

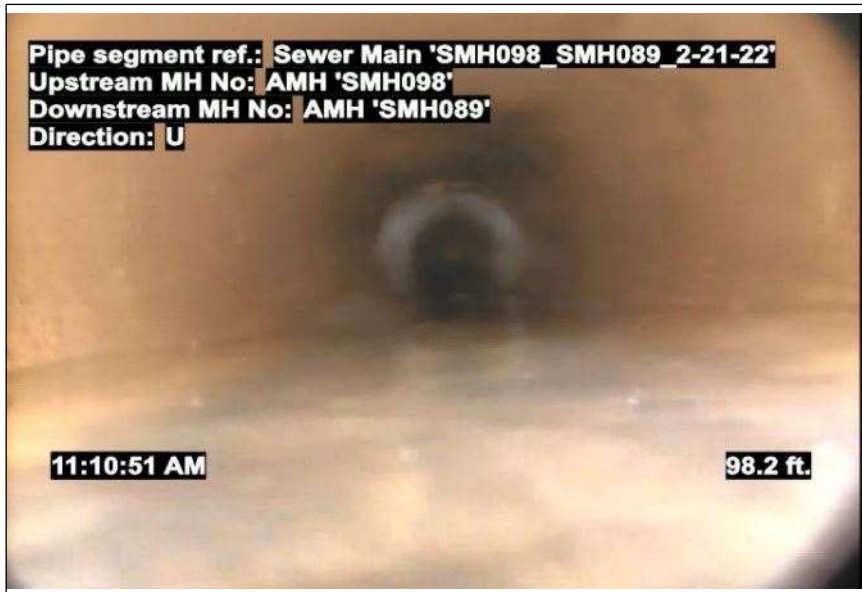
At: 98.308 ft. IDJ - Infiltration Dripper Joint  
12/.  
Joint: Yes

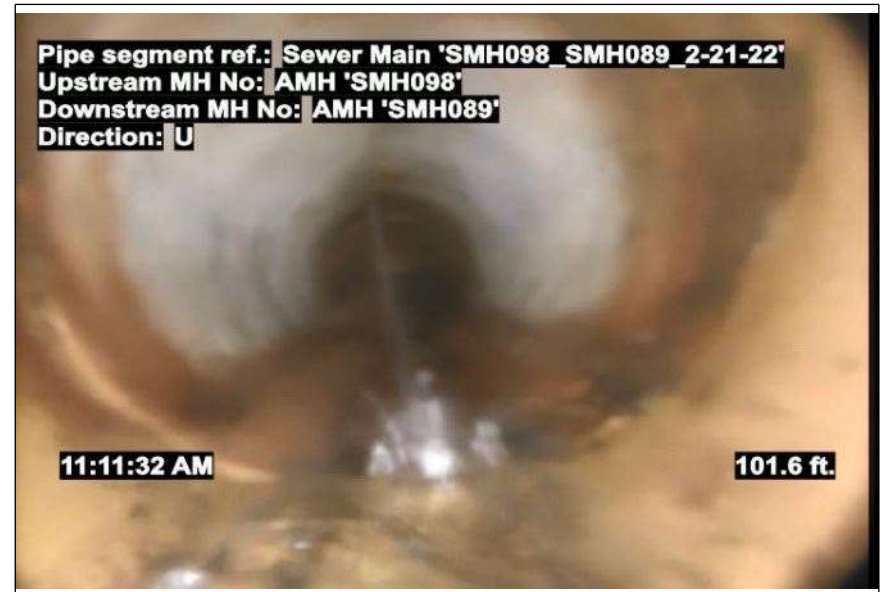
At: 101.824 ft. IDJ - Infiltration Dripper Joint  
12/.  
Joint: Yes

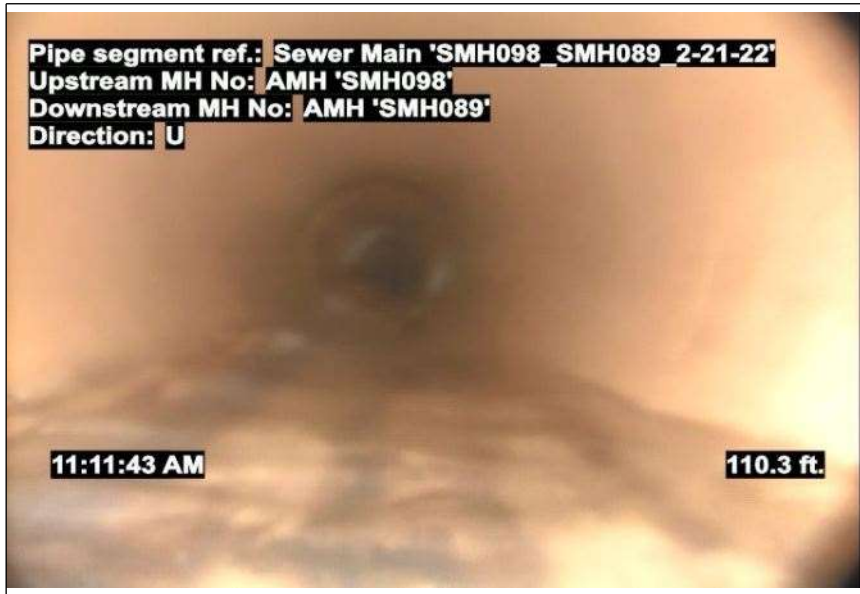
At: 110.41 ft. IDJ - Infiltration Dripper Joint  
12/.

Joint: Yes

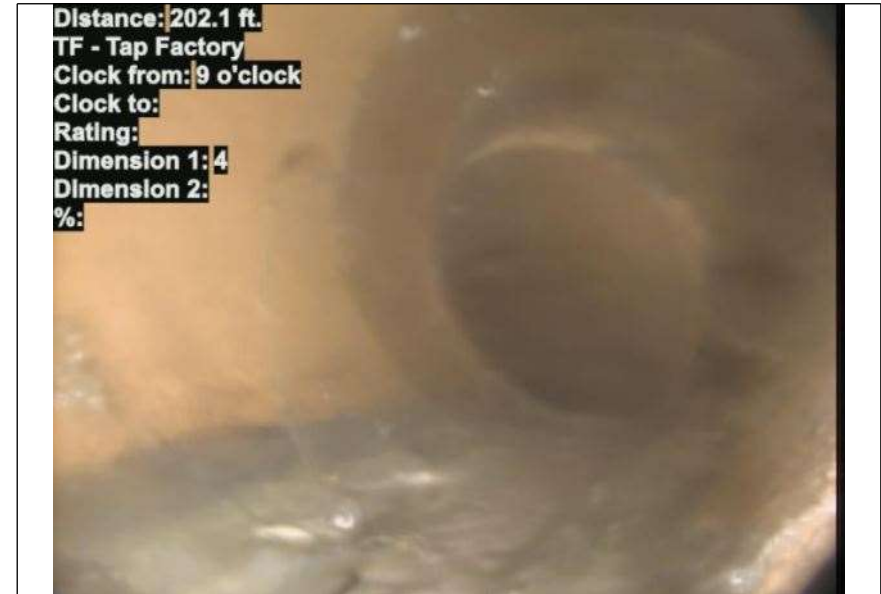
At: 202.1 ft. 9/. TF - Tap Factory

Joint: No

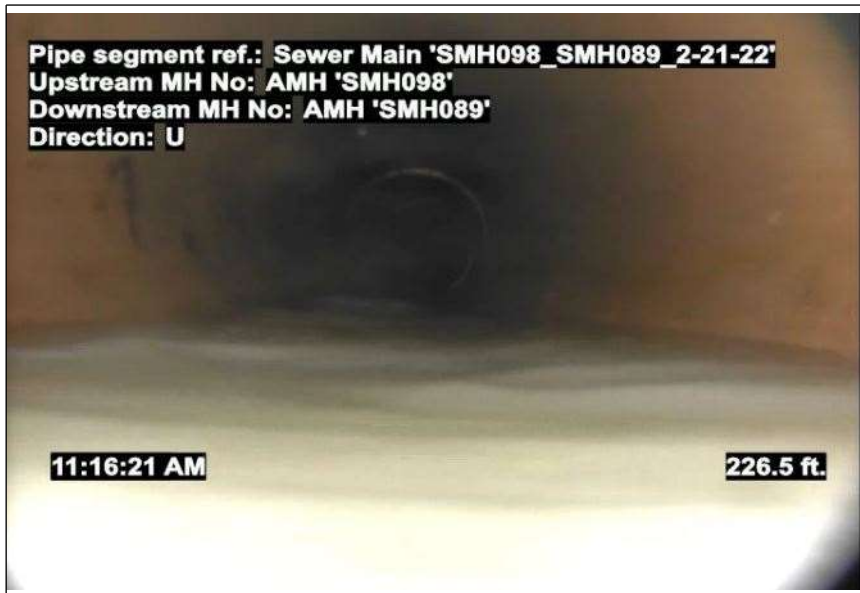
At: 226.677 ft. IDJ - Infiltration Dripper Joint  
1/2

Joint: Yes

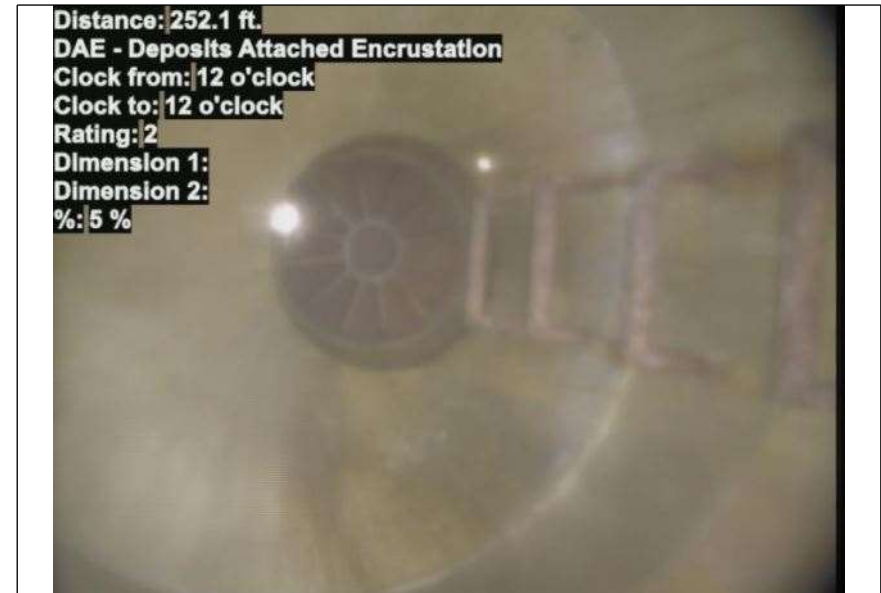
At: 252.1 ft. 7/5 DAE - Deposits Attached Encrustation

Joint: No 5 %

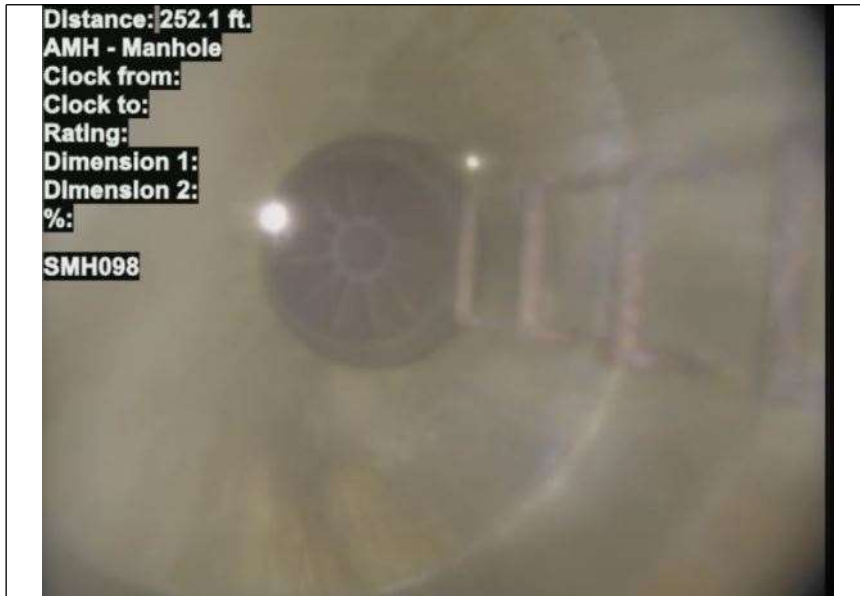
At: 252.1 ft. AMH - Manhole  
Joint: No SMH098
