PACP Report with Pipe Run and Incident Snapshots

Surveyed by: Mike Brooks	Certificate number: Mike Brooks	Owner:	Customer:	Drainage area:	P/O number:	Sheet number:
Pipe segment ref.: SMH099_SMH091	Start date/time: 20220331 10:52	Street: MISHLER		City: SMITHVILLE		
Location details: STREET		Upstream MH No: SMH099	Rim to invert:	Grade to invert:	Rim to grade:	
Pipe use: SS	Direction: U	Flow control:	Downstream MH No: SMH091	Rim to invert:	Grade to invert:	Rim to grade:
Height: 8 in.	Width:	Shape: C	Material: VCP	Lining method:	Pipe joint length:	Total length: 152.200 ft.
Media label:	PreCleaning: L	Date cleaned:	Weather: 1	Length surveyed: 152.200 ft.	Purpose:	Sewer category:
Project name: Sewer Cleaning & CCTV - Project No. 210670		Additional info:

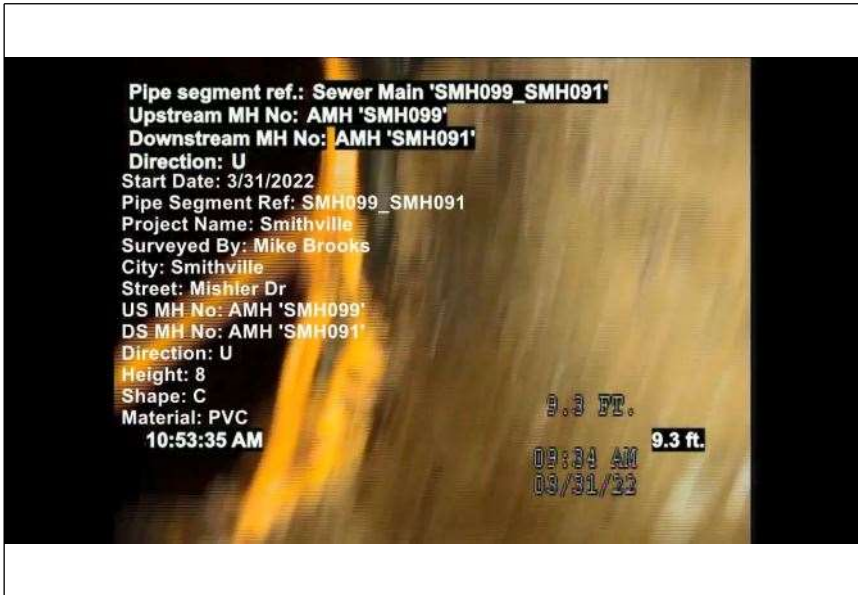
At: 0 ft. AMH - Manhole
 Joint: No SMH091

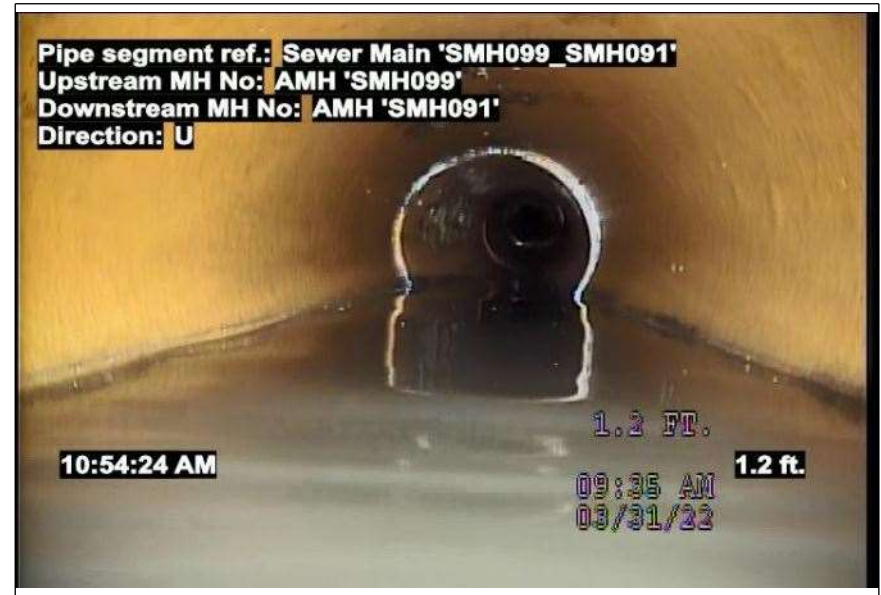
At: 0 ft. MWL - Miscellaneous Water Level
 Joint: No 5%

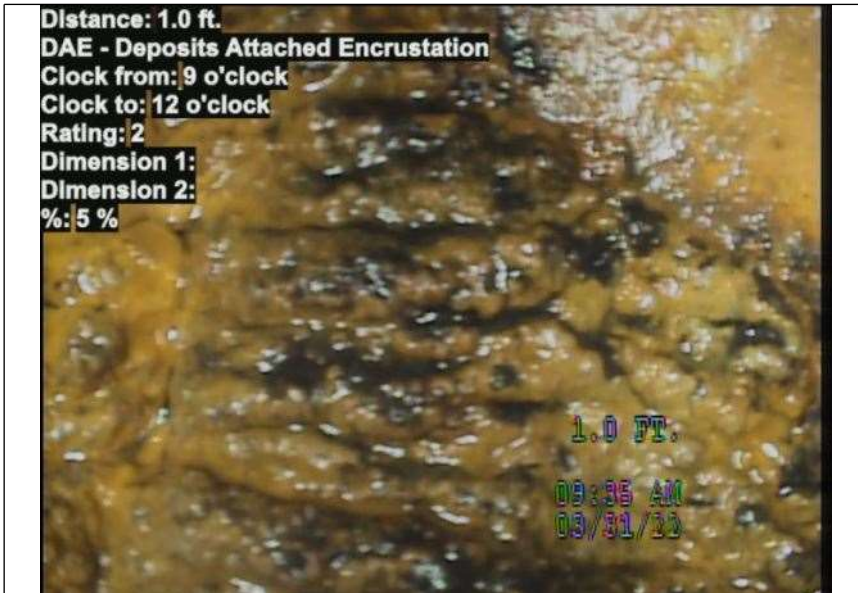
At: 1 ft. 9/12 DAE - Deposits Attached Encrustation
 Joint: No 5%

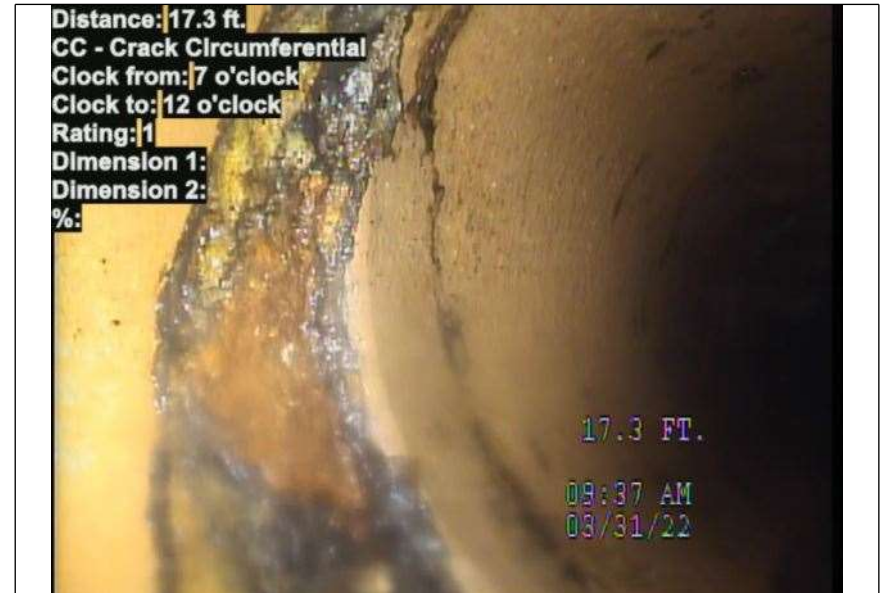
At: 17.3 ft. 7/12 CC - Crack Circumferential
 Joint: No

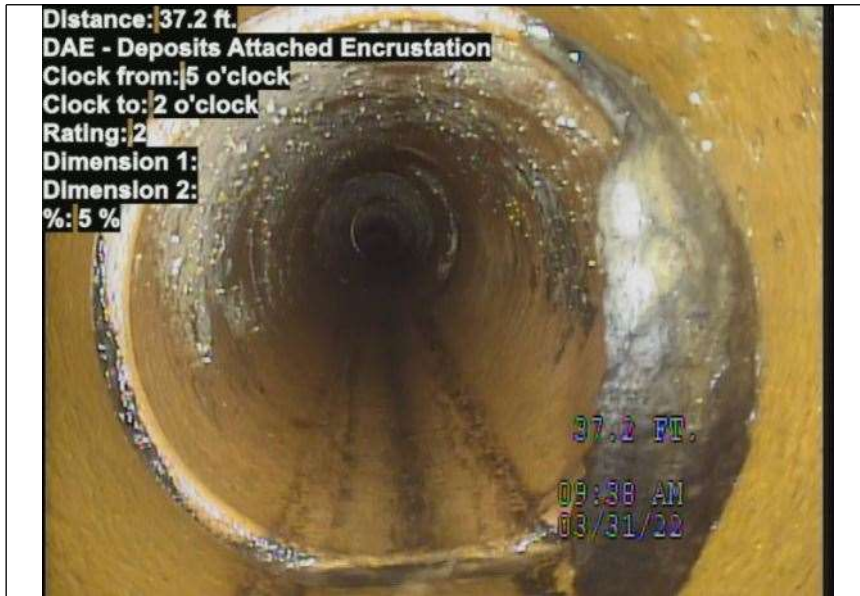
At: 37.2 ft. 5/2 DAE - Deposits Attached Encrustation
Joint: No 5 %

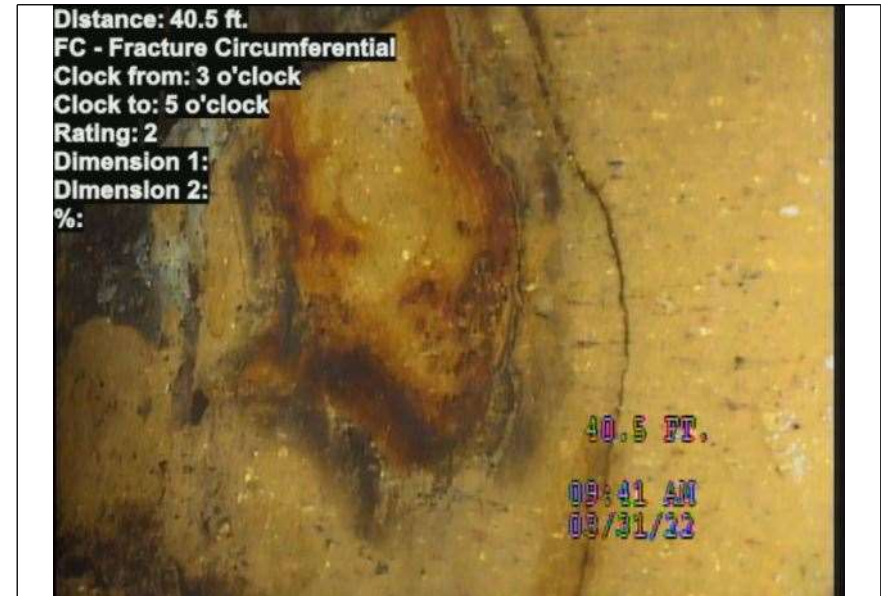
At: 40.5 ft. 3/5 FC - Fracture Circumferential
Joint: No

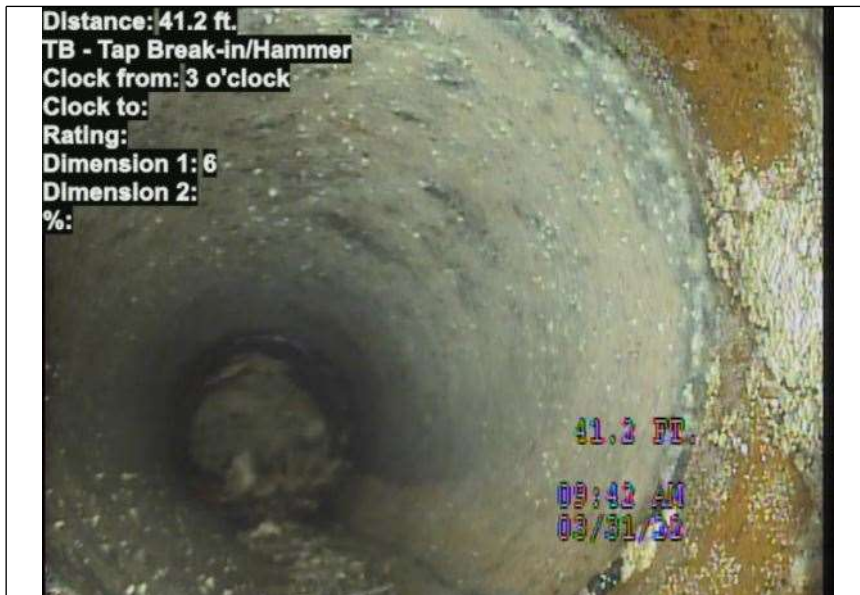
At: 41.2 ft. 3/. TB - Tap Break-in/Hammer
Joint: No

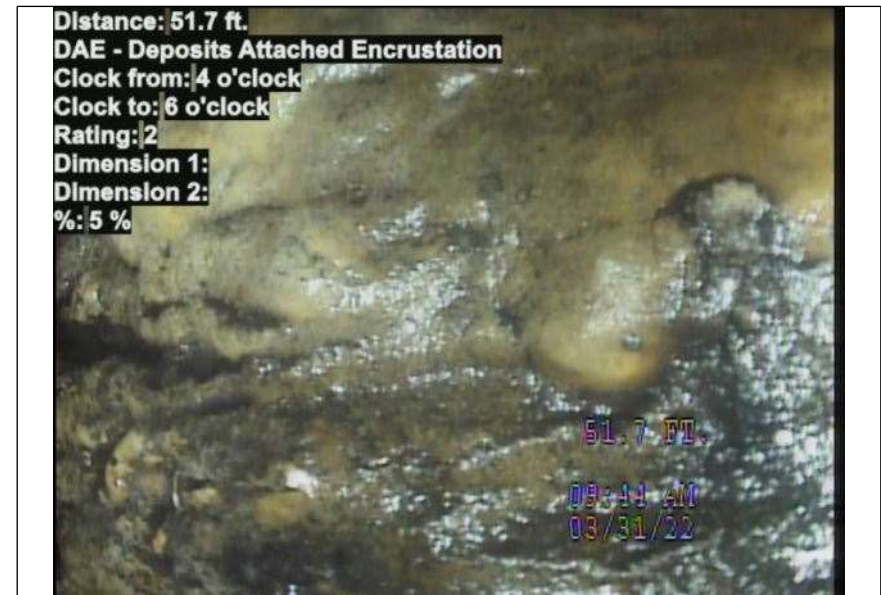
At: 51.7 ft. 4/6 DAE - Deposits Attached Encrustation
Joint: No 5 %

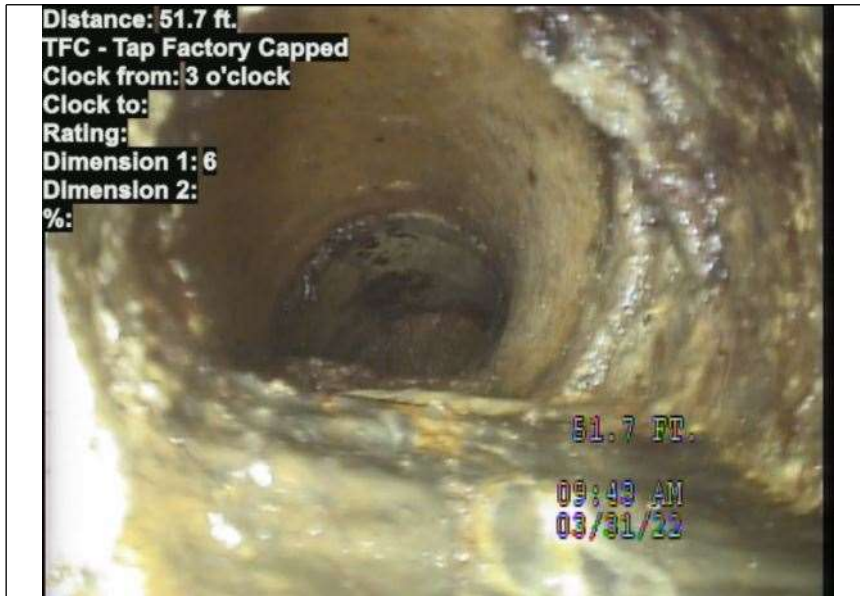
At: 51.7 ft. 3/. TFC - Tap Factory Capped
Joint: No

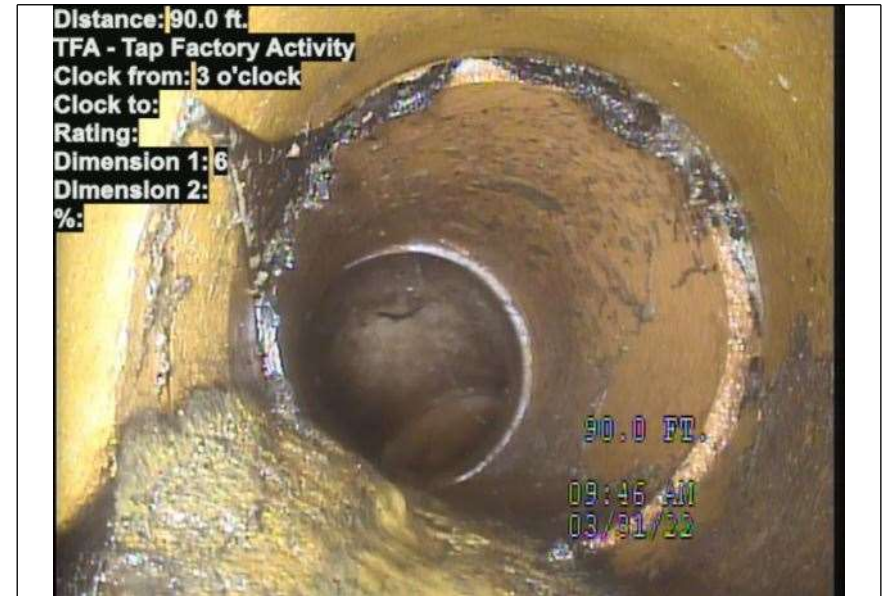
At: 90 ft. 3/. TFA - Tap Factory Activity
Joint: No

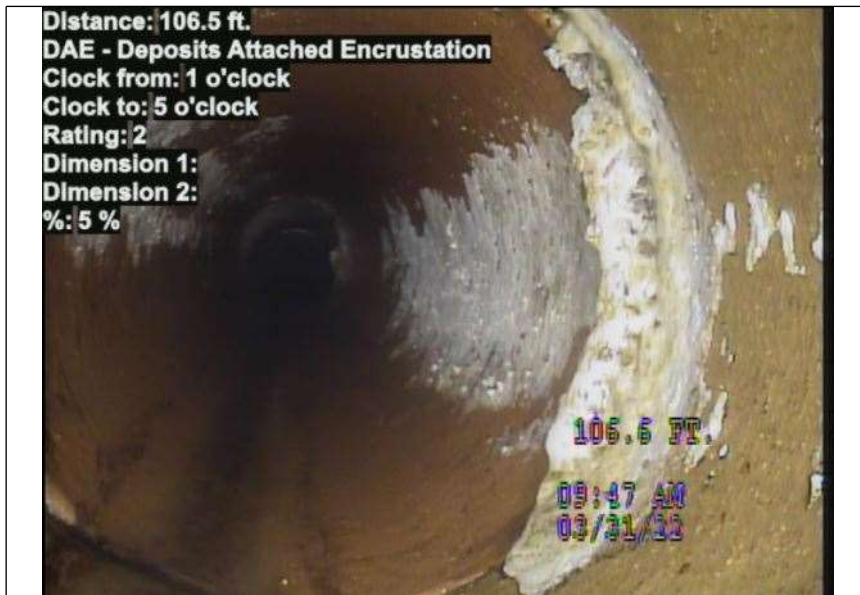
At: 106.5 ft. 1/5 DAE - Deposits Attached Encrustation
Joint: No 5 %

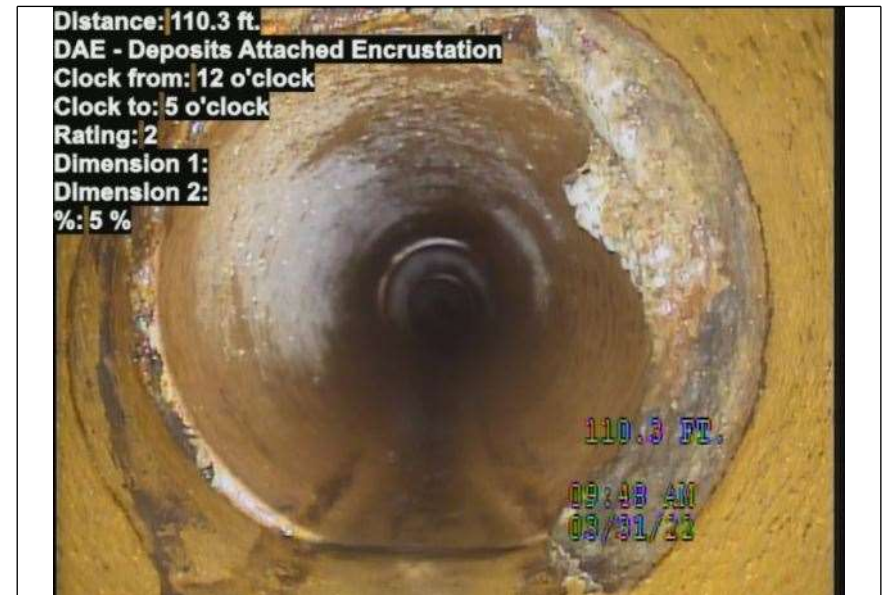
At: 110.3 ft. 12/5 DAE - Deposits Attached Encrustation
Joint: No 5 %

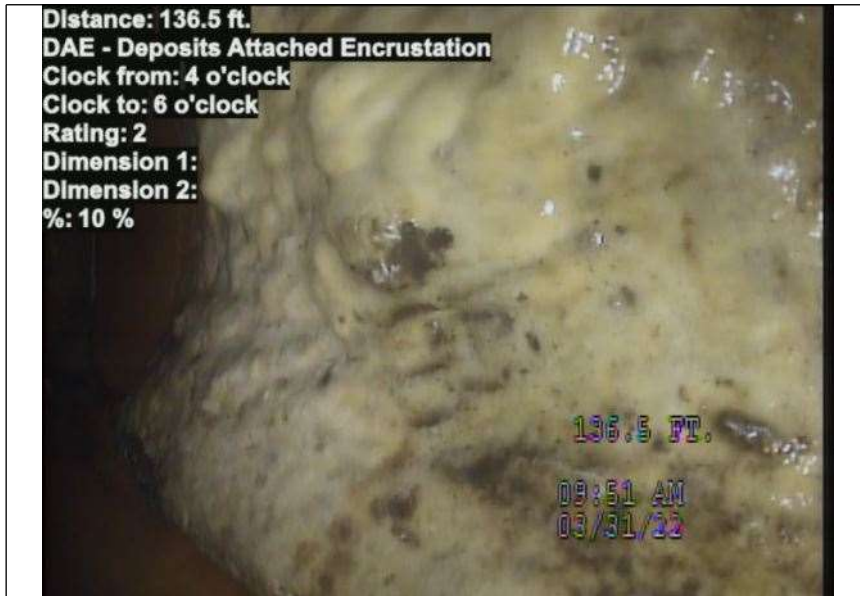
At: 136.5 ft. 4/6 DAE - Deposits Attached Encrustation
Joint: No 10 %

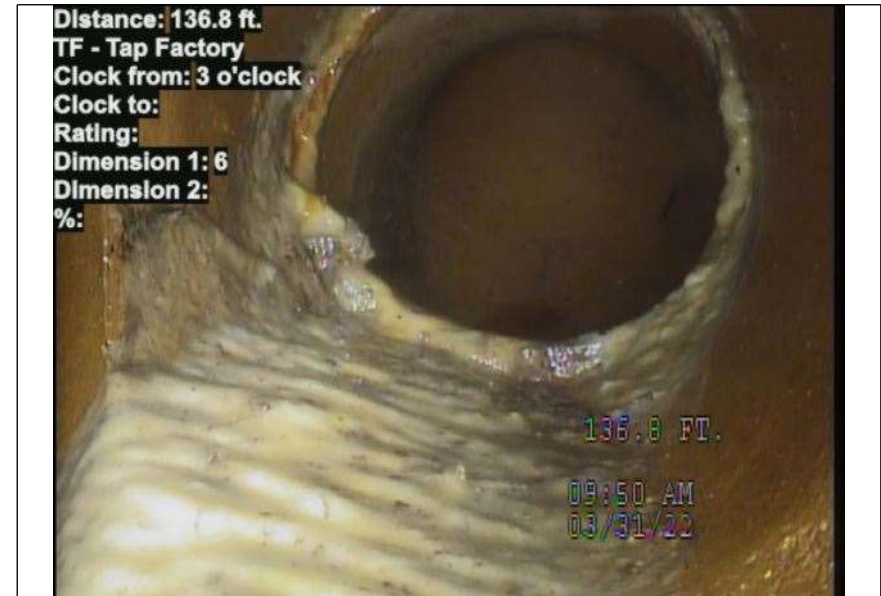
At: 136.8 ft. 3/. TF - Tap Factory
Joint: No

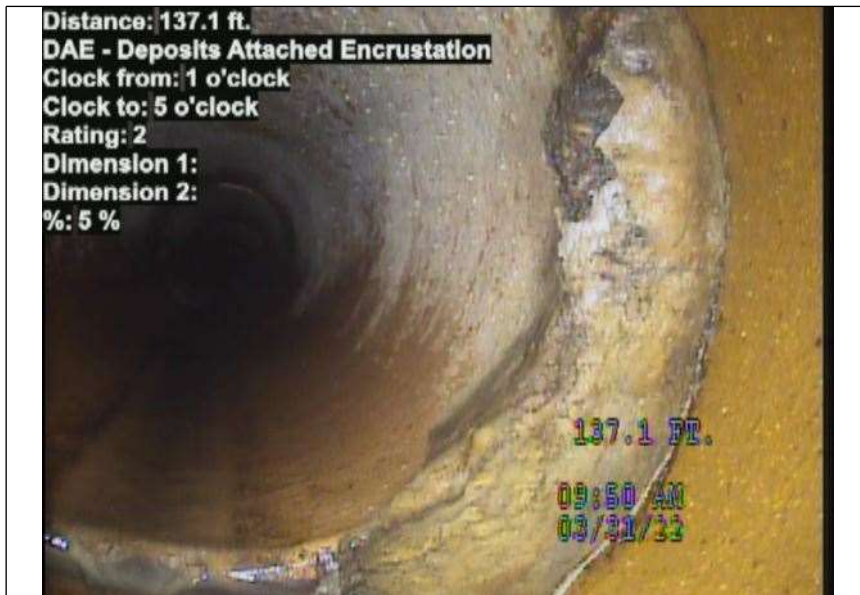
At: 137.1 ft. 1/5 DAE - Deposits Attached Encrustation
Joint: No 5 %

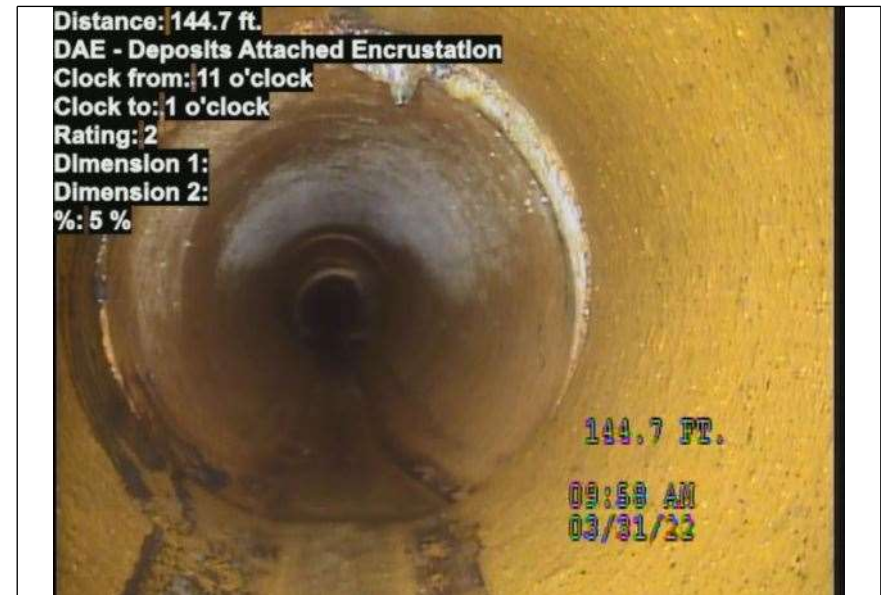
At: 144.7 ft. DAE - Deposits Attached Encrustation
11/1
Joint: No 5 %

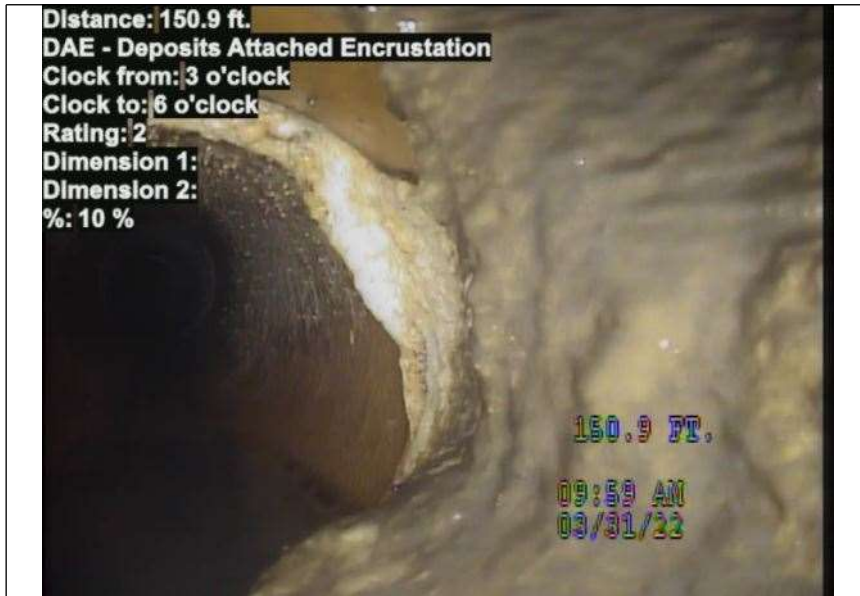
At: 150.9 ft. 3/6 DAE - Deposits Attached Encrustation

Joint: No 10 %

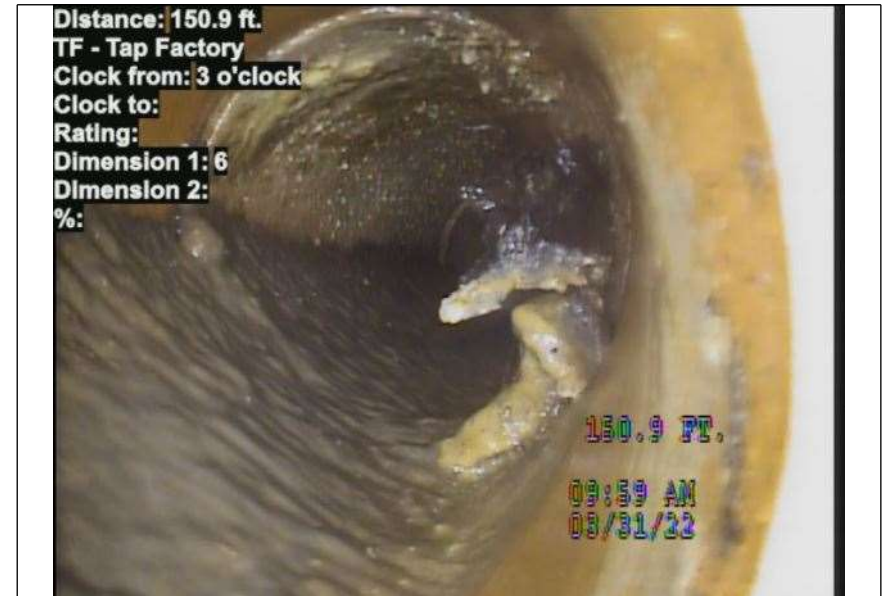
At: 150.9 ft. 3/. TF - Tap Factory

Joint: No

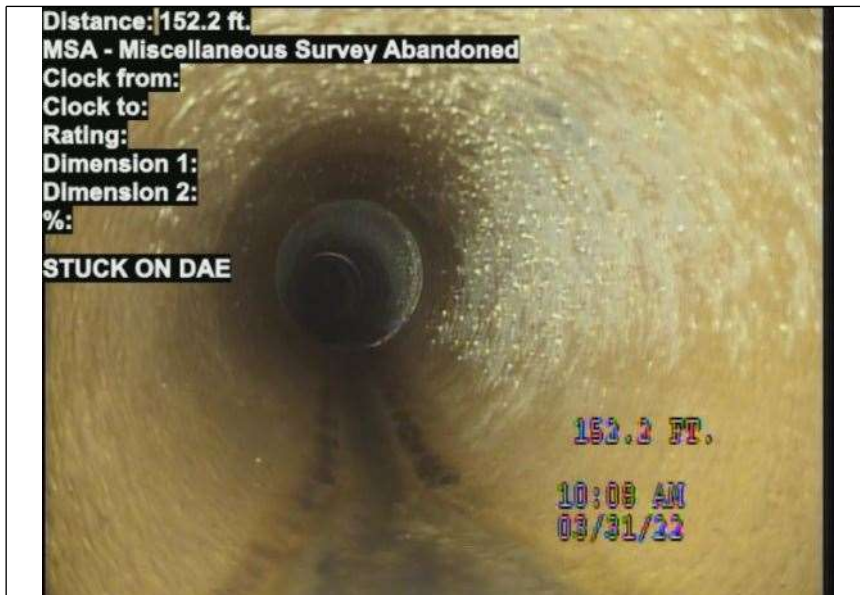
At: 152.2 ft. MSA - Miscellaneous Survey Abandoned

Joint: No STUCK ON DAE
