PACP Report with Pipe Run and Incident Snapshots

Surveyed by: Mike Brooks	Certificate number: Mike Brooks	Owner:	Customer:	Drainage area:	P/O number:	Sheet number:
Pipe segment ref.: SMH100_SMH090	Start date/time: 20220221 12:50	Street: EBERLY		City: SMITHVILLE		
Location details: STREET		Upstream MH No: SMH100	Rim to invert:	Grade to invert:	Rim to grade:	
Pipe use: SS	Direction: U	Flow control:	Downstream MH No: SMH090	Rim to invert:	Grade to invert:	Rim to grade:
Height: 6 in.	Width:	Shape: C	Material: VCP	Lining method:	Pipe joint length:	Total length: 502.200 ft.
Media label:	PreCleaning: L	Date cleaned:	Weather: 1	Length surveyed: 291.800 ft.	Purpose:	Sewer category:
Project name: Sewer Cleaning & CCTV - Project No. 210670		Additional info:

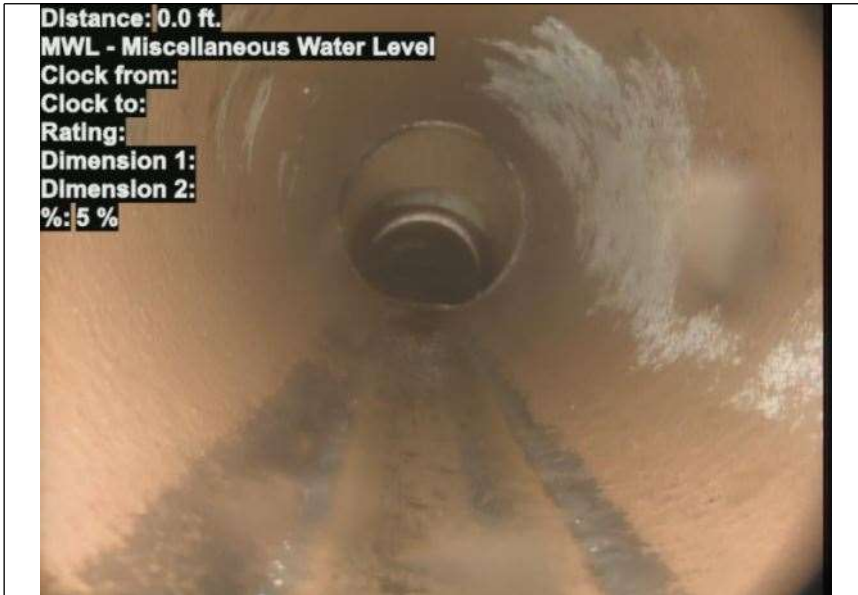
At: 0 ft. MWL - Miscellaneous Water Level
Joint: No 5 %

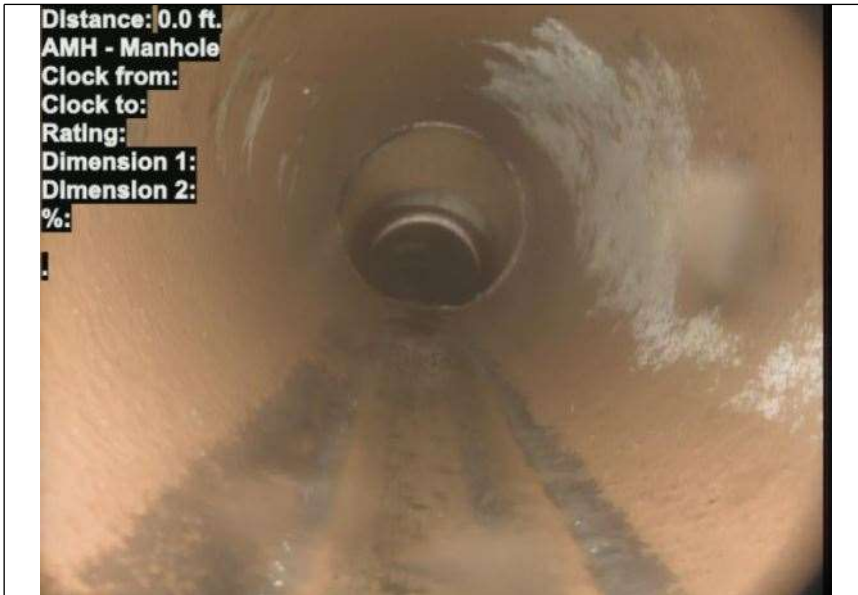
At: 0 ft. AMH - Manhole
Joint: No SMH090

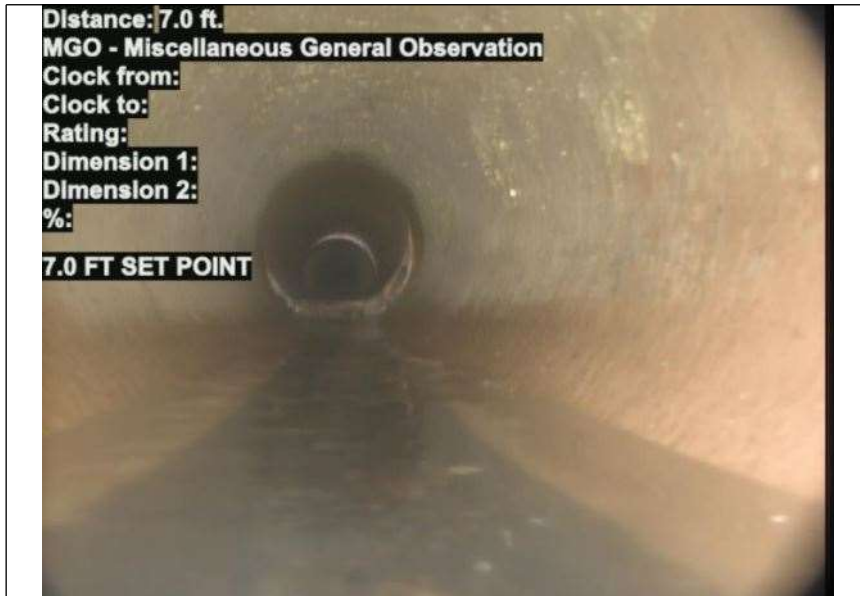
At: 7 ft. MGO - Miscellaneous General Observation
Joint: No 7.0 FT SET POINT

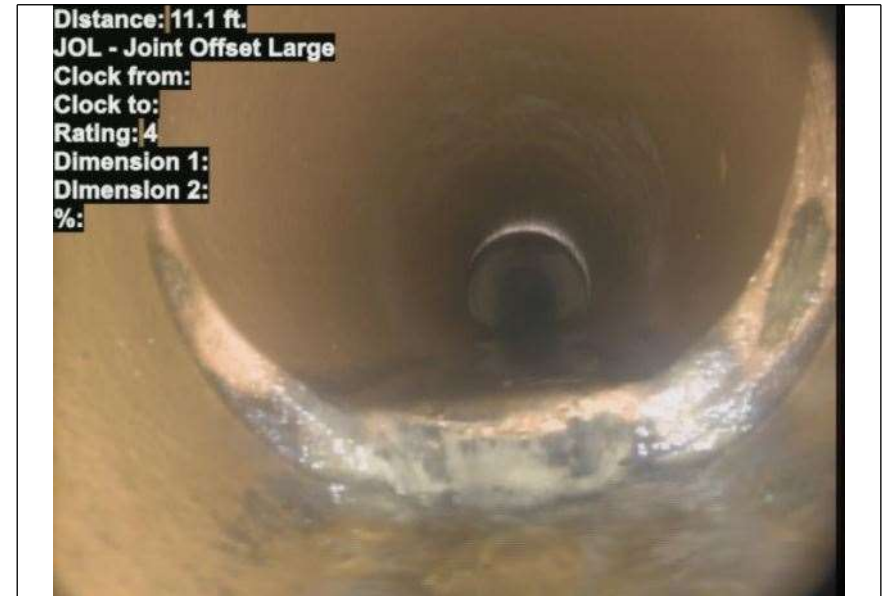
At: 11.1 ft. JOL - Joint Offset Large
Joint: No

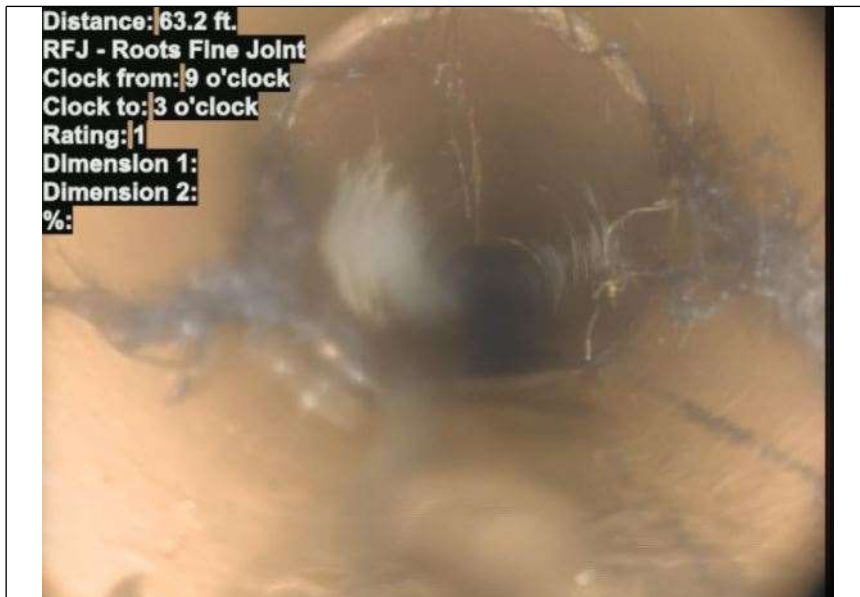
At: 63.2 ft. 9/3 RFJ - Roots Fine Joint
Joint: Yes

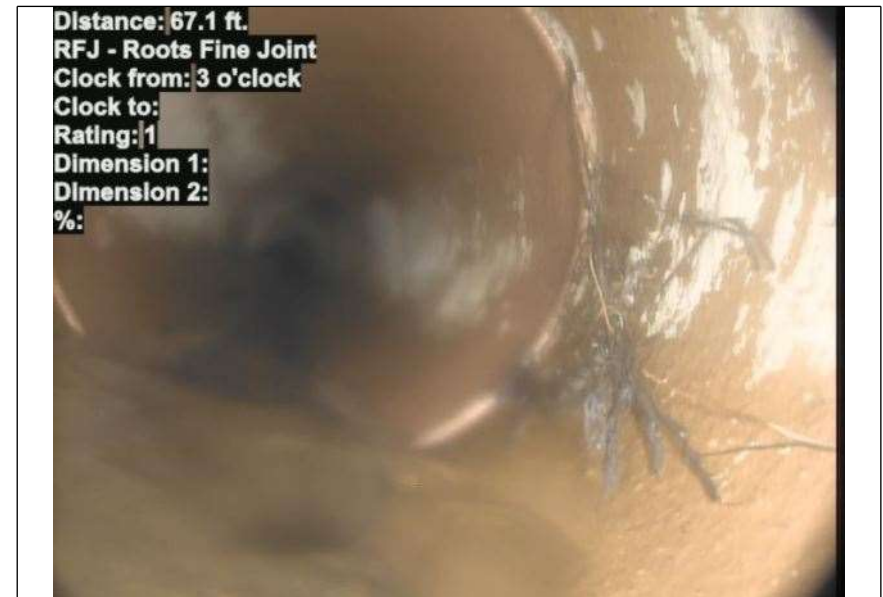
At: 67.1 ft. 3/ RFJ - Roots Fine Joint
Joint: Yes

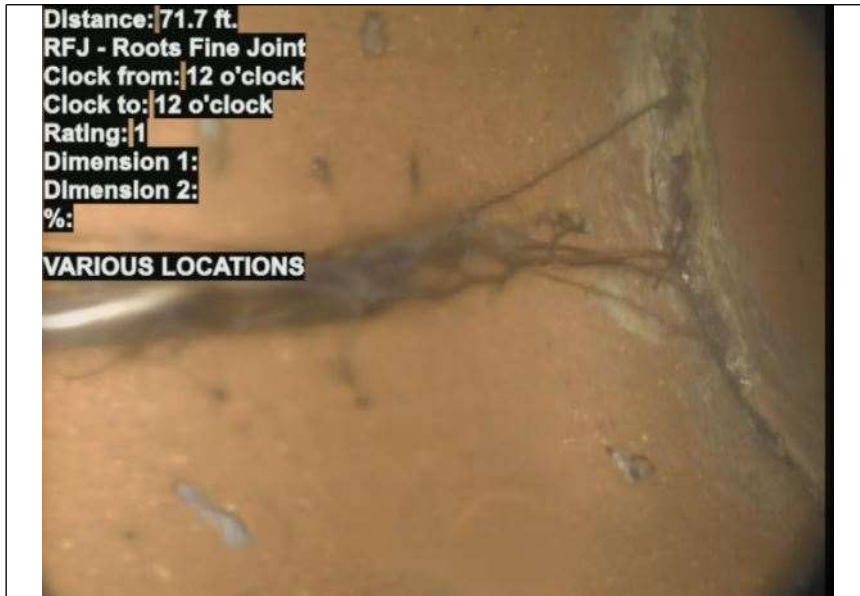
At: 71.7 ft. 7/5 RFJ - Roots Fine Joint
Joint: Yes VARIOUS LOCATIONS

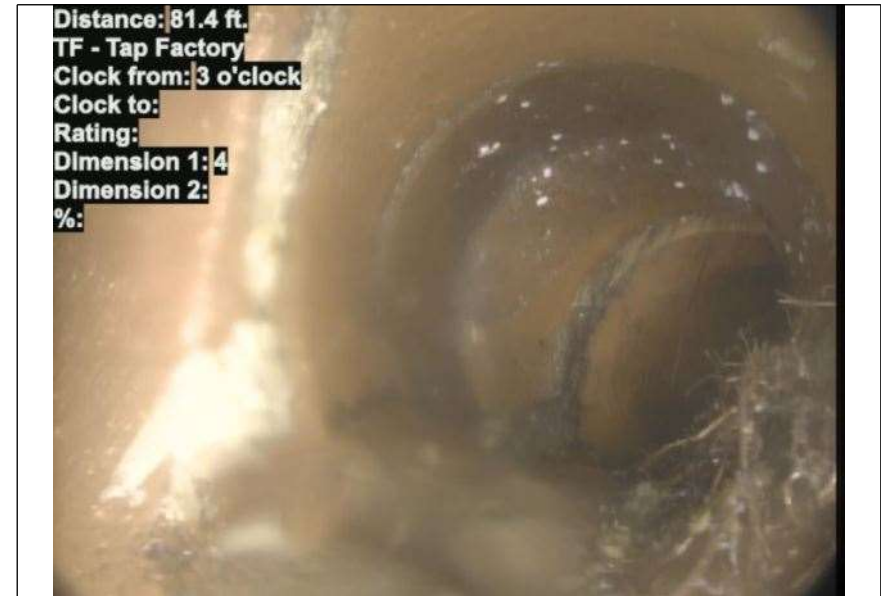
At: 81.4 ft. 3/. TF - Tap Factory
Joint: No

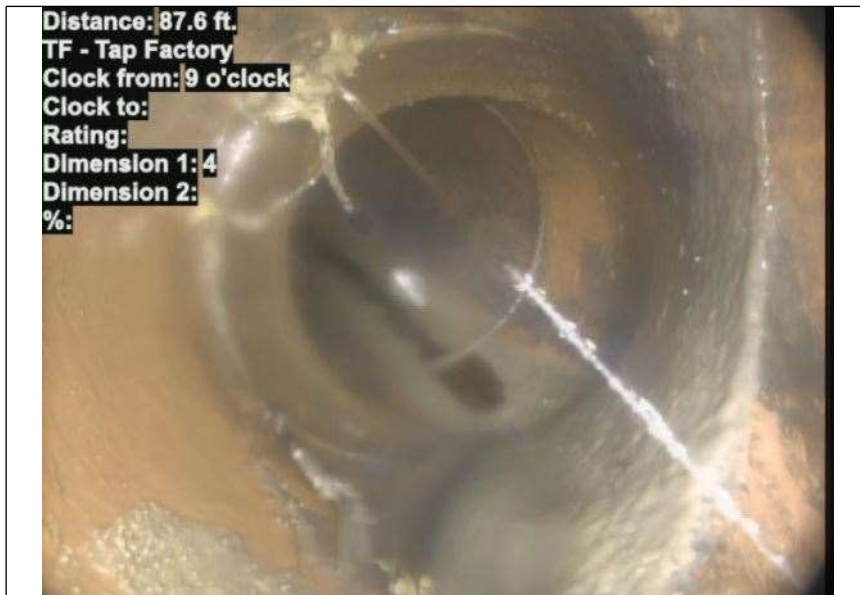
At: 87.6 ft. 9/. TF - Tap Factory
Joint: No

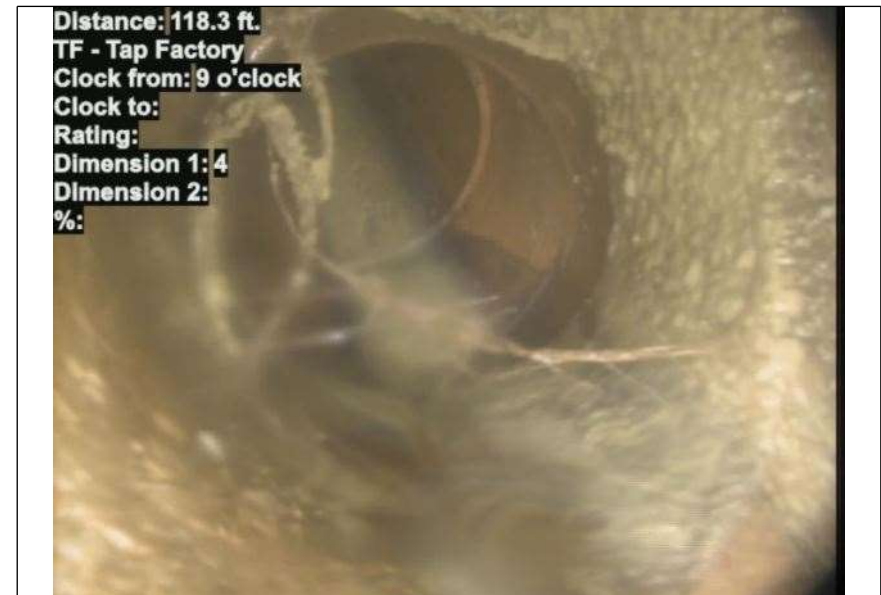
At: 118.3 ft. 9/. TF - Tap Factory
Joint: No

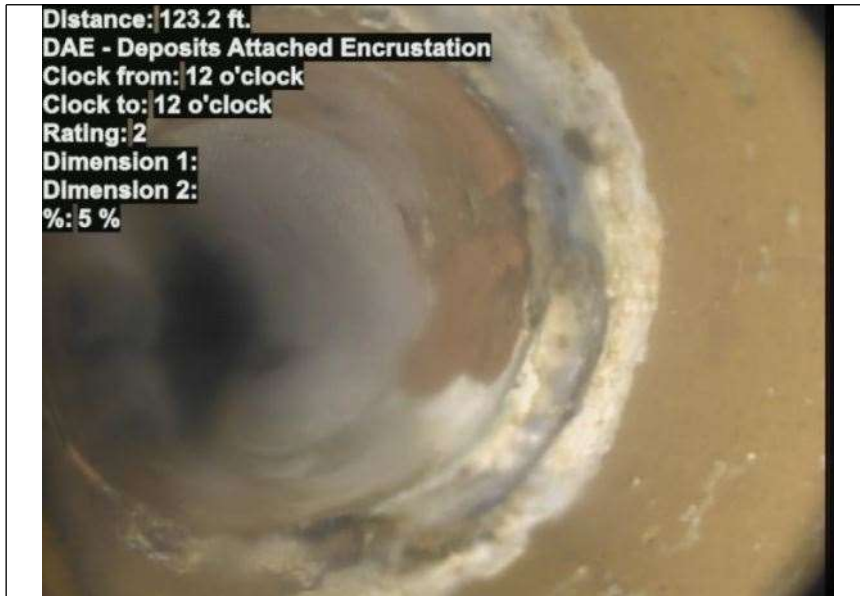
At: 123.2 ft. 7/5 DAE - Deposits Attached Encrustation
Joint: No 5 %

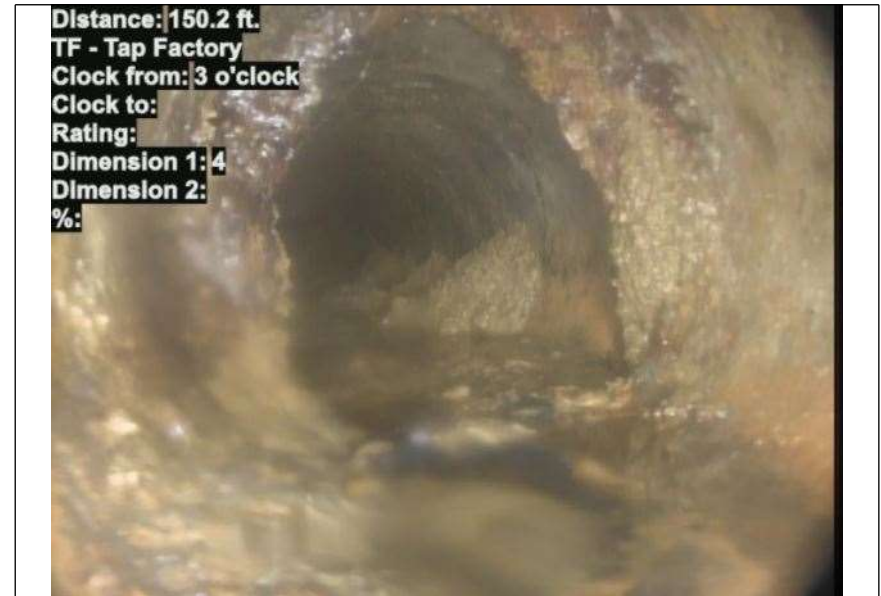
At: 150.2 ft. 3/. TF - Tap Factory
Joint: No

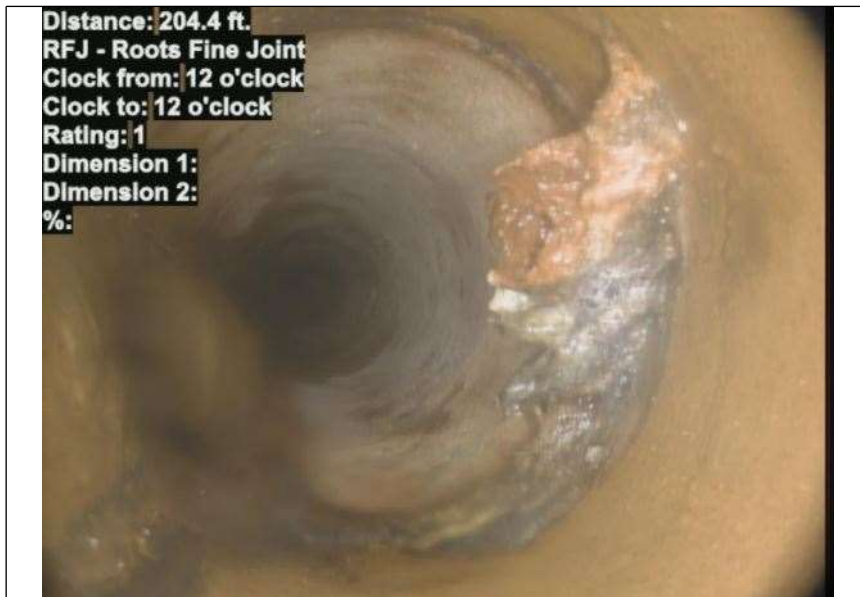
At: 204.4 ft. 7/5 RFJ - Roots Fine Joint
Joint: Yes

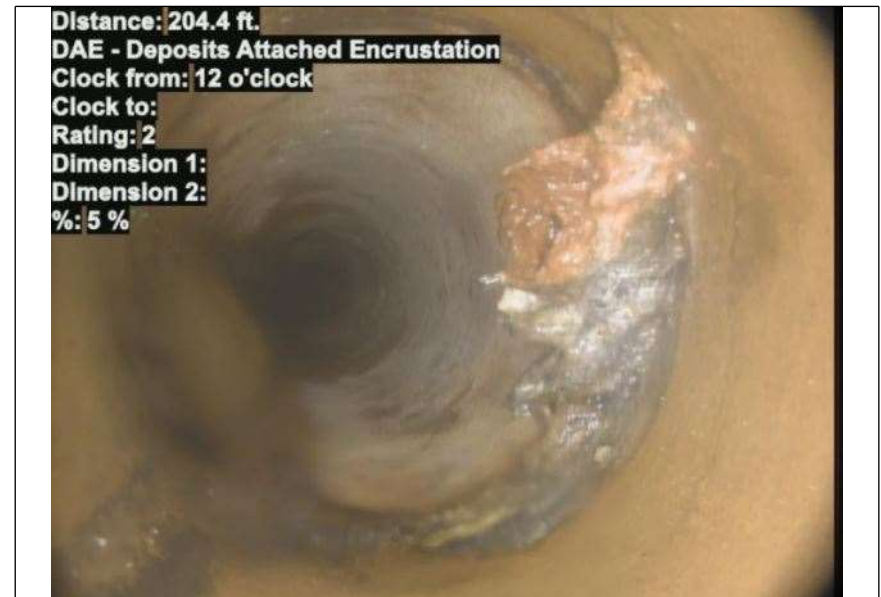
At: 204.4 ft. 12/. DAE - Deposits Attached Encrustation
Joint: No 5 %

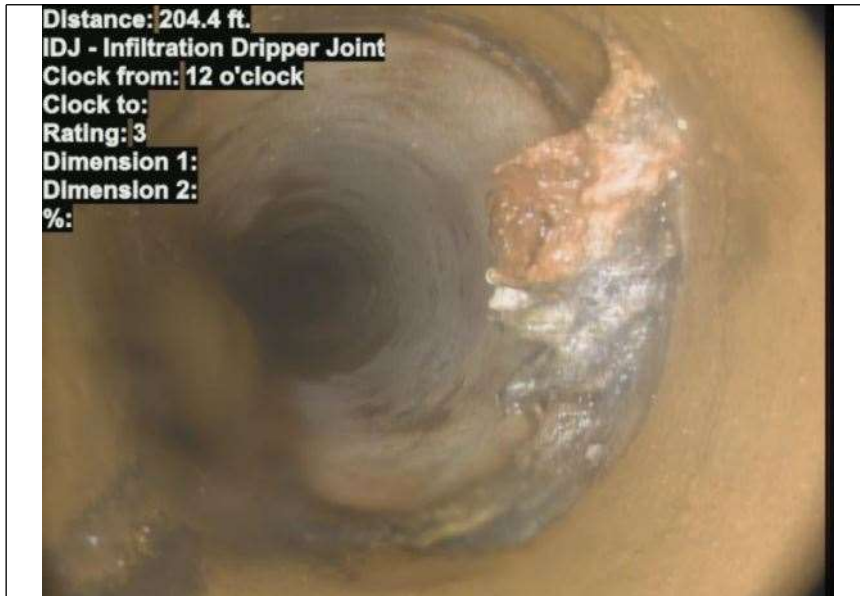
At: 204.4 ft. 12/. IDJ - Infiltration Dripper Joint

Joint: Yes

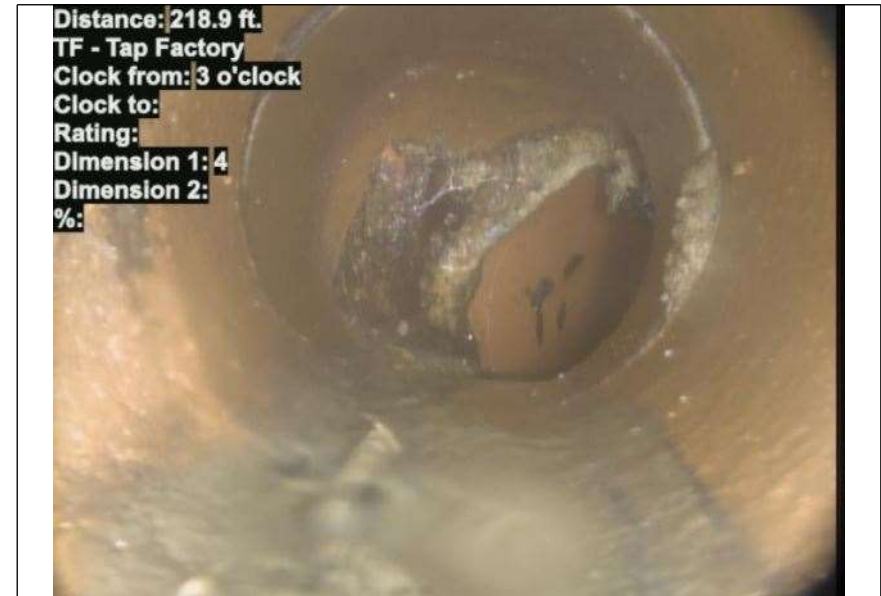
At: 218.9 ft. 3/. TF - Tap Factory

Joint: No

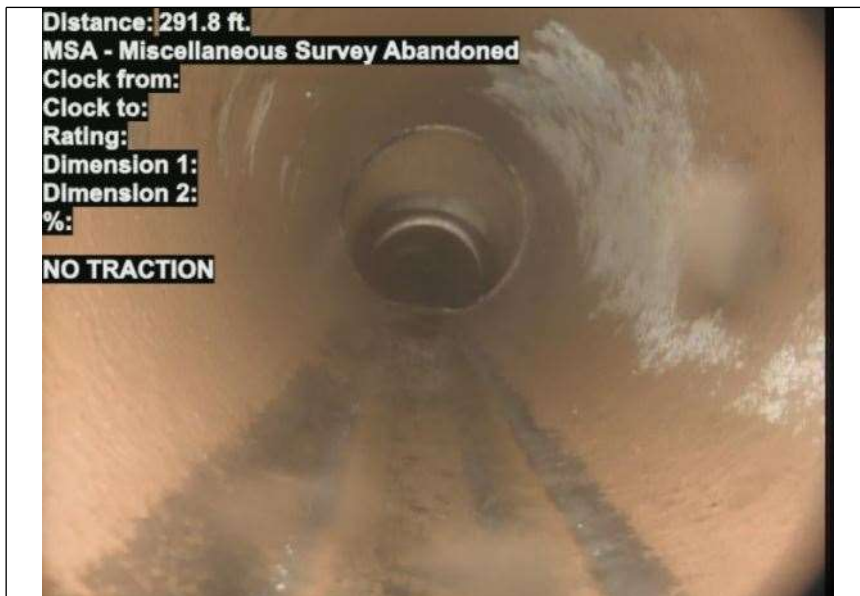
At: 291.8 ft. MSA - Miscellaneous Survey Abandoned

Joint: No NO TRACTION
