## PACP Report with Pipe Run and Incident Snapshots

Surveyed by: <b>Mike Brooks</b>	Certificate number: <b>Mike Brooks</b>	Owner:	Customer:	Drainage area:	P/O number:	Sheet number:			
Pipe segment ref.: <b>SMH100_SMH090</b>	Start date/time: <b>20220222 09:22</b>	Street: <b>EBERLY</b>	City: <b>SMITHVILLE</b>						
Location details: <b>STREET</b>	Upstream MH No: <b>SMH100</b>	Rim to invert:	Grade to invert:	Rim to grade:					
Pipe use: <b>SS</b>	Direction: <b>D</b>	Flow control:	Downstream MH No: <b>SMH090</b>	Rim to invert:	Grade to invert:	Rim to grade:			
Height: <b>6 in.</b>	Width:	Shape: <b>C</b>	Material: <b>VCP</b>	Lining method:	Pipe joint length:	Total length: <b>502.200 ft.</b>	Length surveyed: <b>210.400 ft.</b>	Purpose: <b>F</b>	Sewer category:
Media label:	PreCleaning: <b>L</b>	Date cleaned:	Weather:	Location code:	Pressure value:				
Project name: <b>Sewer Cleaning &amp; CCTV - Project No. 210670</b>	Additional info:

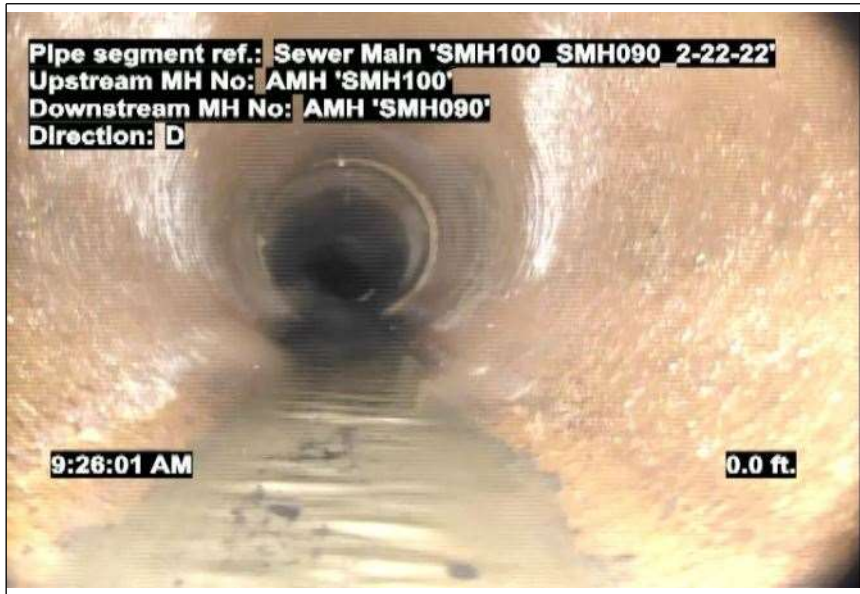
At: 0 ft. MWL - Miscellaneous Water Level  
Joint: No 5 %

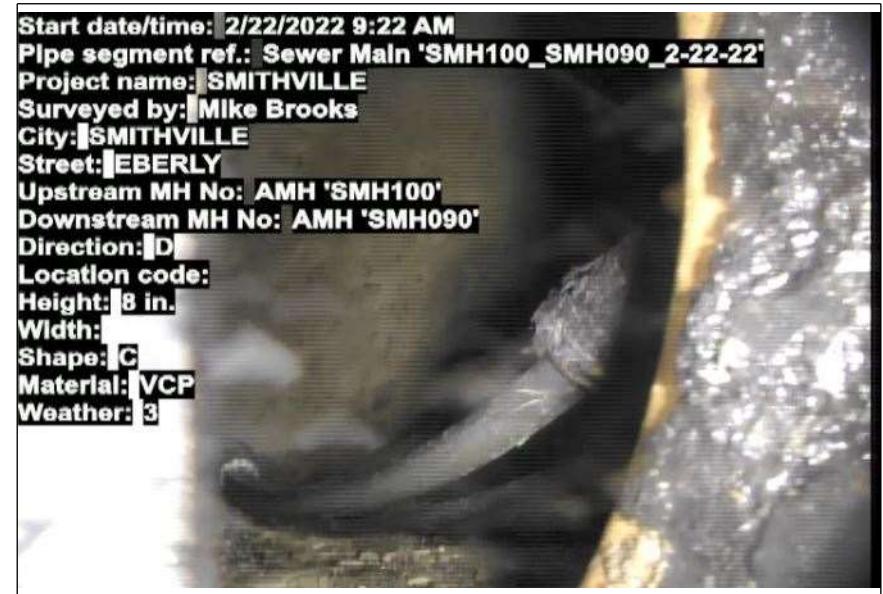
At: 0 ft. AMH - Manhole  
Joint: No SMH100

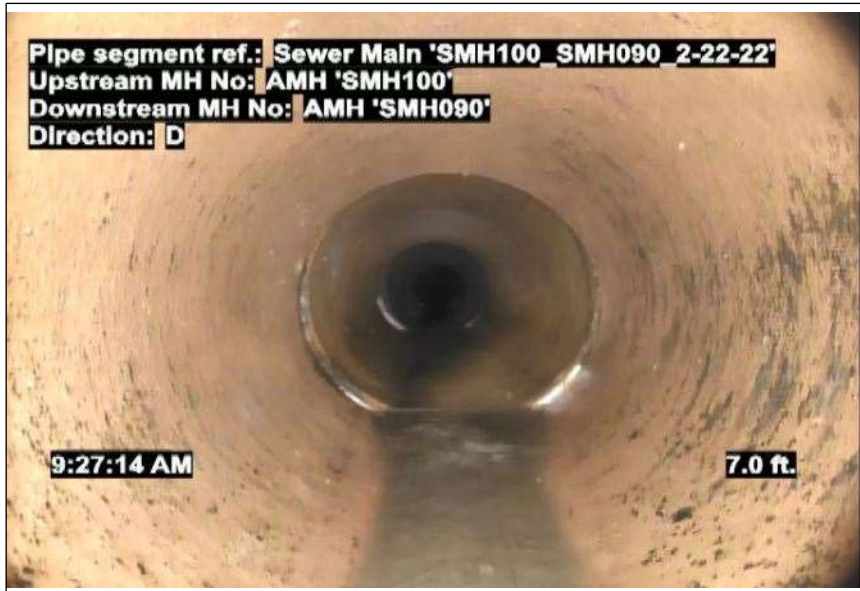
At: 7 ft. MGO - Miscellaneous General Observation  
Joint: No 7.0FT SET DISTANCE

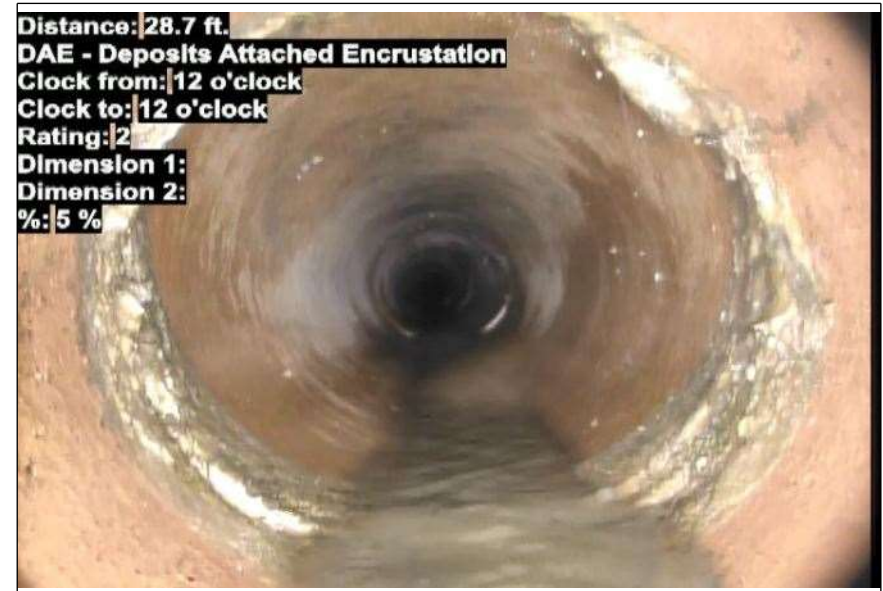
At: 28.7 ft. 7/5 DAE - Deposits Attached Encrustation  
Joint: No 5 %

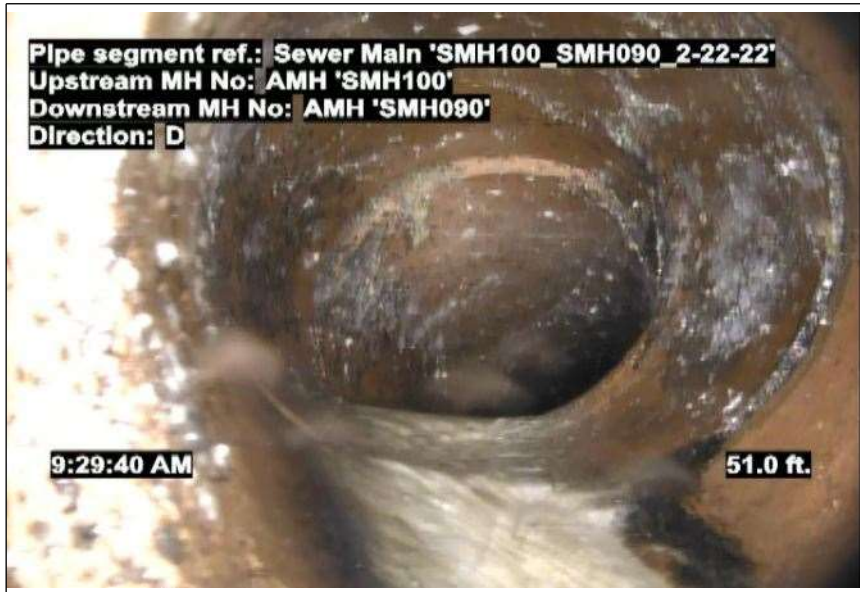
At: 51 ft. 9/. TF - Tap Factory  
Joint: No

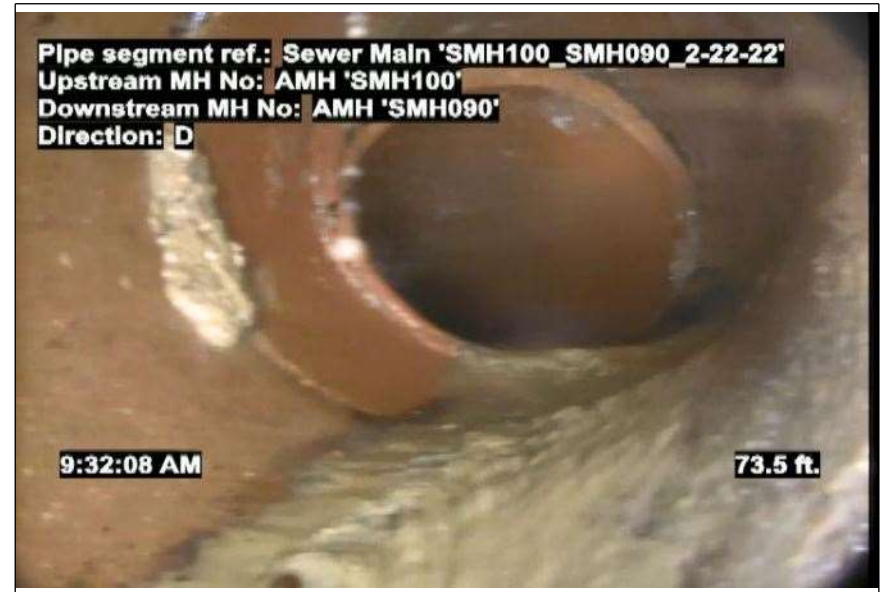
At: 73.5 ft. 3/. TF - Tap Factory  
Joint: No

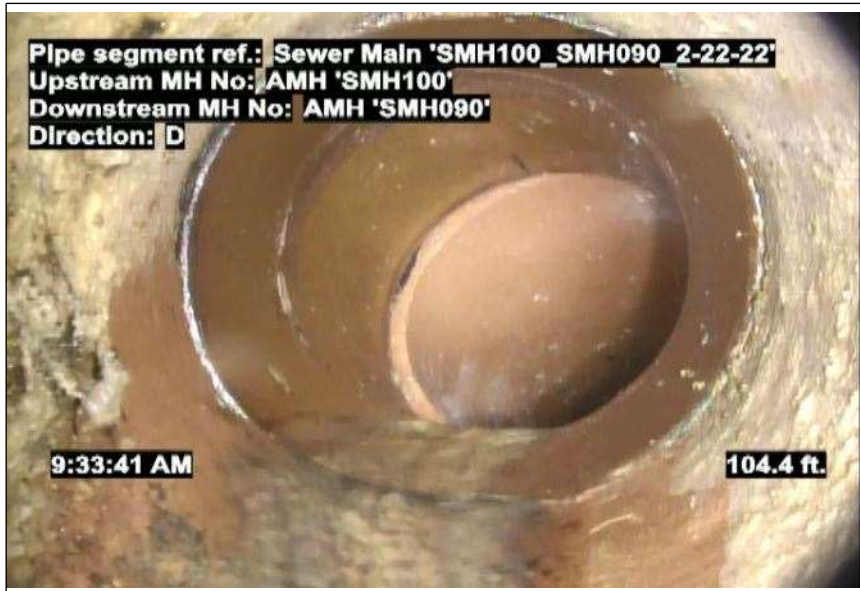
At: 104.4 ft. 9/. TF - Tap Factory  
Joint: No

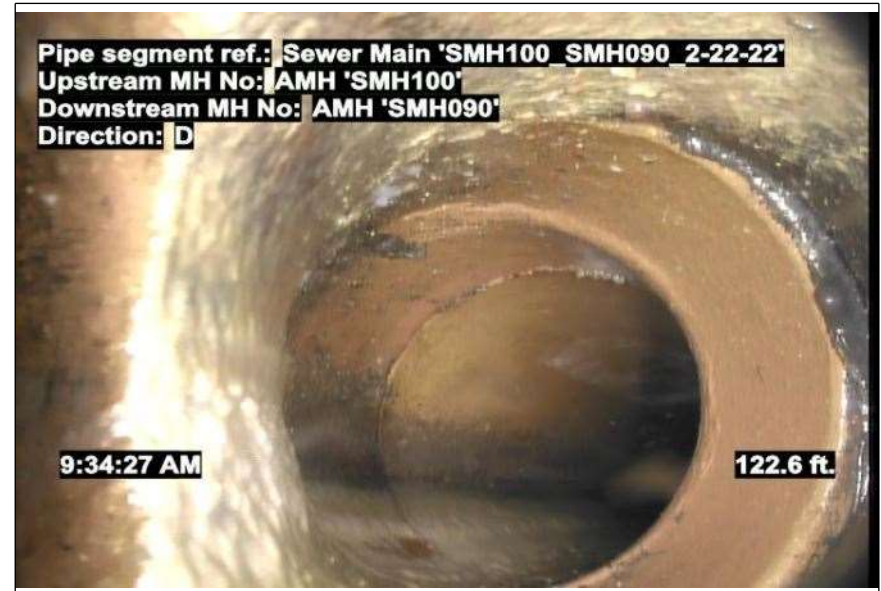
At: 122.6 ft. 12/. TF - Tap Factory  
Joint: No

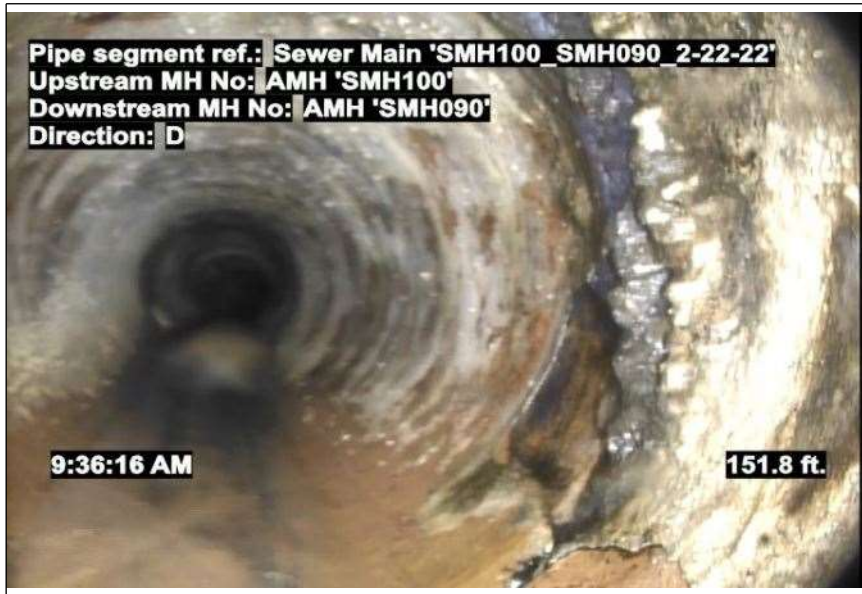
At: 151.8 ft. 1/4 DAE - Deposits Attached Encrustation  
Joint: No 5%

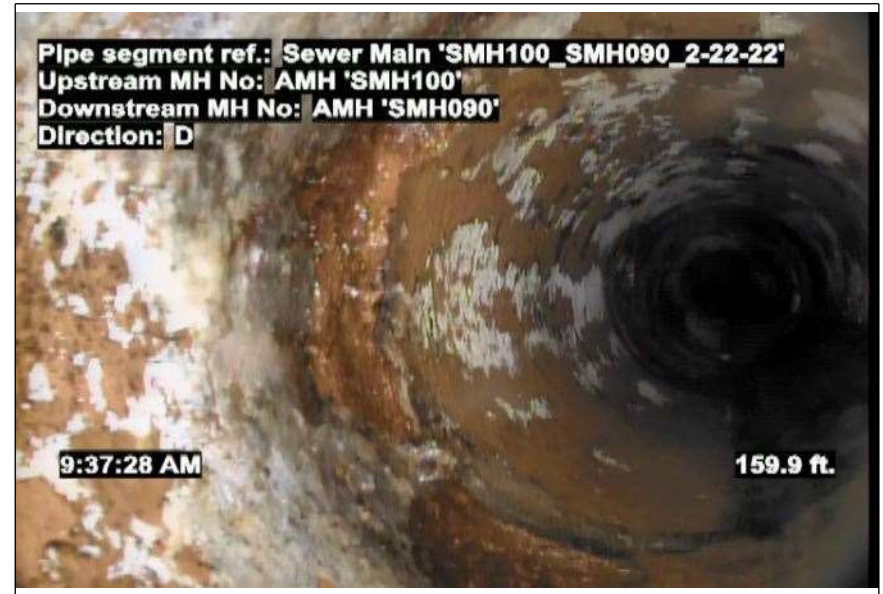
At: 159.9 ft. 7/10 DAE - Deposits Attached Encrustation  
Joint: No 5%

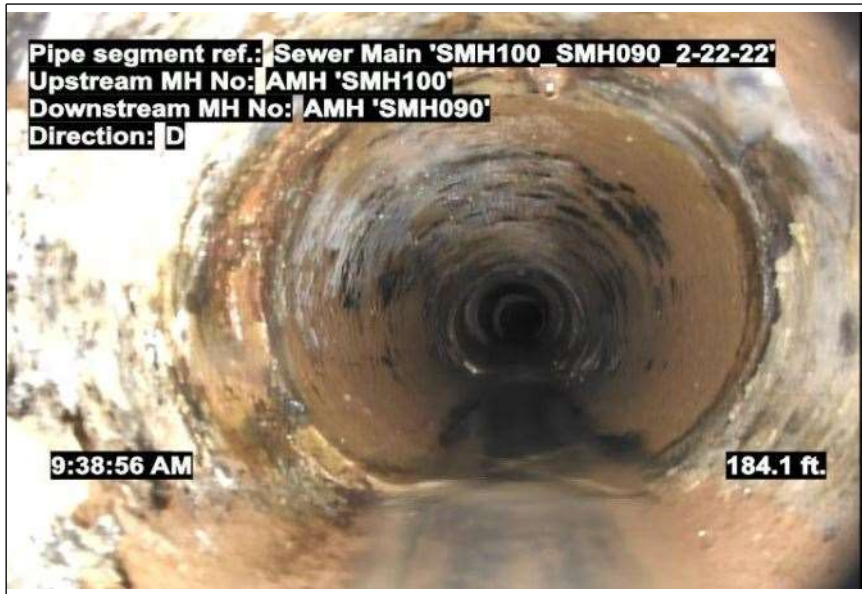
At: 184.1 ft. 7/1 DAE - Deposits Attached Encrustation  
Joint: No 5%

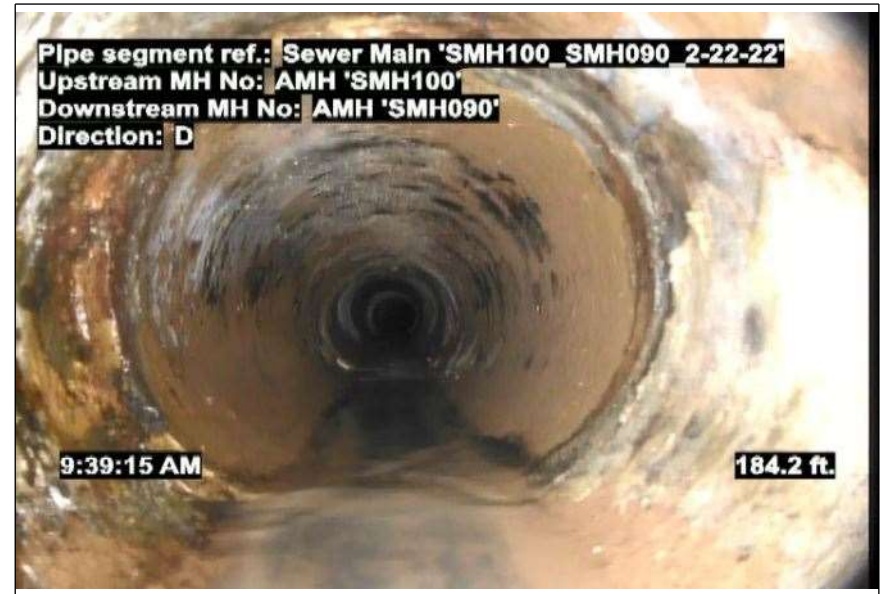
At: 184.2 ft. 12/ IDJ - Infiltration Dripper Joint  
Joint: Yes

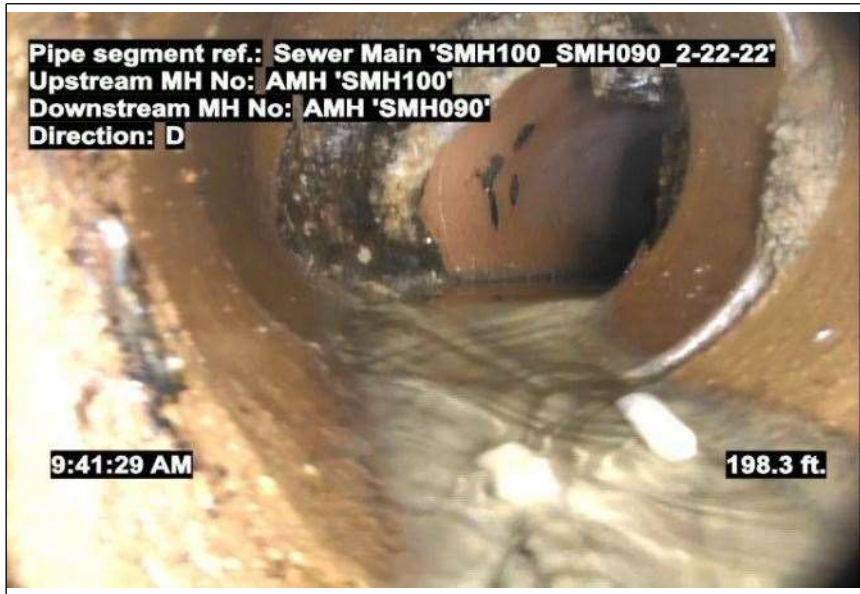
At: 198.3 ft. 9/. TF - Tap Factory  
Joint: No

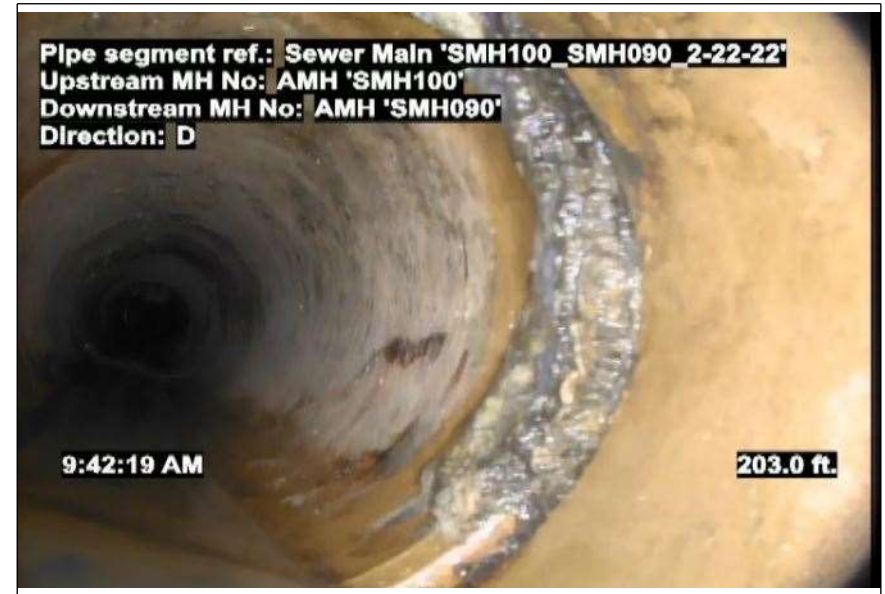
At: 203 ft. 2/5 DAE - Deposits Attached Encrustation  
Joint: No 5 %

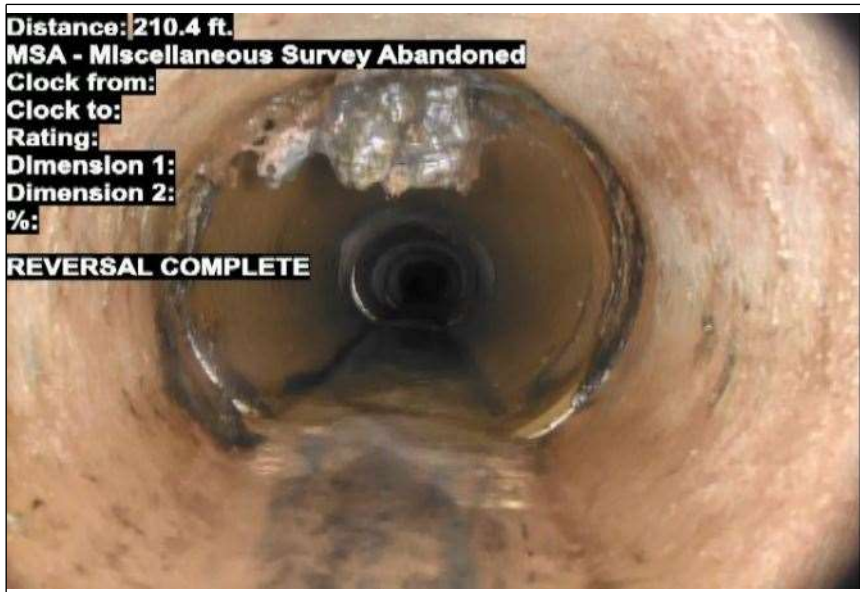
At: 210.4 ft. MSA - Miscellaneous Survey Abandoned  
Joint: No REVERSAL COMPLETE
