Re: *Addendum No. 1*
High Service Area Water Tower Rehabilitation
City of Germantown, Ohio

- Pittsburg Tank & Tower Group - Inspection Report dated June 18, 2019.
- Dixon Engineering - Maintenance Inspection 750,000 Gallon Composite (Route 4) Report dated January 16, 2023.

**City of Germantown
RE: Germantown, OH
750,000 Gallon Composite Tank
Job No. 319262**

750,000 gallon composite (Route 4) elevated water storage tank owned by the City of Germantown, Ohio.

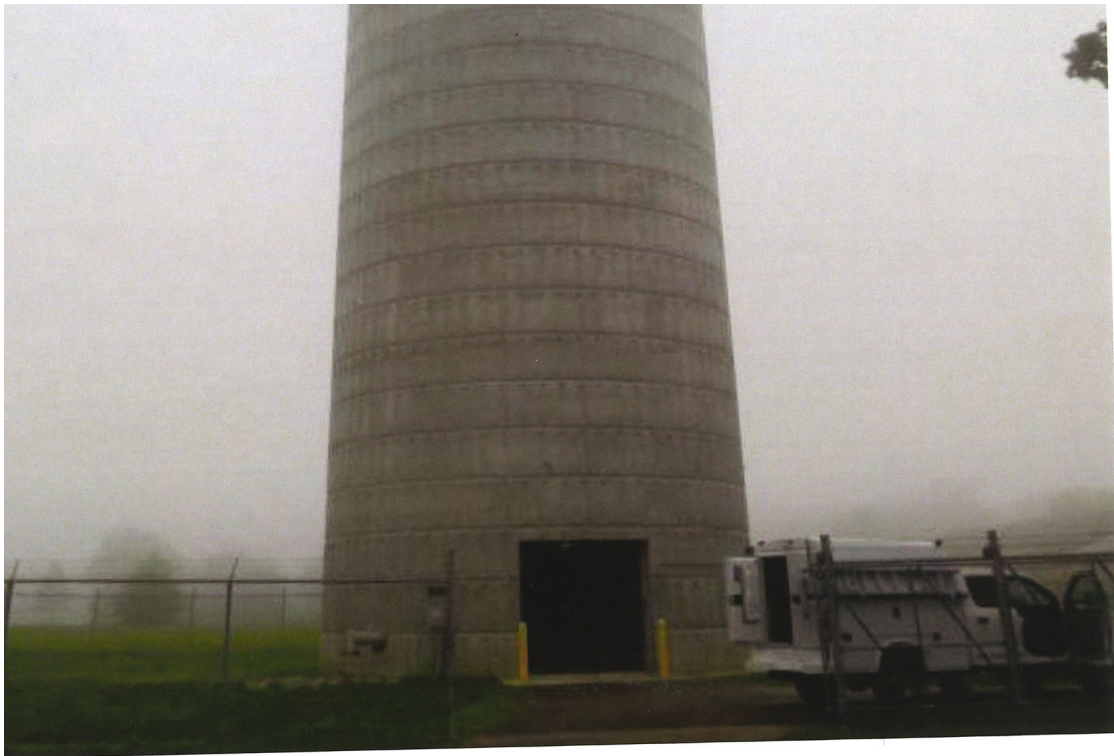
Photo shows the tank is secured with fencing. We recommend posting a **Warning, Tampering With This Facility is a Federal Offense (US code title 42, section 300i-1)** sign and a **No Trespassing** sign.

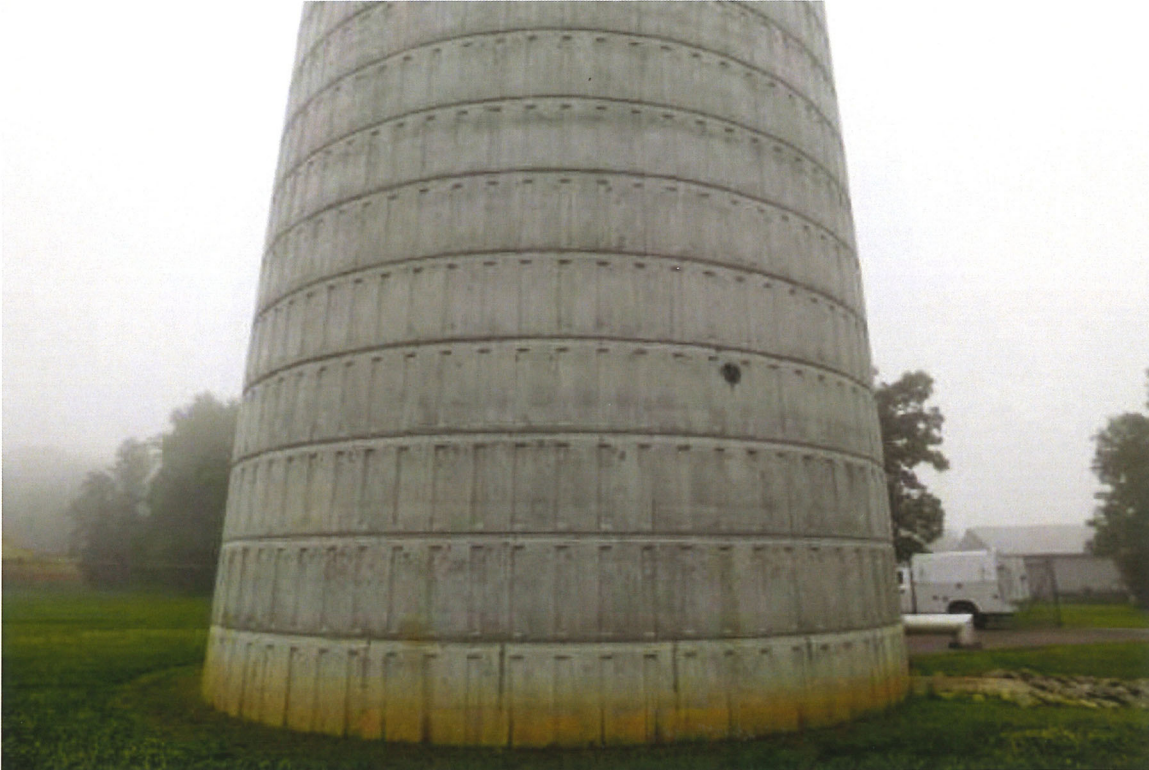
Photo shows the tank has no grounding system. We recommend electrically grounding the tank for lightning protection as required by **OSH Act of 1970 Section 5**, and **AWWA 0107-16; 8.8 Lightning Protection**.

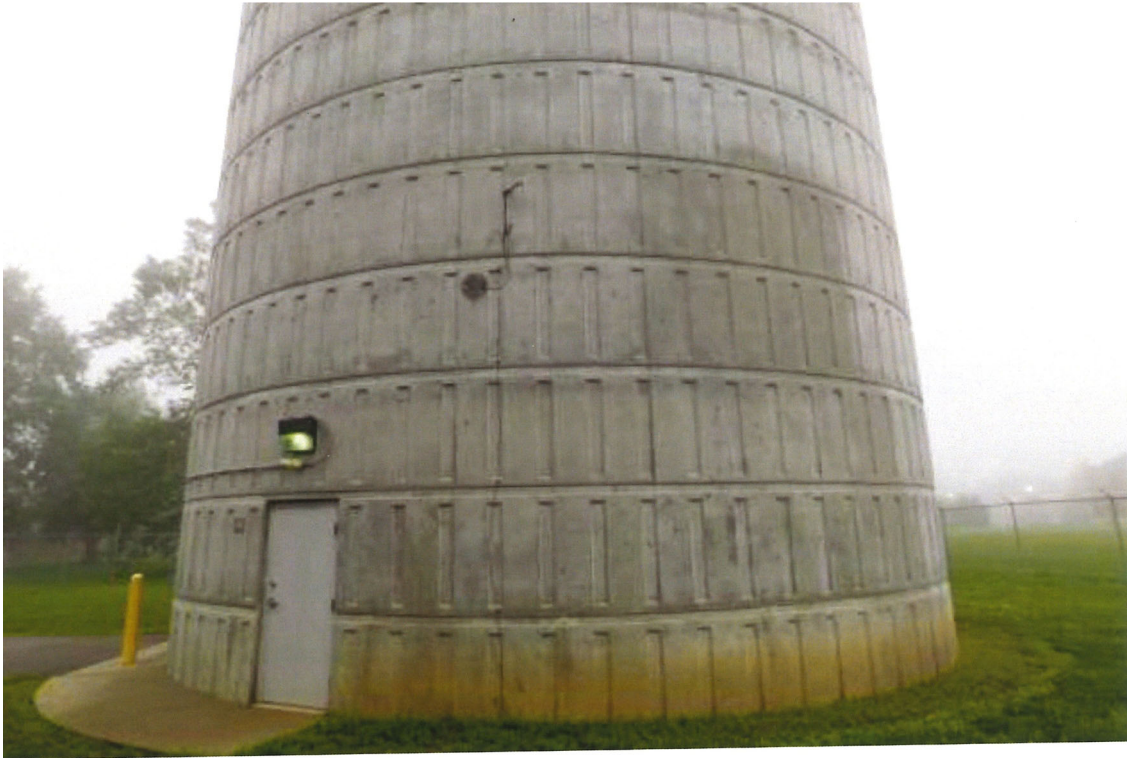
Photo shows the condition of the personnel door. The personnel door requires
Photo shows the condition of the personnel door. The personnel door requires
the following to be in compliance with **AWWA 0107-16; 8.4.1.1 Personnel doors**
and **OSHA 1910.146(c)(2) Confined spaces**.

We recommend:

Post **Confined Space Entry** sign

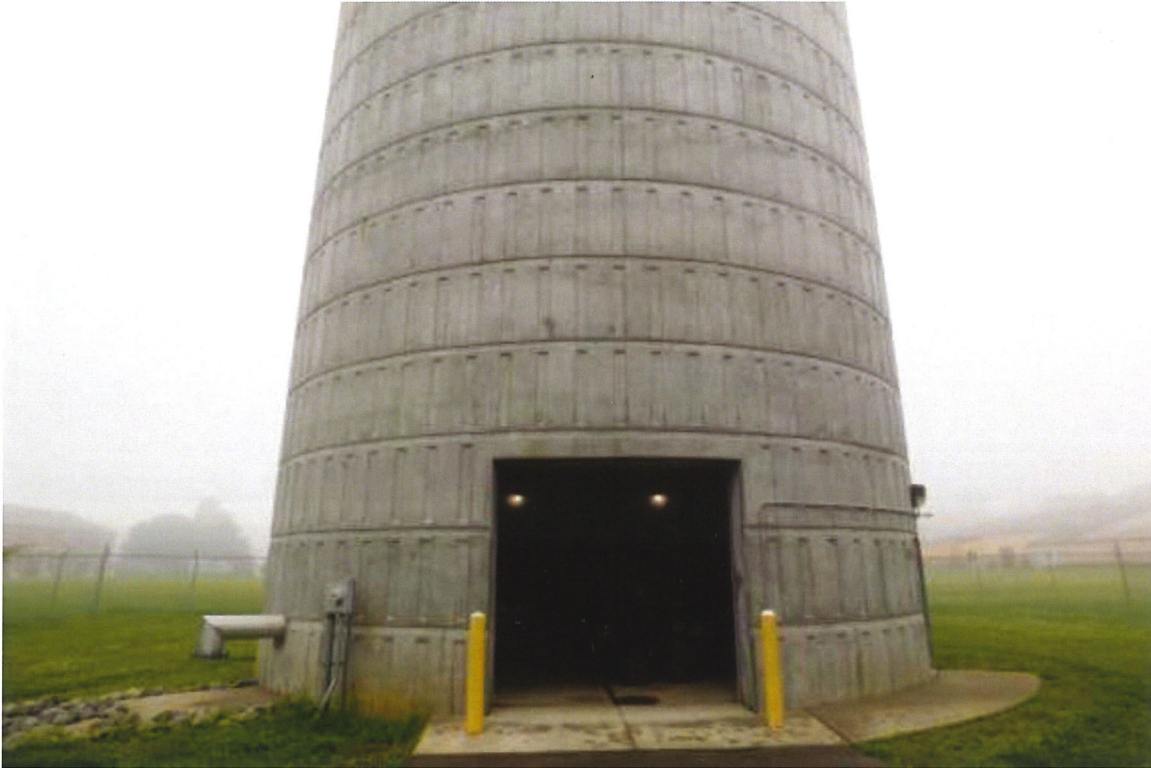
Photo shows the condition of the vehicle door. The vehicle door requires the following to be in compliance with [AWWA D107-16; 8.4.1.2 Vehicle doors](#) and [OSHA 1910.146\(c\)\(2\) Confined spaces](#).

We recommend:

Post **Confined Space Entry** sign

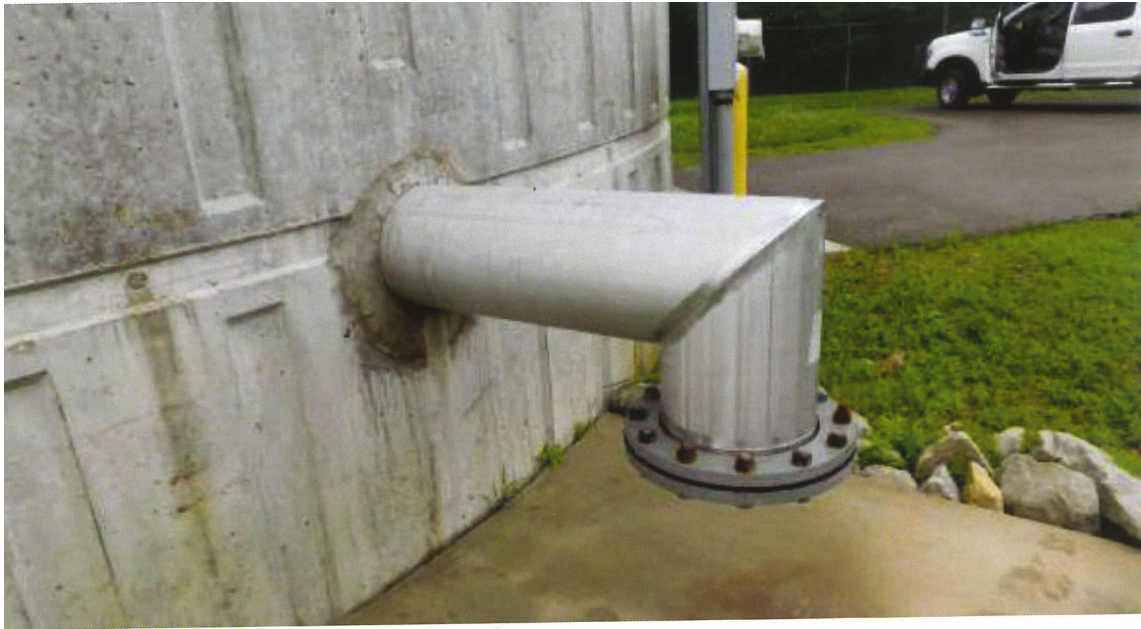
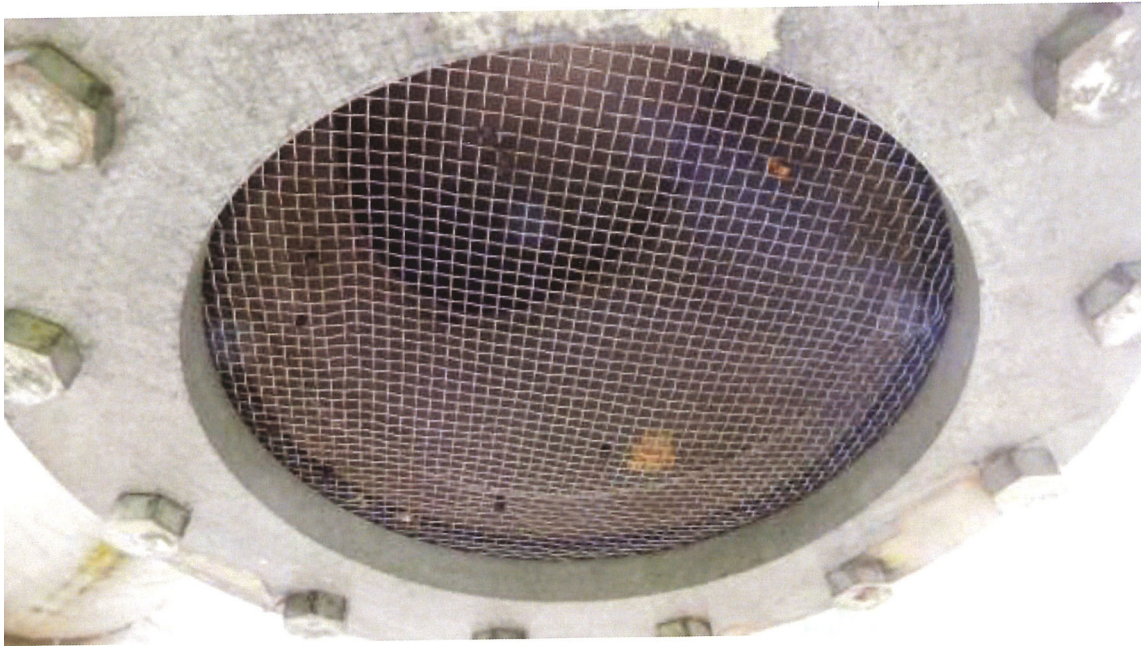
Photos show the 12" overflow pipe system, which is not equipped with a flapper valve as required by [AWWA D107-16; 8.7.5 Overflow piping](#). We recommend installing a flapper valve and new screen on the existing overflow pipe elbow.

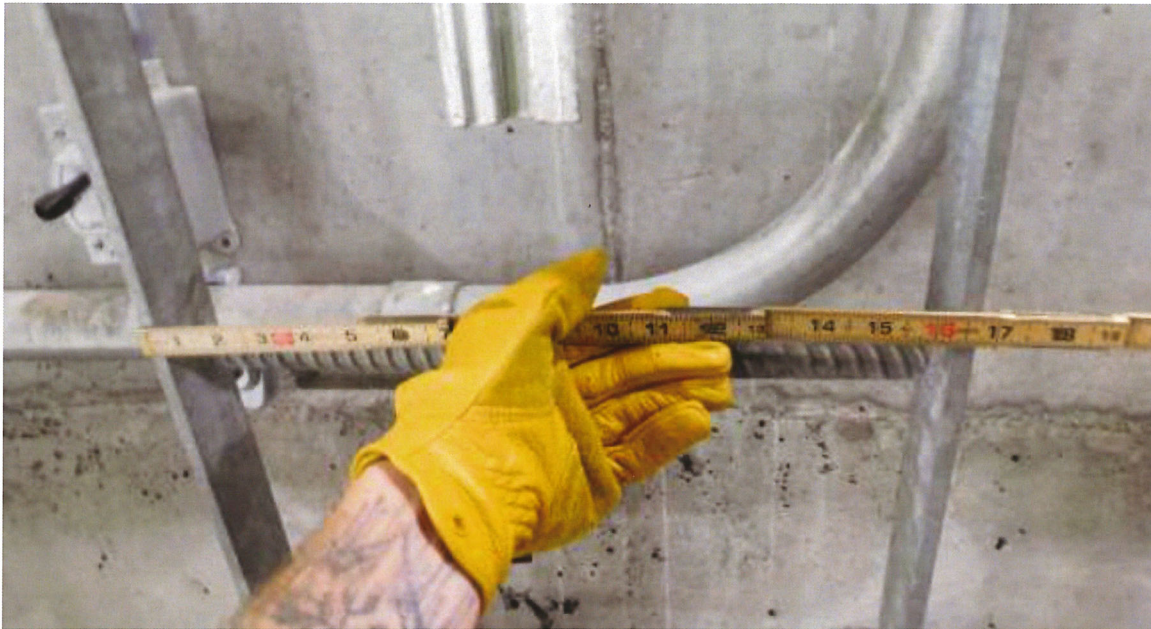
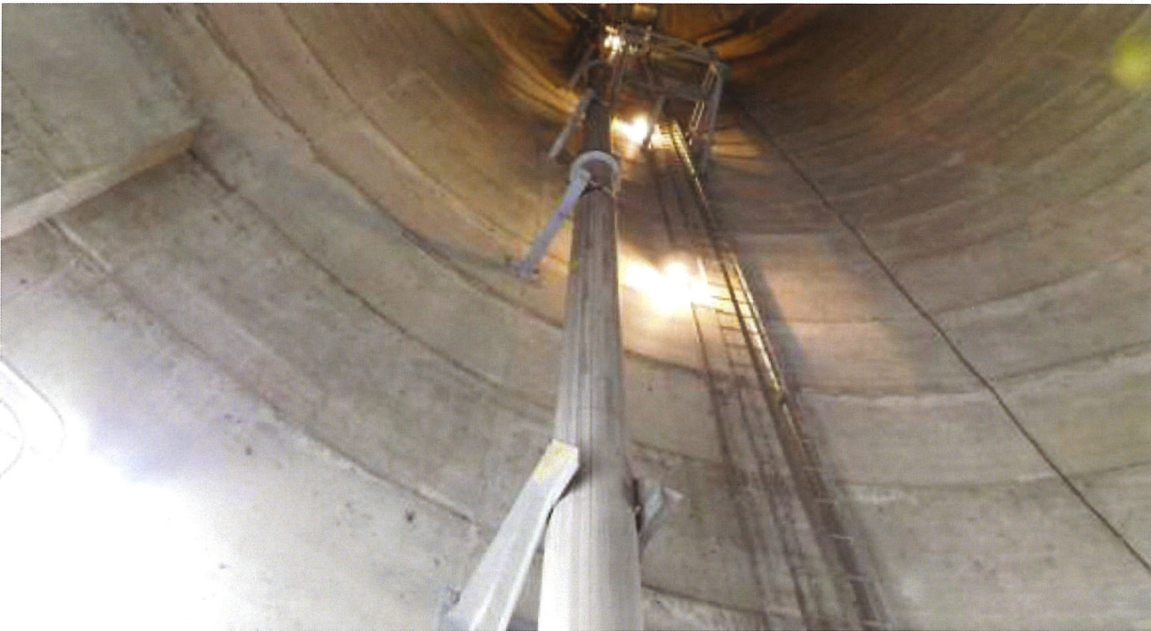
Pillar access ladders in above photos are 16" wide in compliance with [OSHA 1910.23 Ladders](#) and [AWWA 0107-16; 8.2 Ladders](#). We recommend posting a **Fall Protection Required** sign at the base of the ladder.

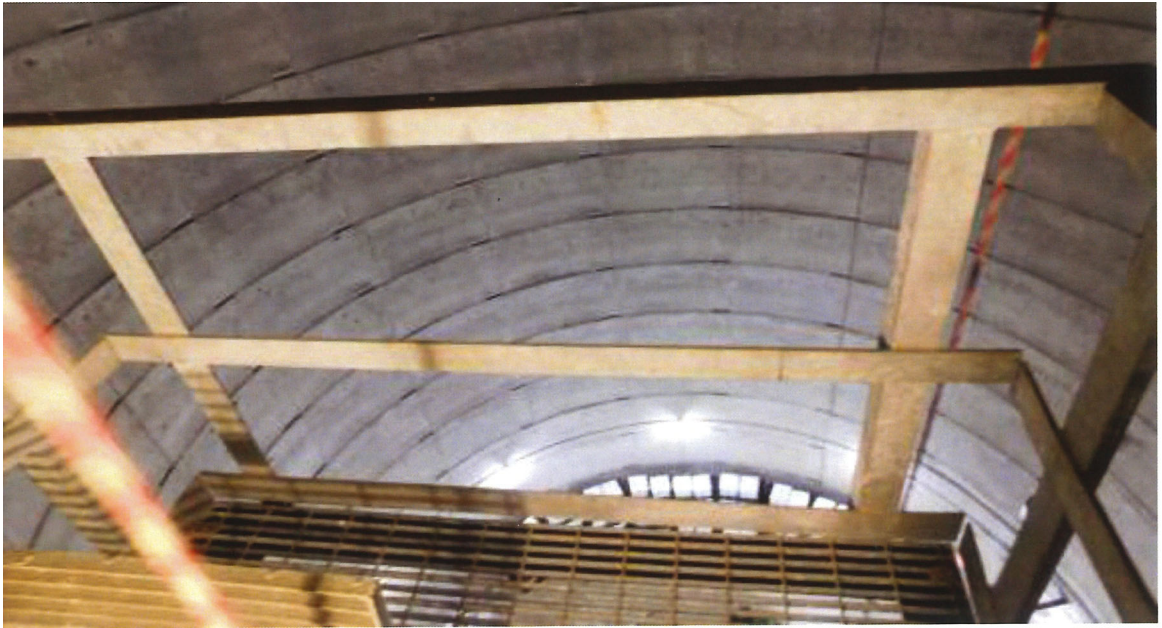
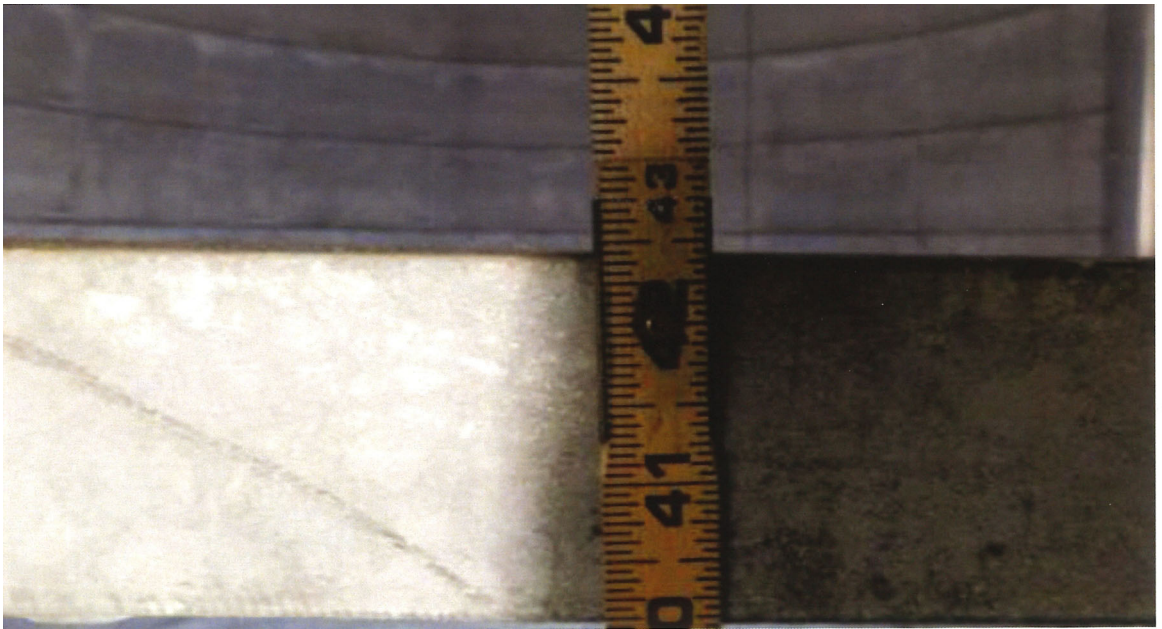
Photos show the pillar access ladder resting platforms, which appear to be in good condition.

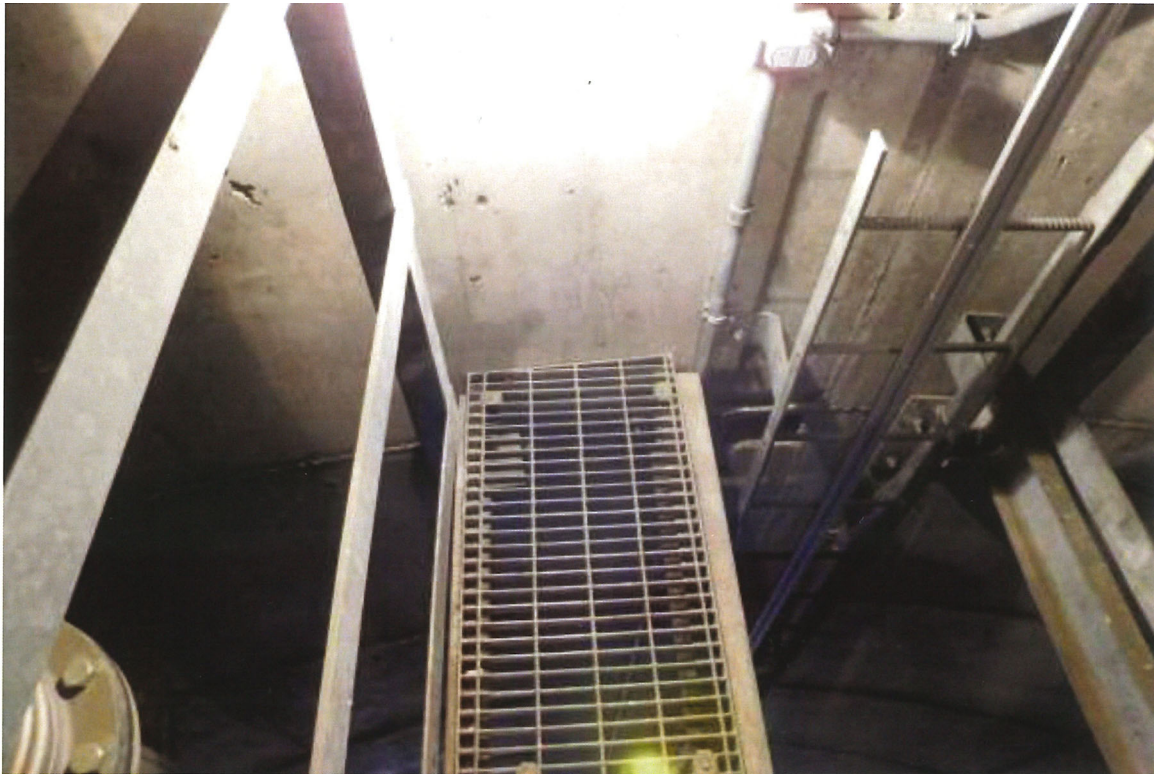
Photo shows the transfer walkway, from the access ladder to the access tube, which is equipped with 42" high OSHA compliant handrail system, and appears to be in good condition.

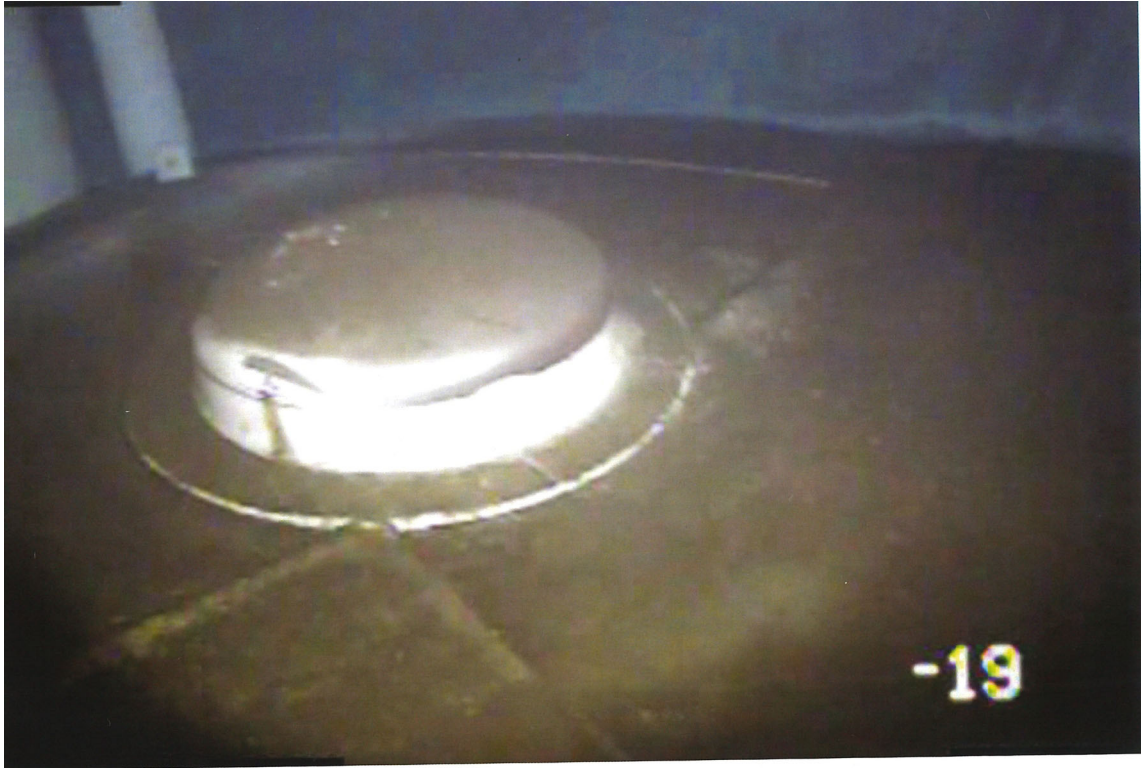
Photo shows the tank floor manhole, which is in compliance with **AWWA D107-16; 8.4.5 Tank floor manhole** and appears to be in good condition.

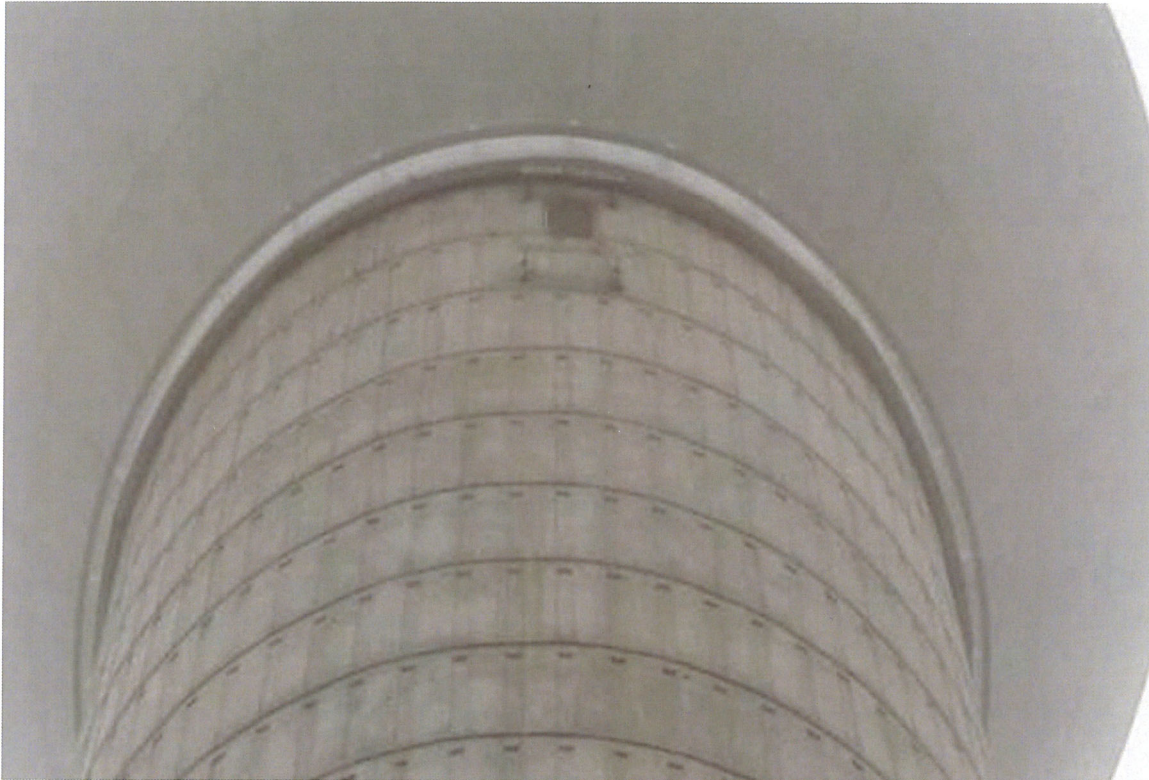
Photo shows one of the pedestal vents, which appears to be in good condition.

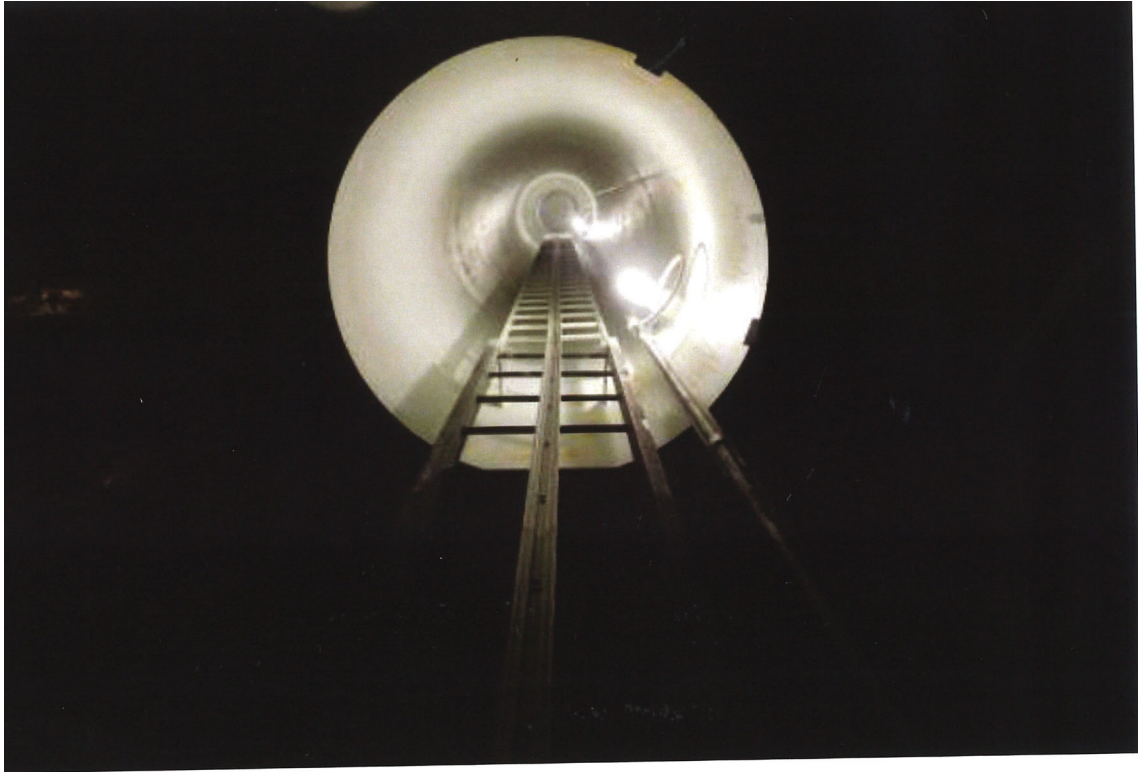
Access tube ladder in above photo is 17" wide, in compliance with **OSHA 1910.23 Ladders** and **AWWA D107-16; 8.2 Ladders**.

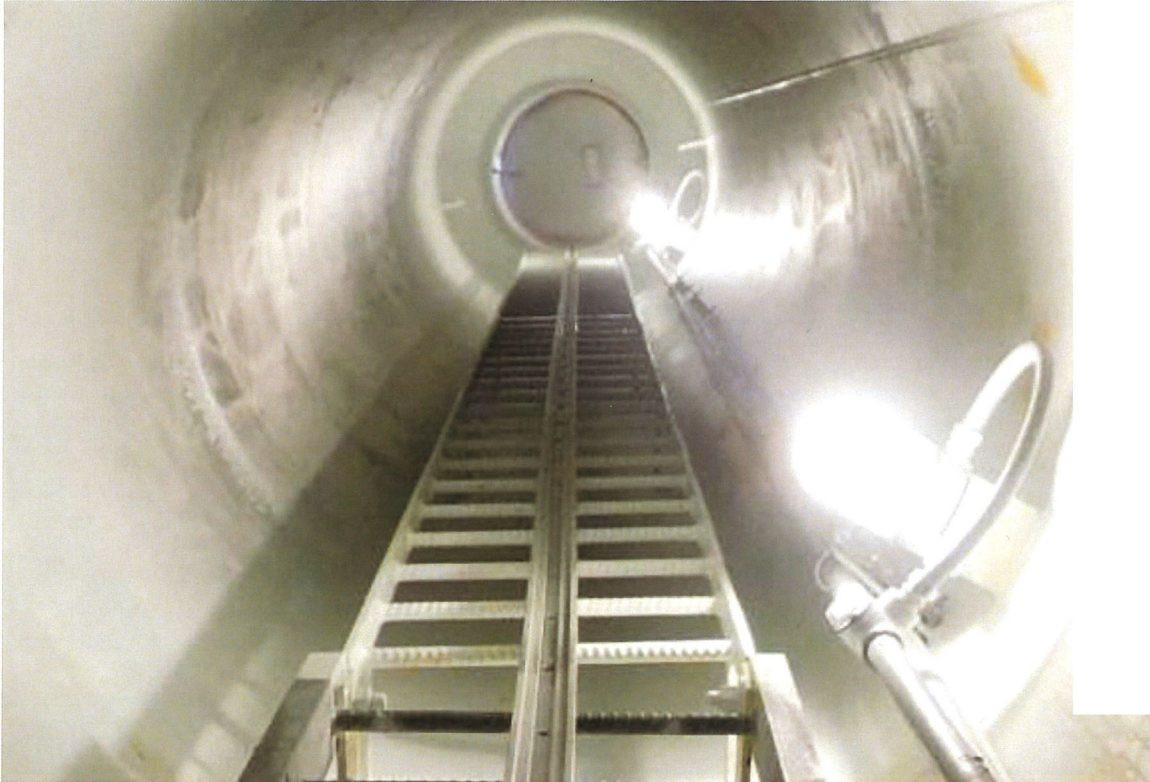
Photo shows the tank interior dry area coating system. The overall tank interior dry area coating system appears to be in good condition. We recommend re-evaluating the tank interior dry area at next inspection cycle.

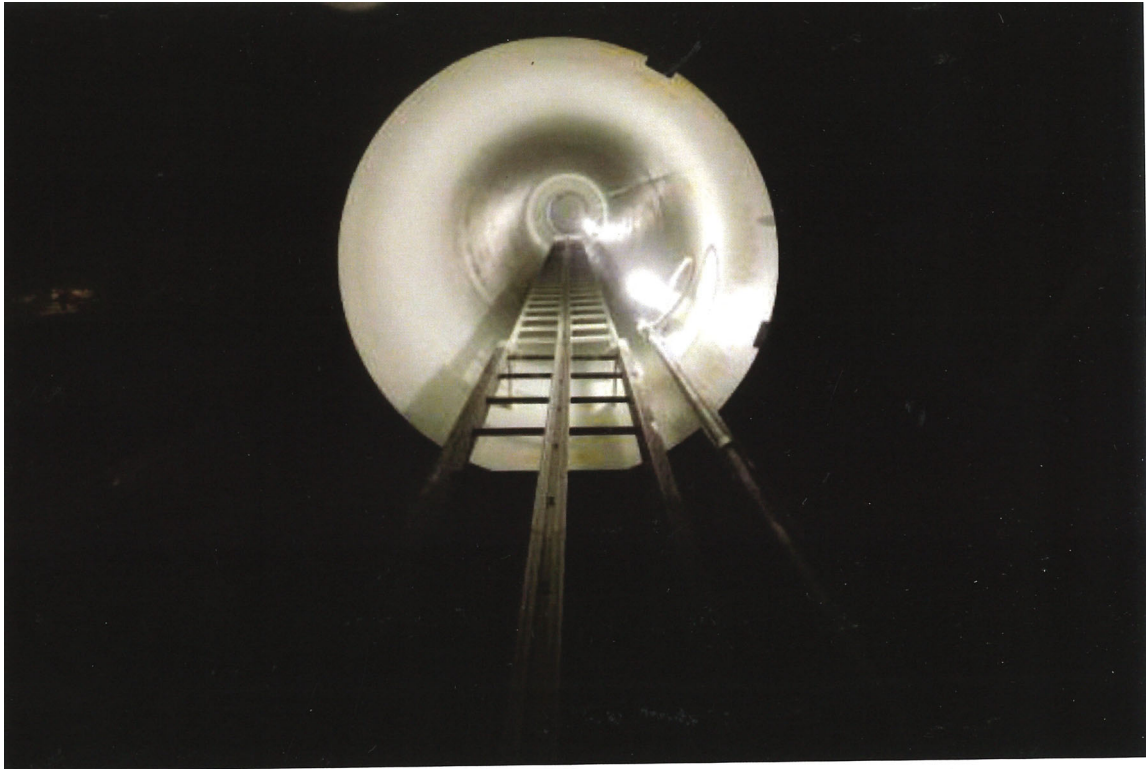
Photo shows the access tube hatch, which appears to be in good condition.

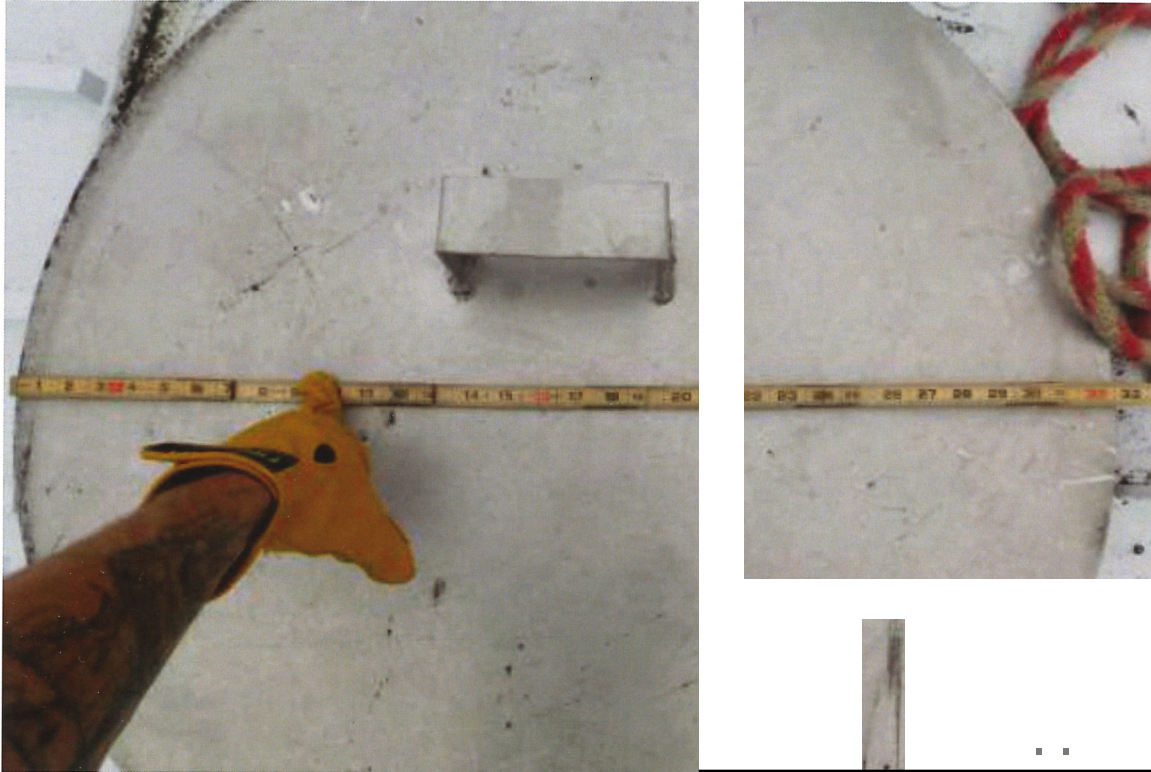
Photo shows the condition of the 30" primary roof hatch. Roof openings on this tank require the following to be in compliance with **AWWA D100-11; 5.4.3 Roof openings** and **OSHA 1910.146(c)(2) Confined spaces** .

We recommend:

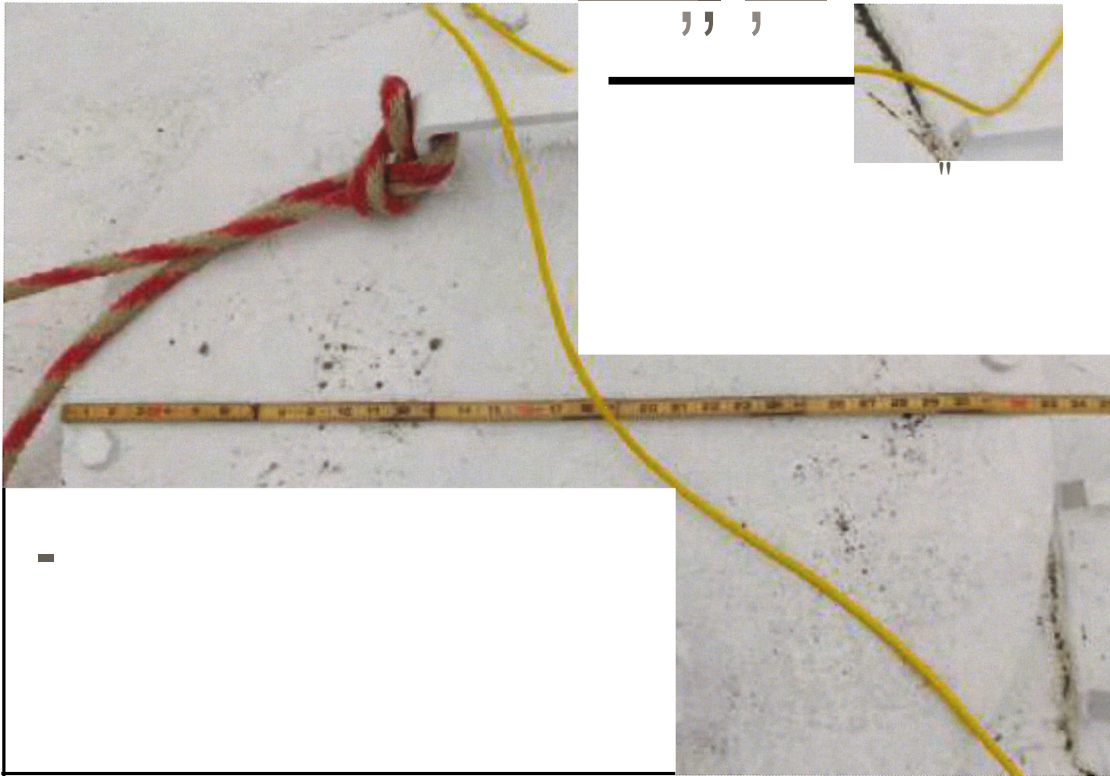
Photo shows the condition of the 30" secondary roof hatch. Roof openings on this tank require the following to be in compliance with [AWWA D100-11; 5.4.3 Roof openings](#) and [OSHA 1910.146\(c\)\(2\) Confined spaces](#).

We recommend:

Post **Confined Space Entry** sign

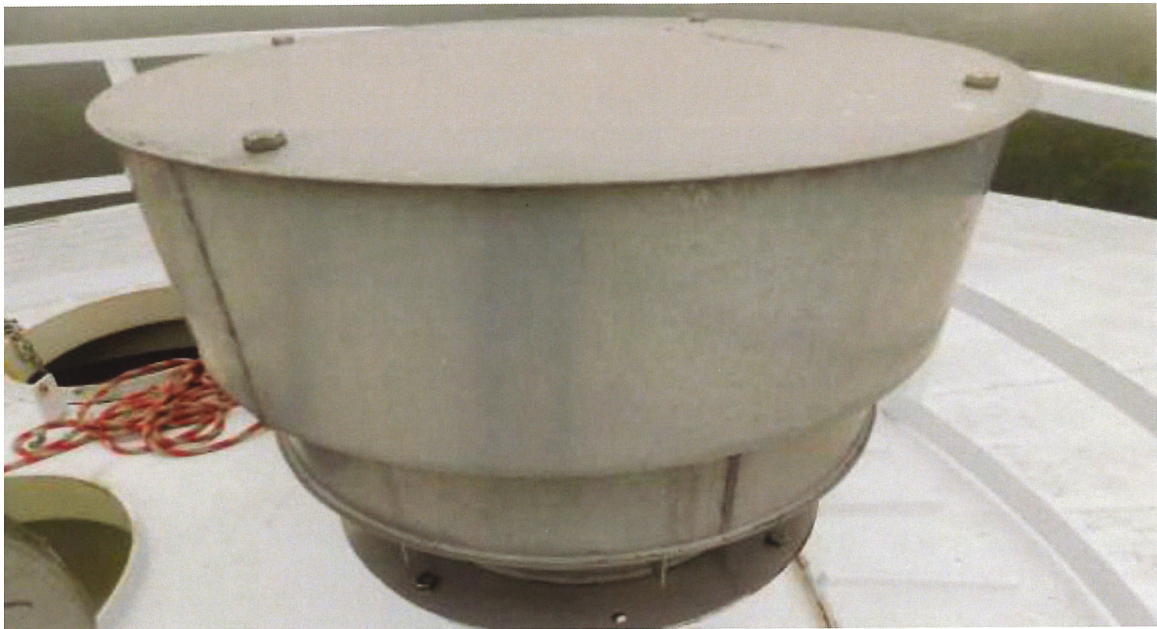
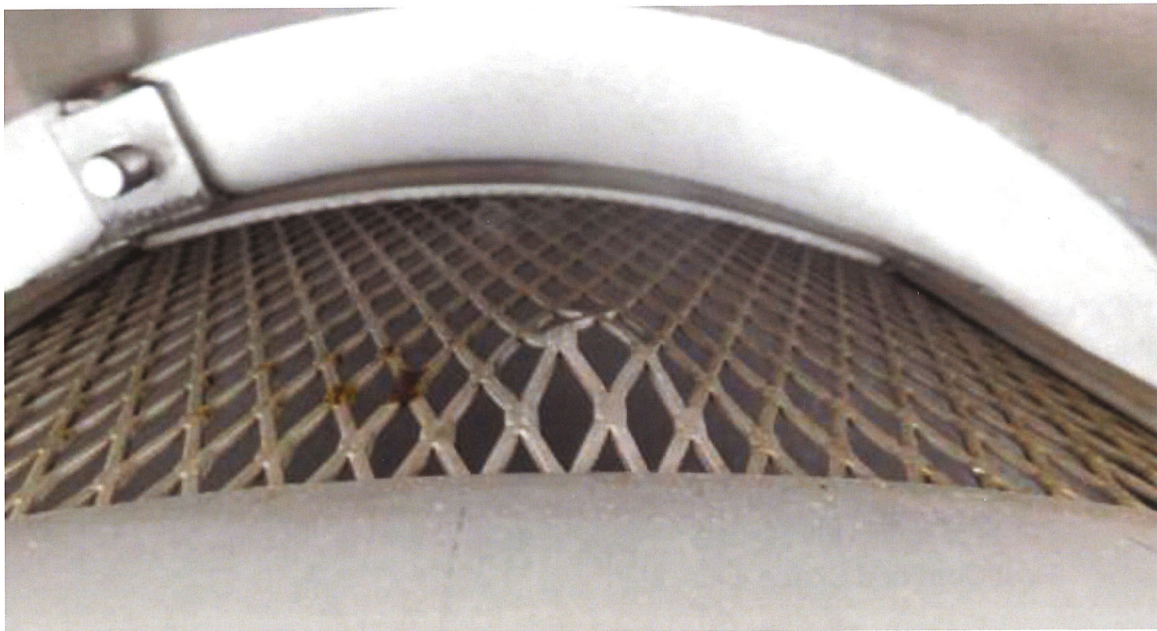
Photos show the existing 24" roof vent, which appears to be in good condition.

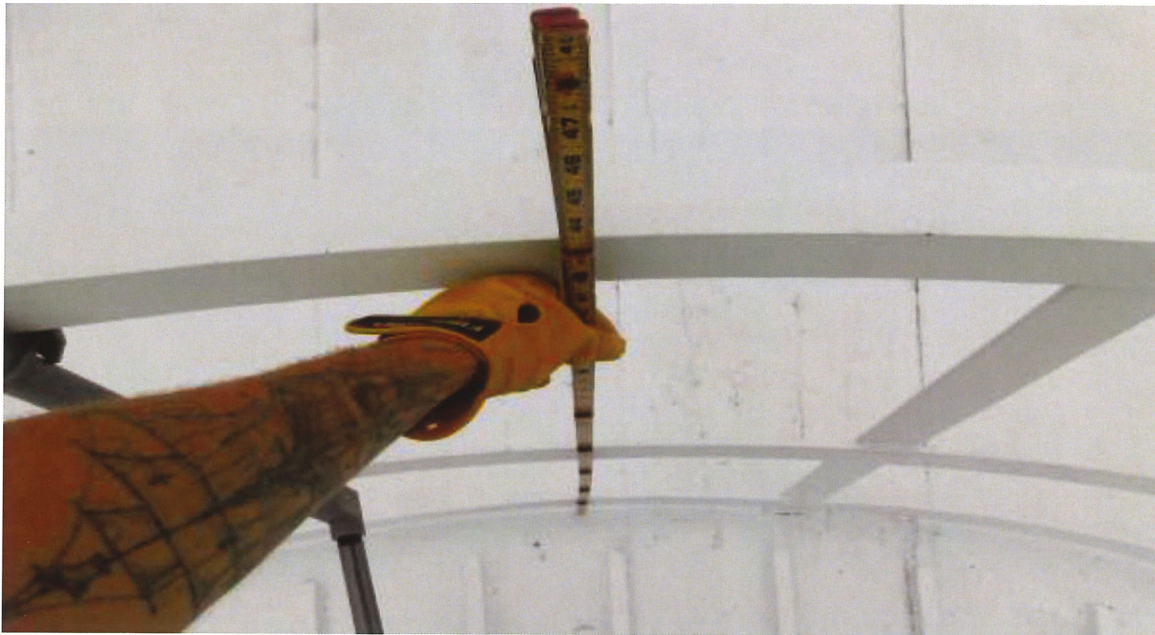
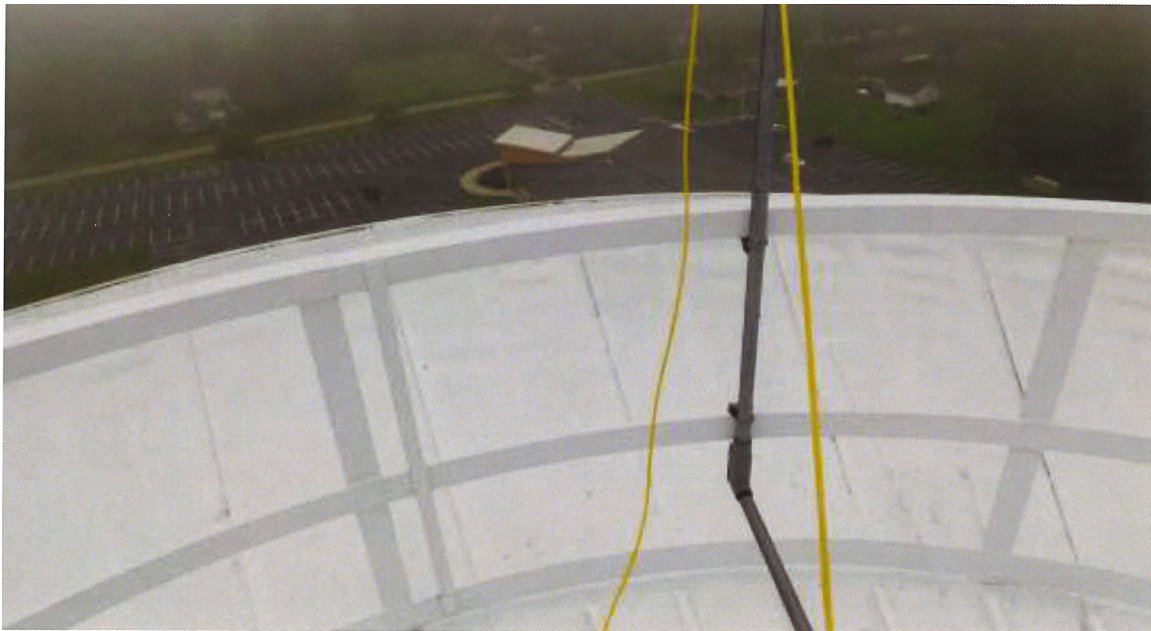
Photos show the tank roof edge is equipped with a 42" high compliant handrail system for fall protection as required by [OSHA 1910.28\(b\)\(1\)](#) . The handrail system is equipped with an intermediate rail and toeboard, and appears to be in good condition.

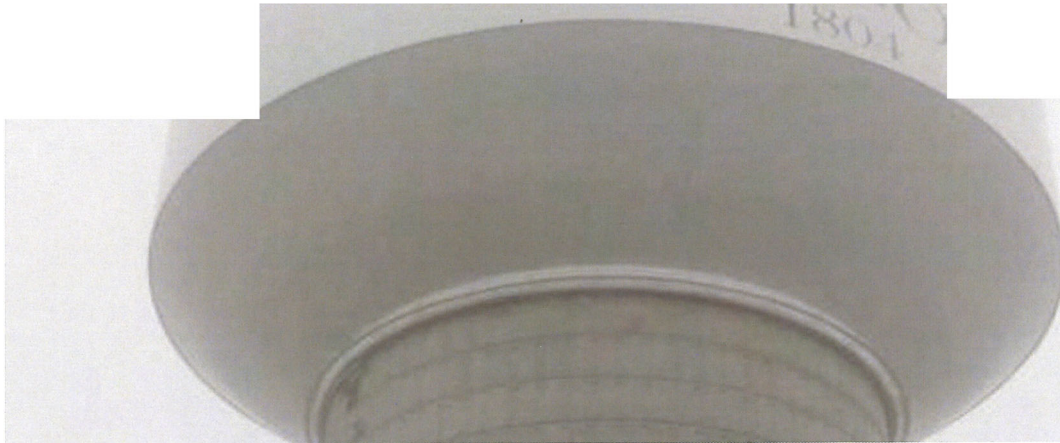
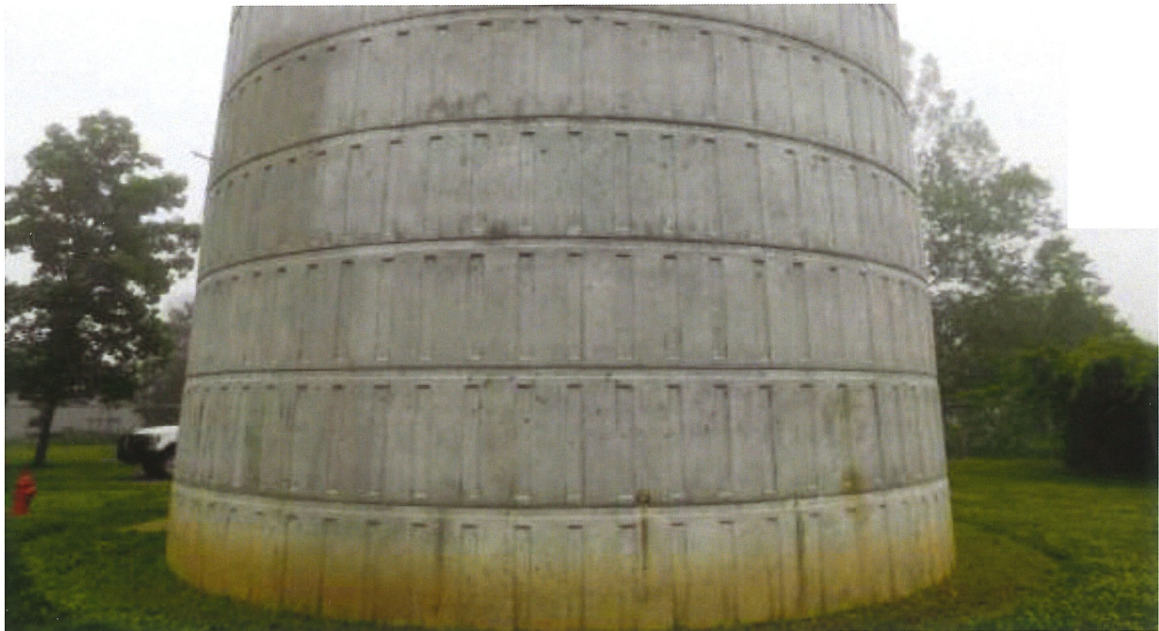
Photos show the tank exterior. The overall tank exterior appears to be in good condition. We recommend re-evaluating the tank exterior at next inspection cycle.

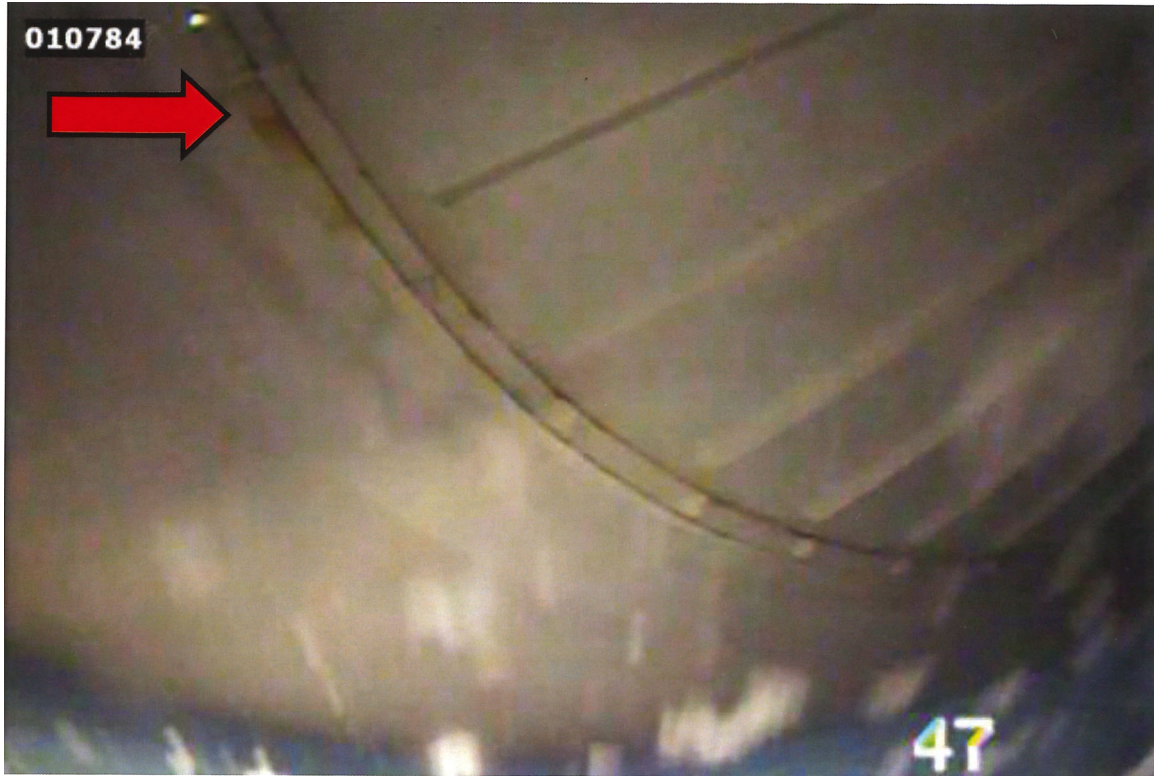
Photo shows the condition of the interior roof-to-rim angle connection. Notice the rust forming in the crevice between the roof and rim angle. We recommend seam sealing using Sikaflex® 1a around the circumference of this connection to prevent failure of a new interior liner. This work is to be performed in conjunction with application of new interior liner.

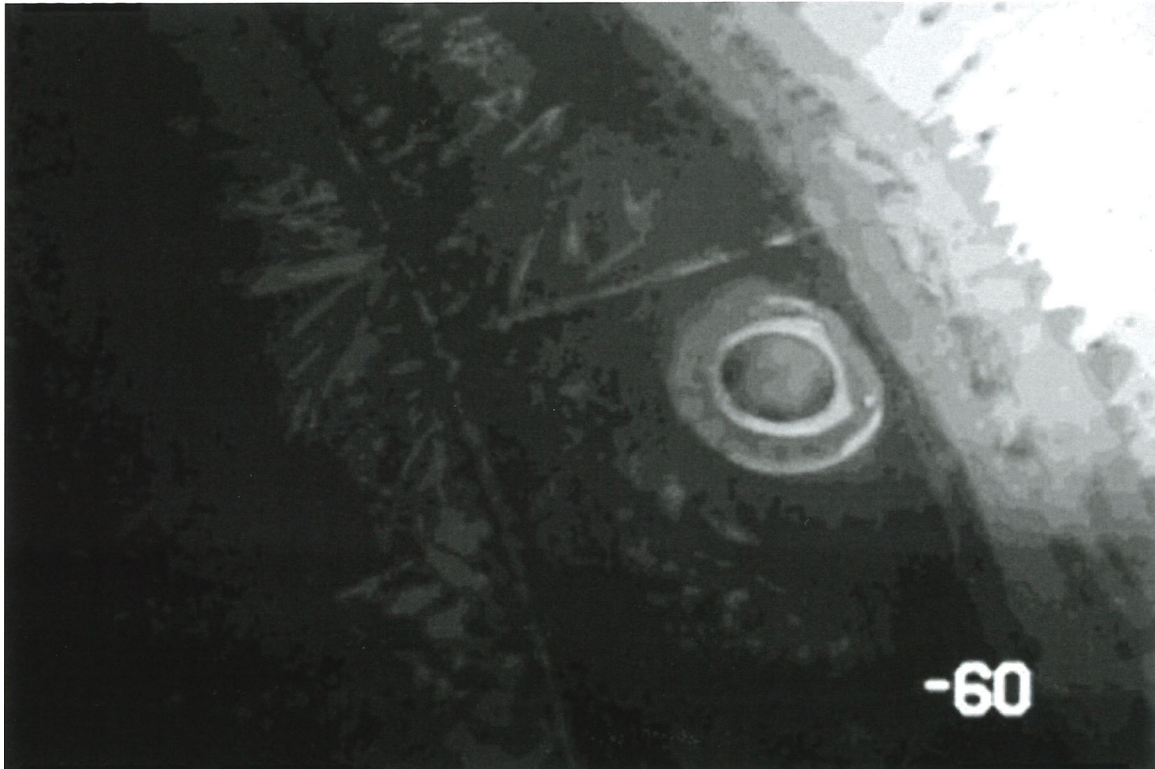
Photo shows a fill pipe on the tank interior. A temperature difference between the water in the top and bottom of a tank, even as little as 1-2 degrees Fahrenheit, is an indication of thermal stratification and the tank water not being completely mixed. Incomplete mixing would result in short-circuiting, and localized increase in water age would develop inside the tank. This typically leads to water quality problems, such as loss of residual, DBP spikes, HPC spikes, bacteria regrowth, formation of bio-film, changes in pH and dissolved oxygen. We recommend installing a mixing system. Electrical work to be done by others if required.

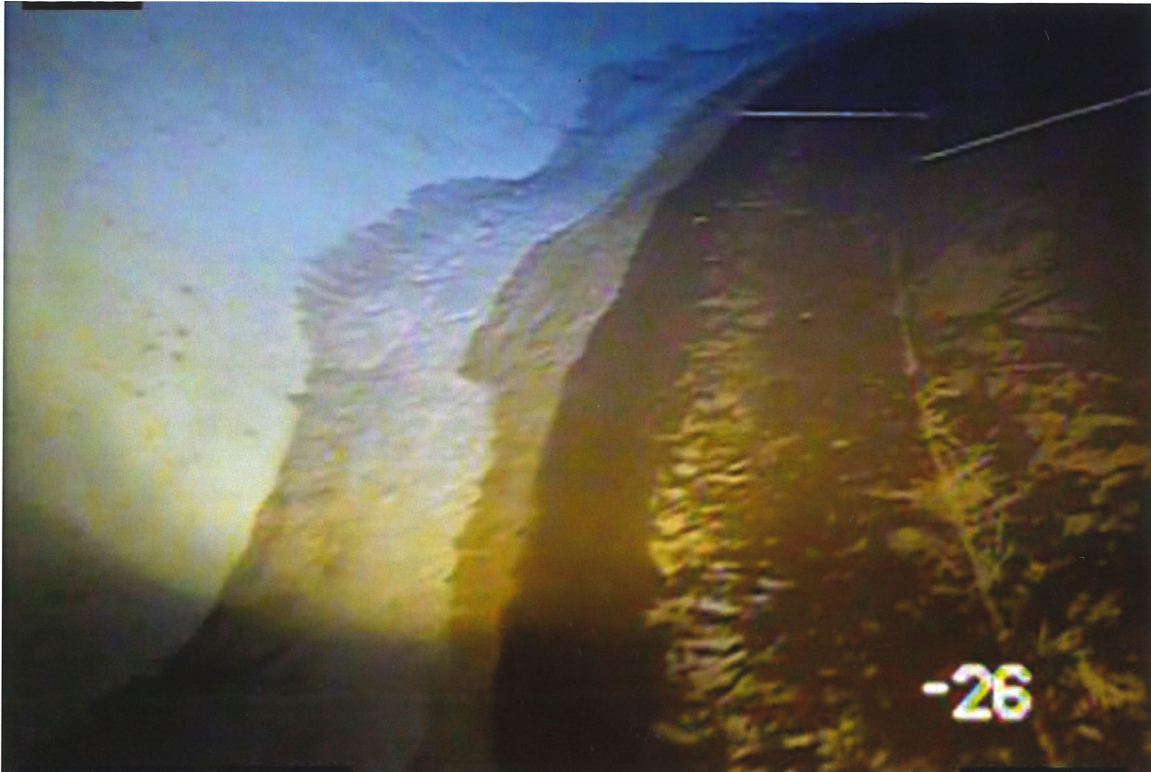
Photo shows sediment in the tank. We recommend performing a dry interior cleanout in order to prevent contamination issues associated with excessive sediment buildup.

This work should be performed on an emergency basis.

We further recommend installing a passive cathodic protection system.
