Re: *Addendum No. 1*
High Service Area Water Tower Rehabilitation
City of Germantown, Ohio

- Pittsburg Tank & Tower Group - Inspection Report dated June 18, 2019.
- Dixon Engineering - Maintenance Inspection 750,000 Gallon Composite (Route 4) Report dated January 16, 2023.

**City of Germantown
RE: Germantown, OH
750,000 Gallon Composite Tank
Job No. 319262**

750,000 gallon composite (Route 4) elevated water storage tank owned by the City of Germantown, Ohio.

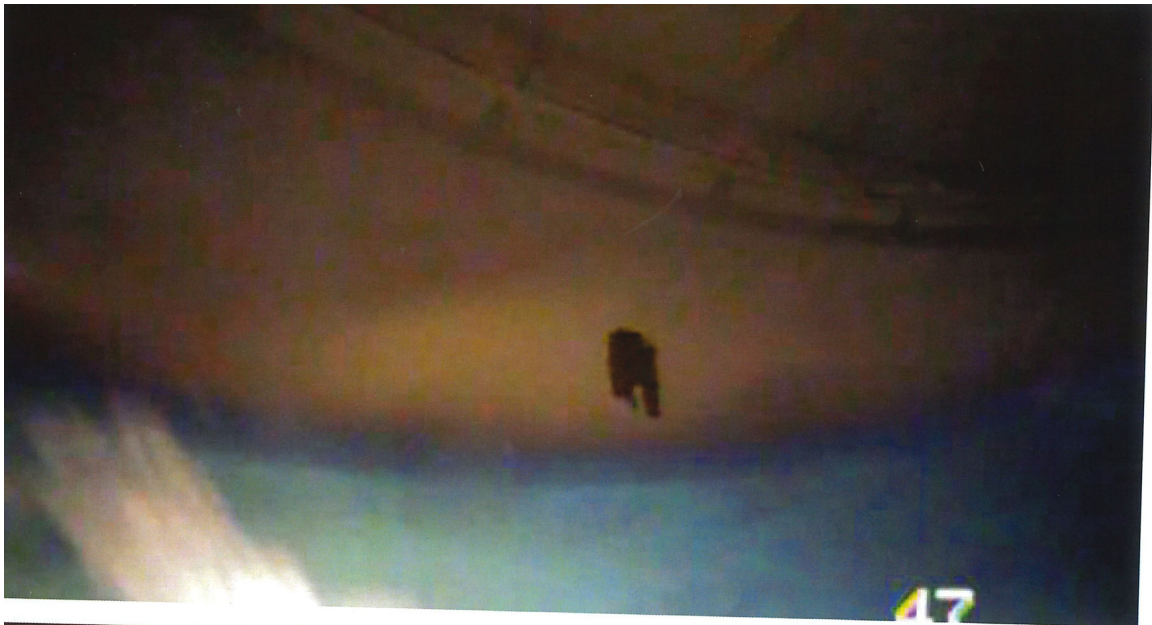
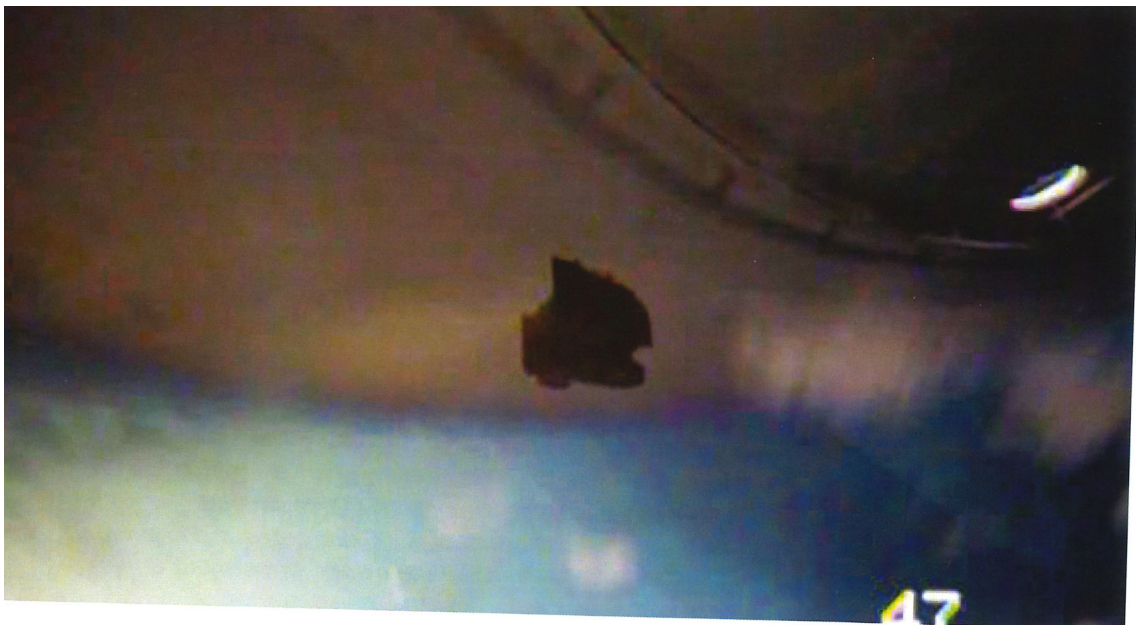
Photos show the condition of the interior coating system. We recommend sandblasting all rusted and abraded interior areas to SSPC-SP10 (near white), and brush blasting all remaining interior areas to SSPC-SP?; then applying one (1) spot coat of epoxy primer to all areas sandblasted to #10, stripe coating all weld seams, and applying epoxy to the entire tank, to achieve 8 to 10 mils of total dry film thickness. Total mil thickness will include a combination of the existing and new coating.

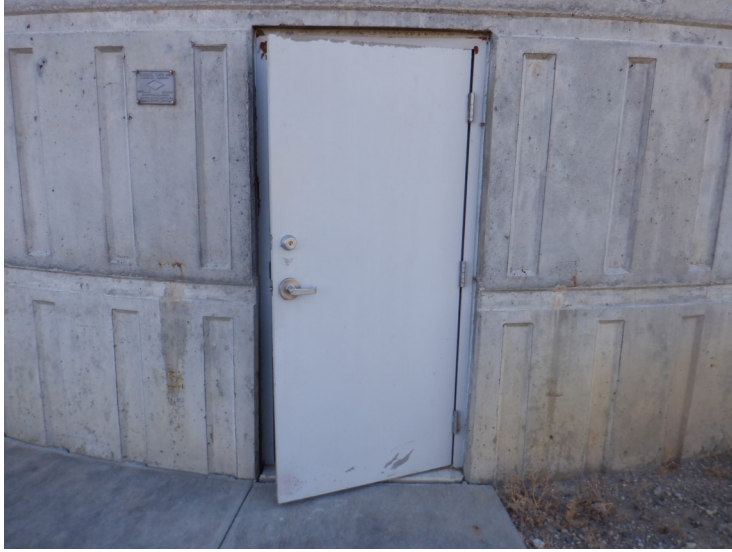
1) The column service door operated properly.

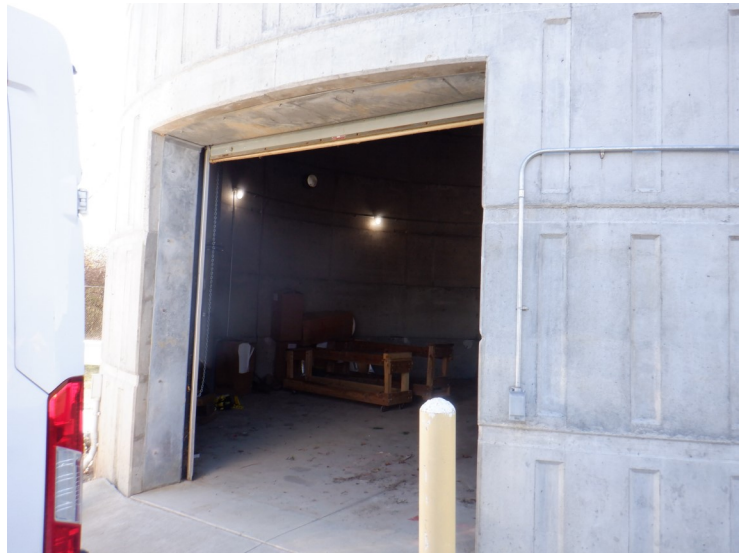
2) The overhead door is in good condition.

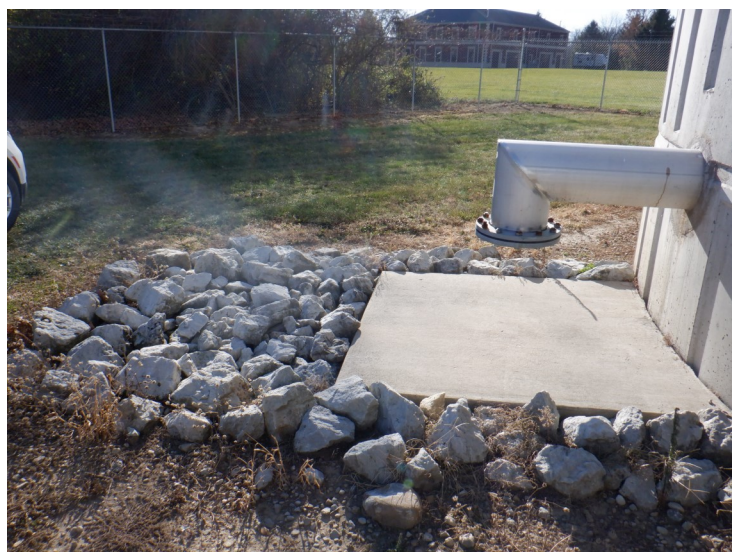
3) The overflow pipe discharges to a concrete splash pad.

Install a screened flap gate at the overflow pipe discharge. The flap gate would allow water to discharge even if the screen becomes covered with debris or frosted over. The gate is designed to stay closed to prevent rodents or birds from entering the pipe. The estimated cost is \$3,000.

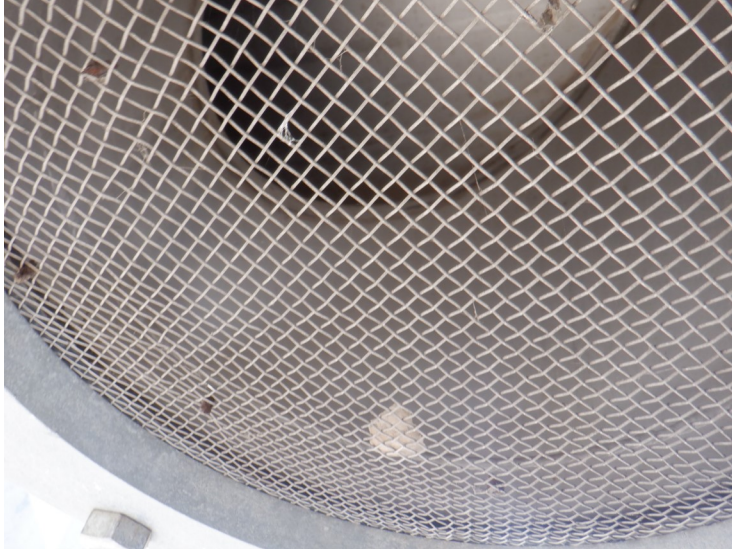
4) The screen at the overflow discharge is intact.

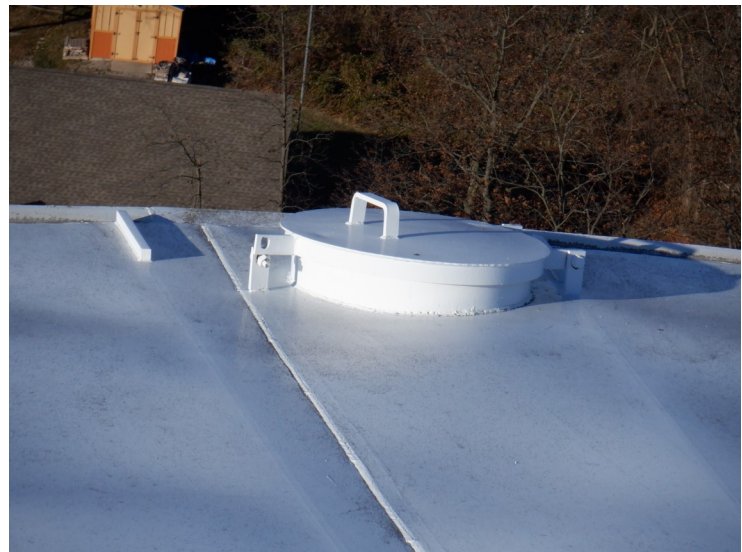
21) There is corrosion at the edges of the bolted ventilation hatch.

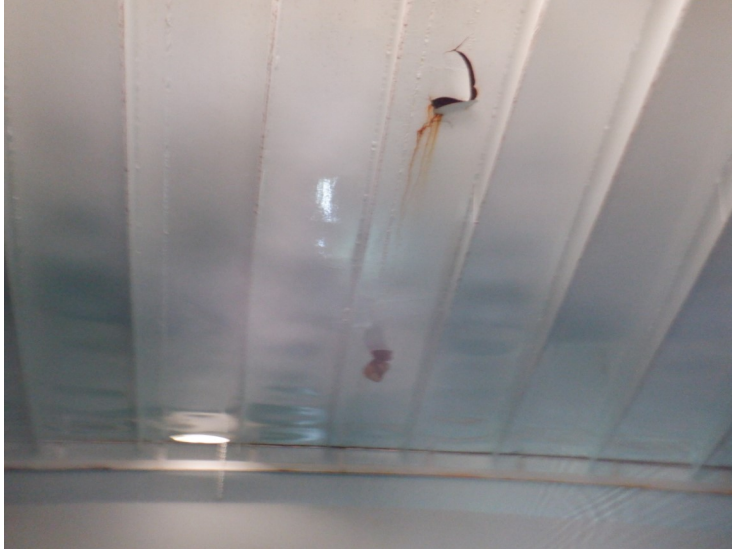
46) There are coating failures on the wet interior roof.

Spot abrasive blast clean the wet interior roof and access tube to a near-white metal (SSPC-SP10) condition and spot repaint with an epoxy system. The estimated cost is \$30,000.

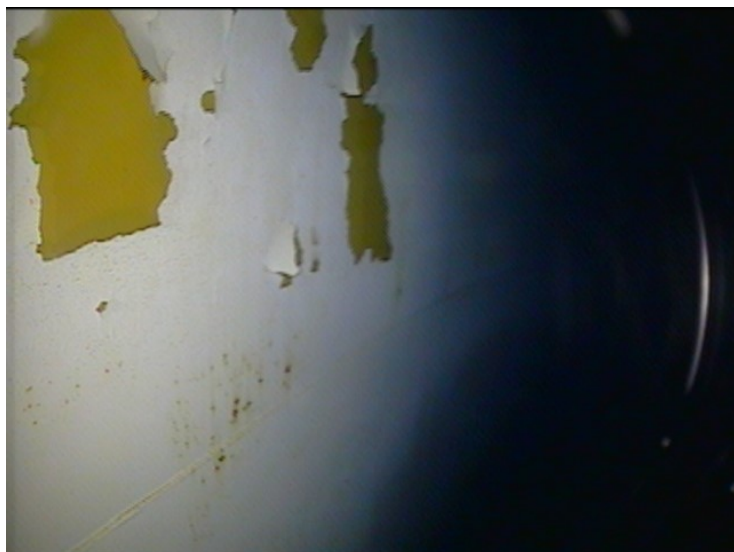
51) There are numerous coating failures on the wet interior sidewall.

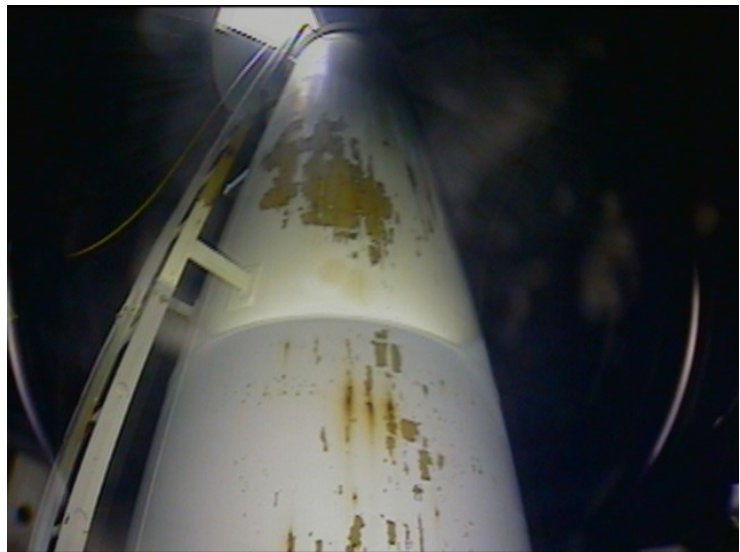
56) The access tube coating is in poor condition with multiple failures.

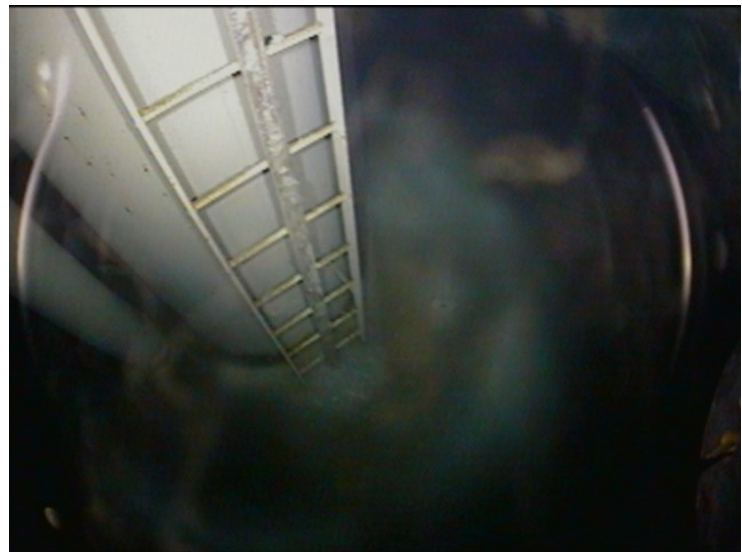
60) The domed bottom was covered in sediment the limited the amount of surface visible with the ROV.
