**WINCAN**

E 305th

## Inspection report

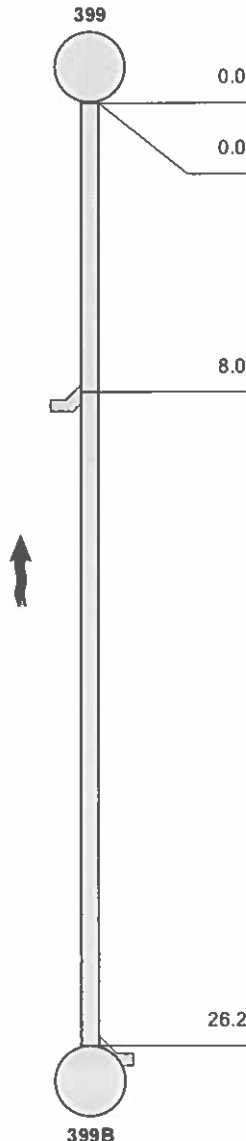
0.0	AMH	Manhole / 399B	00:00:02		
		0.0	MWL	Water Level, 25% of the vertical dimension	00:00:04		
		8.0	TFA	Tap Factory Made Active, at 3 o'clock , 6 inch dim / 438 connection is good 8.05ft from MH 399B	00:05:06		
		26.2	TFA	Tap Factory Made Active, at 9 o'clock , 6 inch dim / 423 connection is good 26.20ft from MH 399B	00:06:02

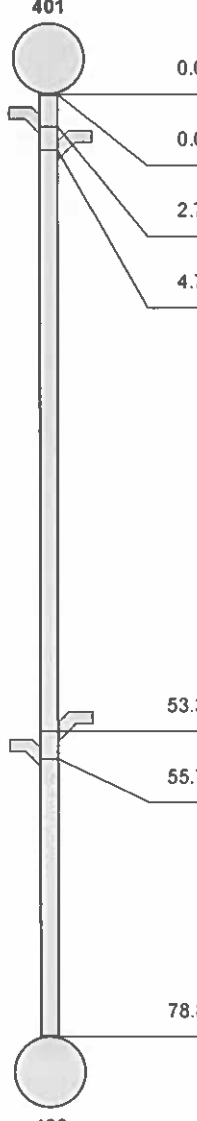
0.0	AMH	Manhole / 401	00:00:00			
	0.0	MWL	Water Level, 25% of the vertical dimension	00:00:02			
	2.7	TFA	Tap Factory Made Active, at 3 o'clock , 6 inch dim / 406? connection is good 2.73ft MH 401	00:02:32			
	4.7	TFB	Tap Factory Made Abandoned, at 9 o'clock , 6 inch dim	00:03:18			
	53.3	TBB	Tap Break-In Abandoned, at 9 o'clock , 6 inch dim	00:05:04			
	55.7	TFA	Tap Factory Made Active, at 3 o'clock , 6 inch dim / 371 connection is good 55.66ft from MH 401	00:05:25			
	78.8	AMH	Manhole / 402	00:07:13

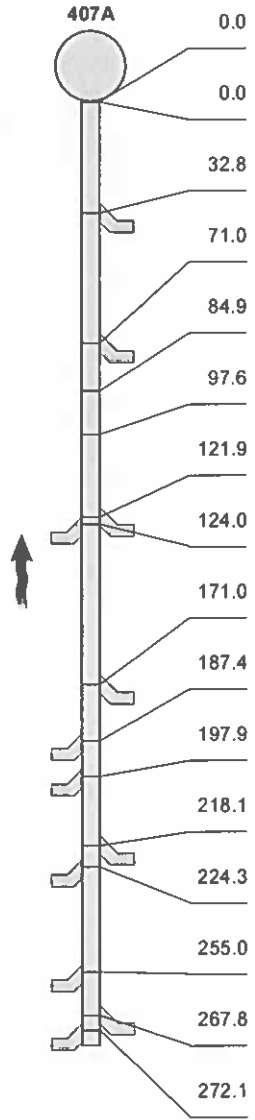
84.9	AMH	Manhole / 407A Heavy Calcium Deposit	00:06:49		
	97.6	CM	Crack Multiple, from 12 o'clock to 4 o'clock	00:07:32		
	121.9	TFC	Tap Factory Made Capped, at 11 o'clock , 6 inch dim	00:09:11

124.0	TFA	Tap Factory Made Active, at 2 o'clock , 6 inch dim / 239 connection is good 123.96ft from MH 407	00:09:33		
	171.0	TFC	Tap Factory Made Capped, at 11 o'clock , 6 inch dim	00:11:21

187.4	TFC	Tap Factory Made Capped, at 2 o'clock , 6 inch dim	00:12:32		
	197.9	TFA	Tap Factory Made Active, at 1 o'clock , 6 inch dim / 233 connection is good 197.93ft from MH 407	00:13:12

218.1	TFC	Tap Factory Made Capped, at 11 o'clock , 6 inch dim	00:14:15		
	224.3	TFA	Tap Factory Made Active, at 1 o'clock , 6 inch dim / 229 connection is good 224.26ft from MH 407	00:14:49

255.0	TFA	Tap Factory Made Active, at 2 o'clock , 6 inch dim / 221 connection is good 254.95ft from MH 407	00:19:28		
	267.8	TFA	Tap Factory Made Active, at 11 o'clock , 6 inch dim / Shoregate	00:20:56

272.1	TFA	Tap Factory Made Active, at 2 o'clock , 6 inch dim / 221? connection is good 272.12 MH 407	00:21:33

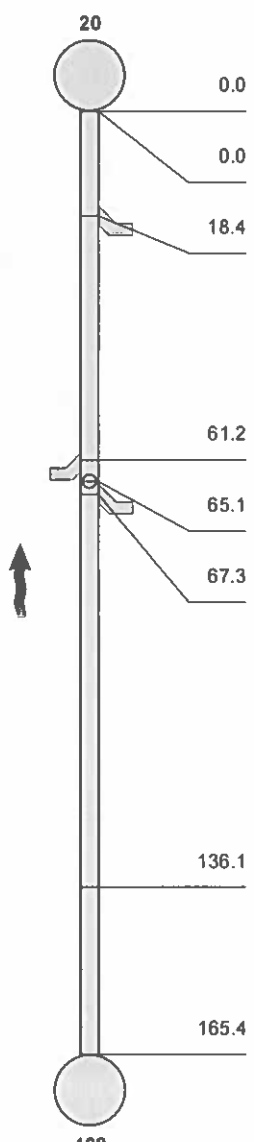
20					
	0.0	AMH	Manhole / 408	00:00:02		
	0.0	MWL	Water Level, 20% of the vertical dimension	00:00:03		
	18.4	TFA	Tap Factory Made Active, at 11 o'clock , 6 inch dim / Shoregate	00:01:41		
	61.2	TFB	Tap Factory Made Abandoned, at 2 o'clock , 6 inch dim	00:07:03		
	65.1	TFB	Tap Factory Made Abandoned, at 12 o'clock , 6 inch dim	00:07:43		
	67.3	TFA	Tap Factory Made Active, at 11 o'clock , 6 inch dim / Shoregate	00:08:17		
	136.1	OBB	Obstacles Brick, 5% of cross sectional area, at 6 o'clock	00:19:44		
	165.4	OBR	Obstacles Rocks, 10% of cross sectional area, at 6 o'clock	00:32:10		
	408
