SECTION 8
APPENDIX

ASBESTOS SURVEY

120 Johnnycake Ridge Road
Painesville, Lake County, Ohio

Prepared for:
CT Consultants, Inc.
8150 Sterling Court
Mentor, Lake County, Ohio 44060

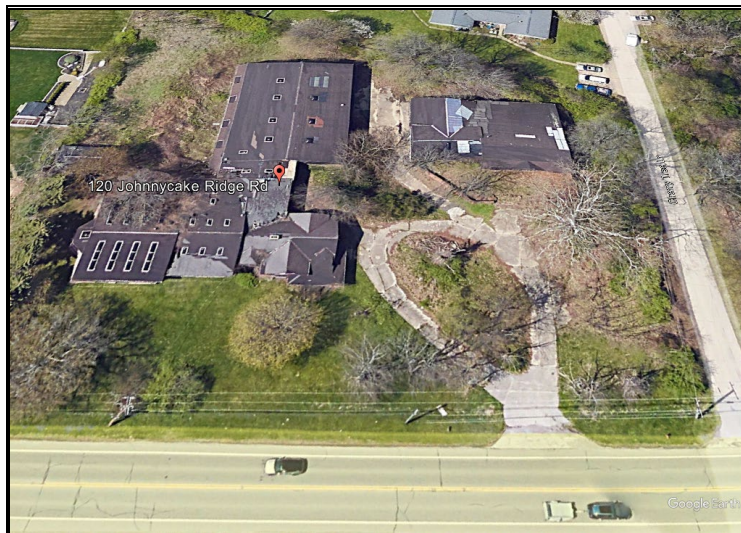
Photograph 01
Aerial of the Structures Located at
120 Johnnycake Ridge Road, Painesville, Lake County, Ohio

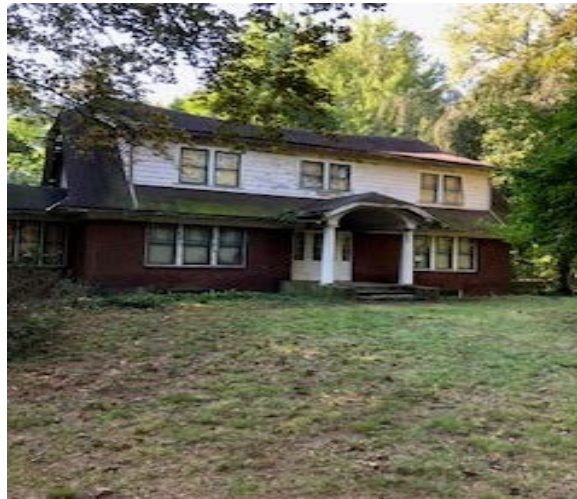
Photograph 01

Exterior View of the Structure Located at
1220 Madison Avenue, Painesville, Lake County, Ohio

During the asbestos survey only the first floor and basement were accessible due to a portion of the roof has collapsed into the second-floor level of the subject structure. Access to the second-floor level was not able to be performed due to the unsafe conditions of the structure. Demolition activities performed at the structure may reveal additional building materials suspected of containing asbestos.

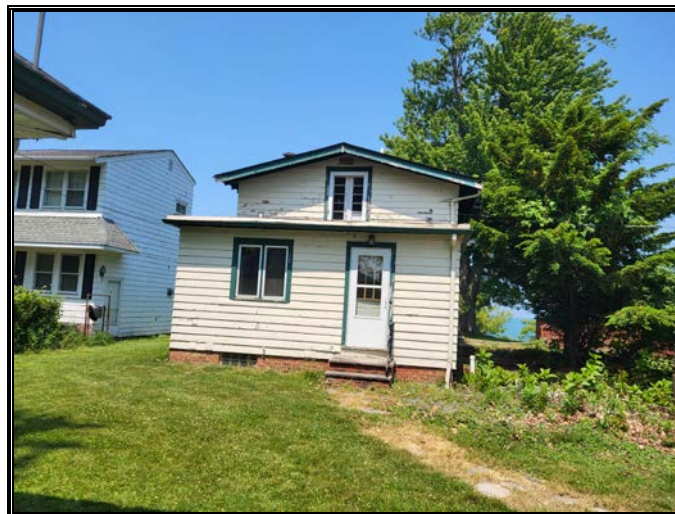
Photograph 01

Exterior View of the Structure Located at
30417 Lakeshore Boulevard, Willowick, Lake County, Ohio

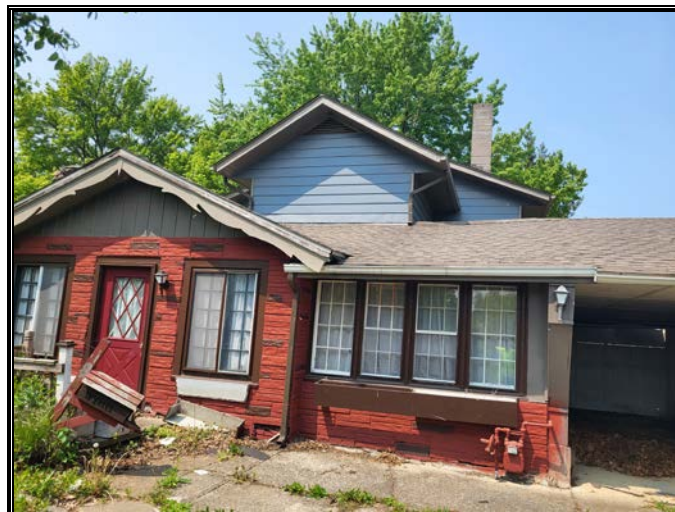
Photograph 01

Exterior View of the Structure Located at
4968 Orchard Road, Mentor, Lake County, Ohio
