Re: *Addendum No. 1*
High Service Area Water Tower Rehabilitation
City of Germantown, Ohio

- Pittsburg Tank & Tower Group - Inspection Report dated June 18, 2019.
- Dixon Engineering - Maintenance Inspection 750,000 Gallon Composite (Route 4) Report dated January 16, 2023.

**City of Germantown
RE: Germantown, OH
750,000 Gallon Composite Tank
Job No. 319262**

750,000 gallon composite (Route 4) elevated water storage tank owned by the City of Germantown, Ohio.

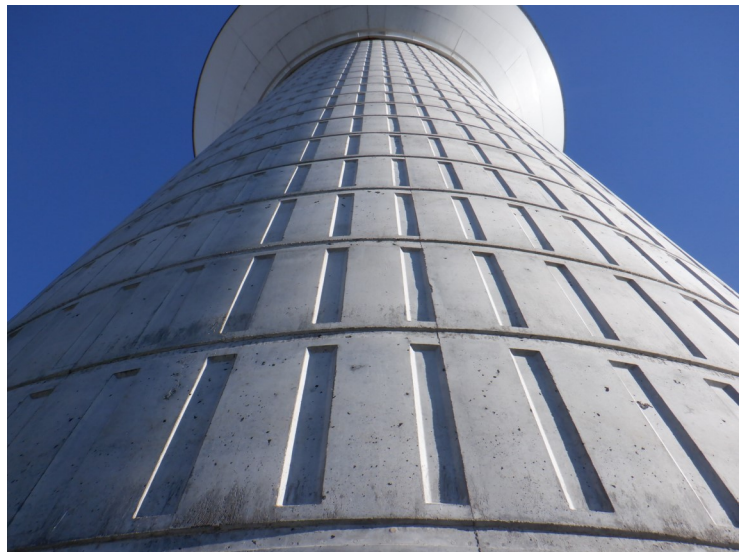
5) The concrete column is in good condition with no deterioration.

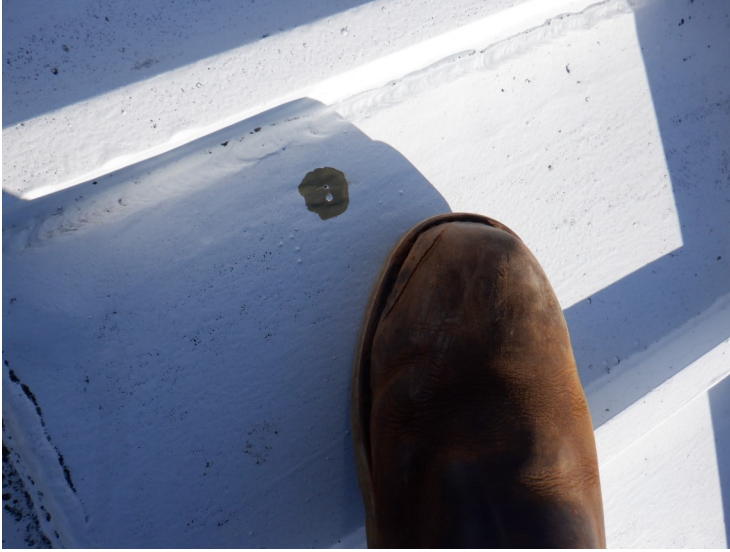
13) There are a few minor coating failures on the roof.

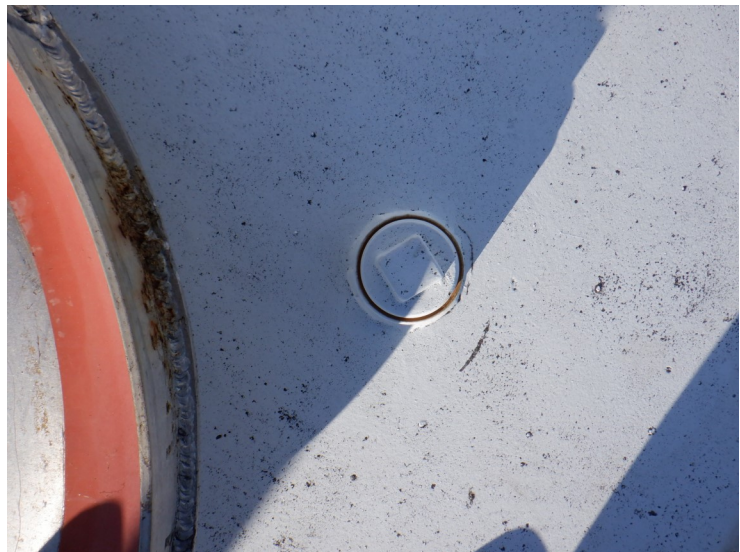
17) The roof rigging couplings are capped.

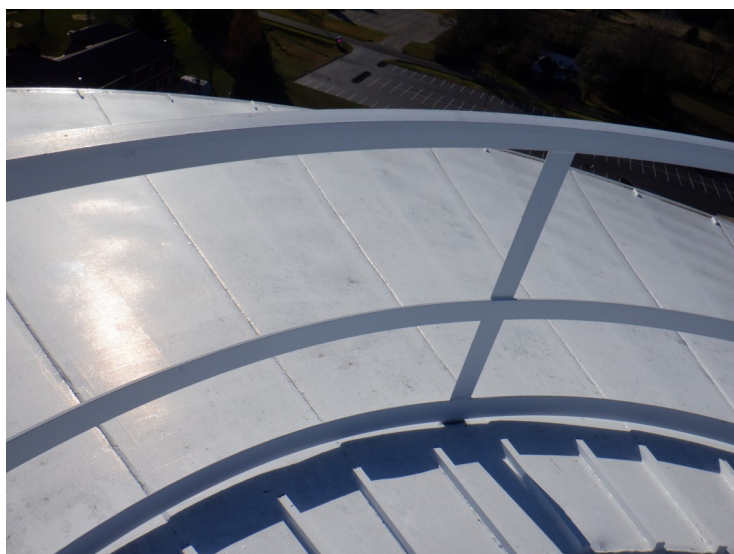
18) The roof handrail is in good condition.

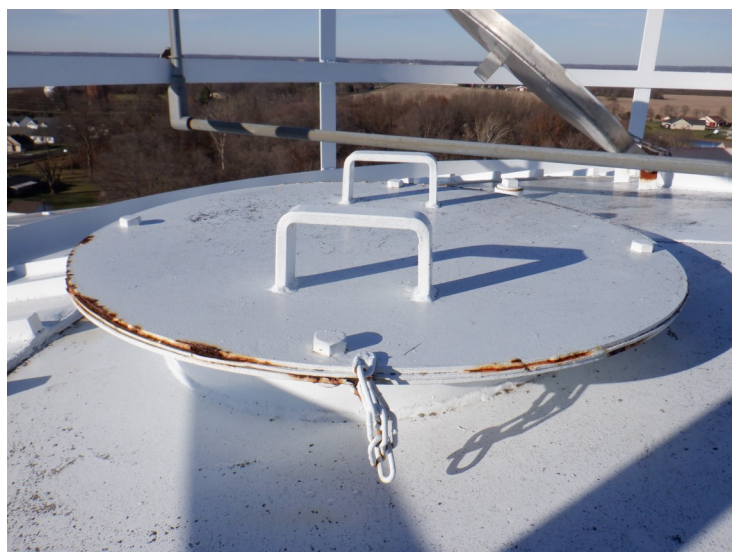
21) There is corrosion at the edges of the bolted ventilation hatch.

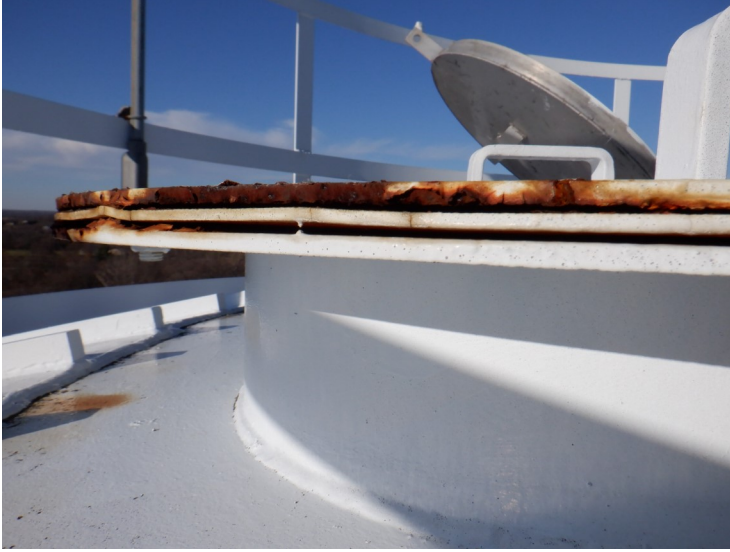
22) There is a gasket on the bolted ventilation hatch.

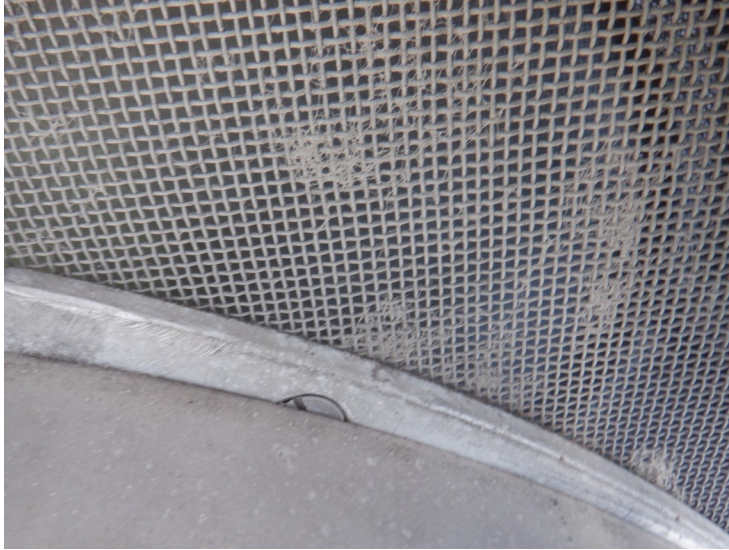
25) The roof vent screened pressure plate is was found to be properly aligned.

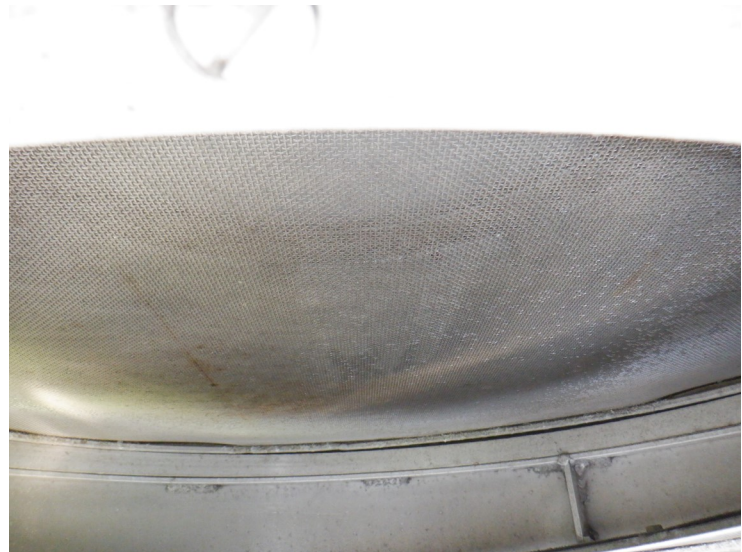
26) The interior roof vent screen is in good condition.

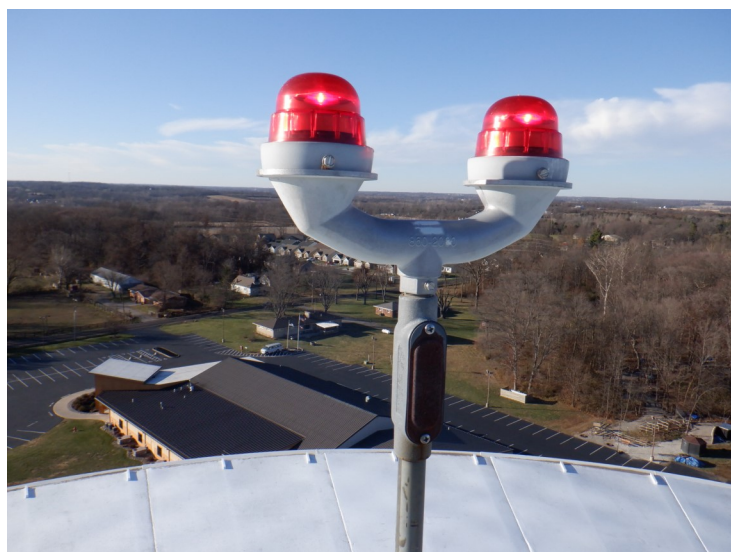
27) The double aviation light is functioning.

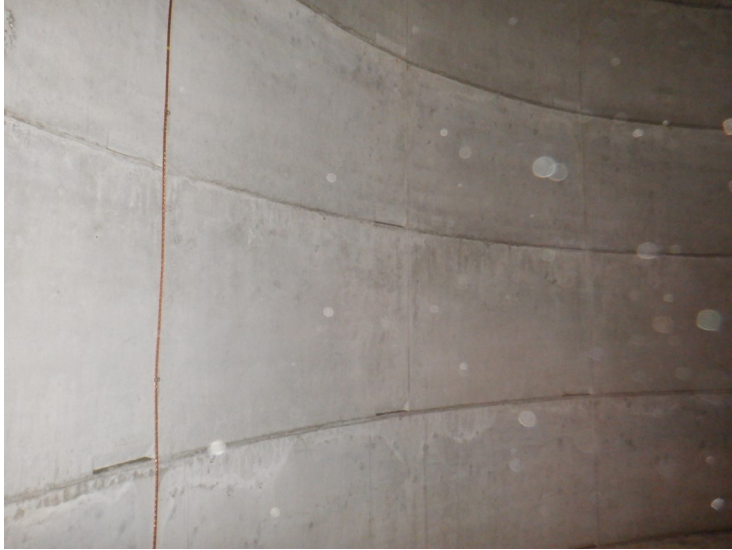
28) The concrete column in the dry interior is in good condition with no deterioration.

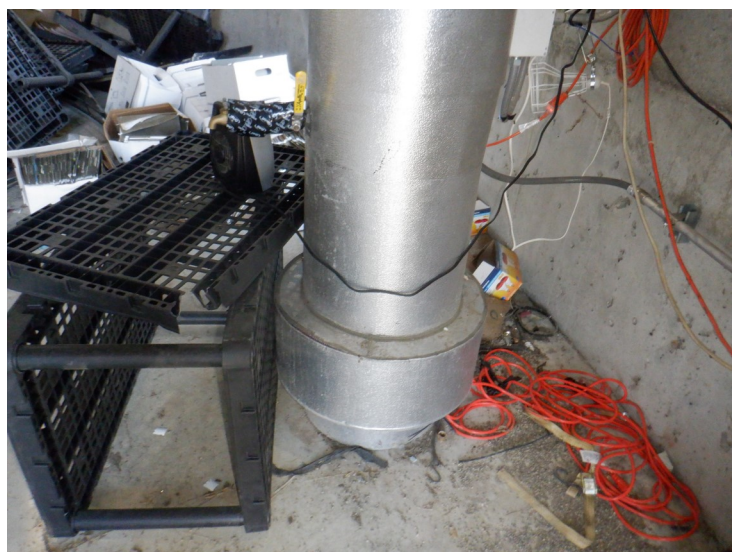
30) The expansion joint at the bottom of the fill/draw pipe is covered with insulation and not accessible for inspection.

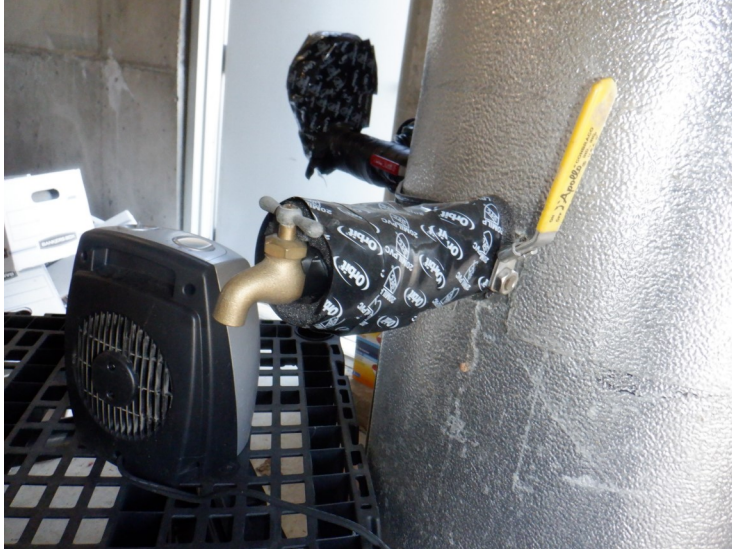
31) The sample tap on the fill/draw pipe is in good condition.

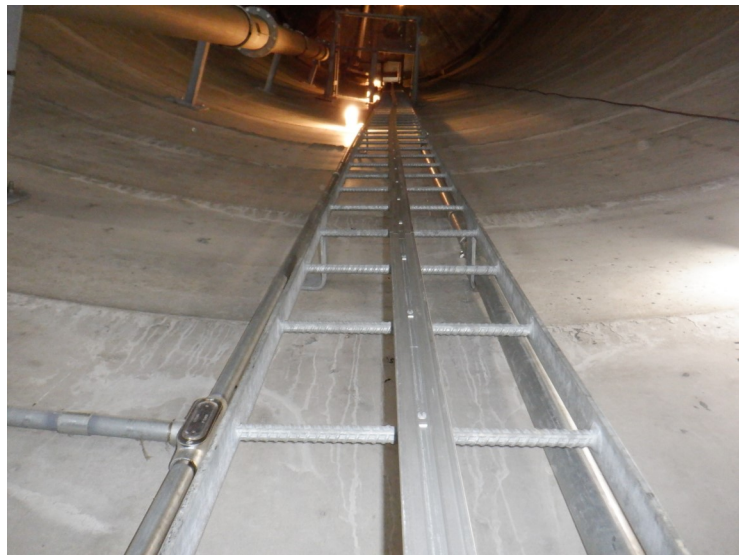
32) The dry interior ladder is in good condition. The ladder is equipped with a fall prevention device.

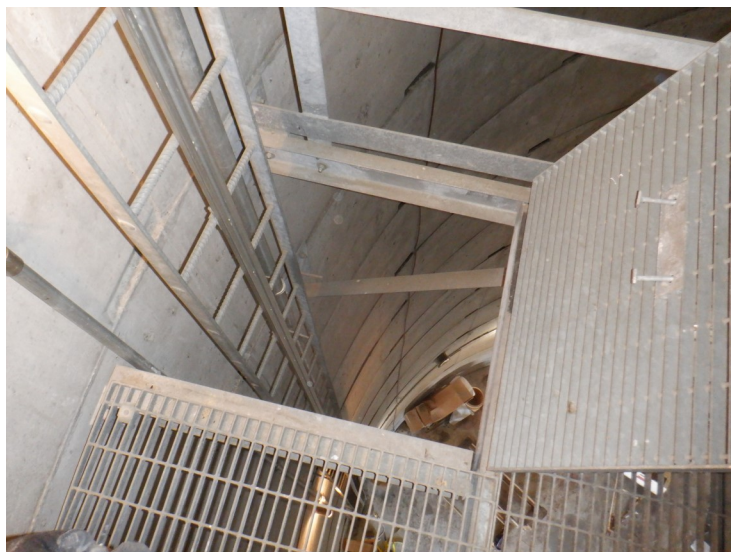
33) The ladder openings at the interior platforms are equipped with hinged covers.

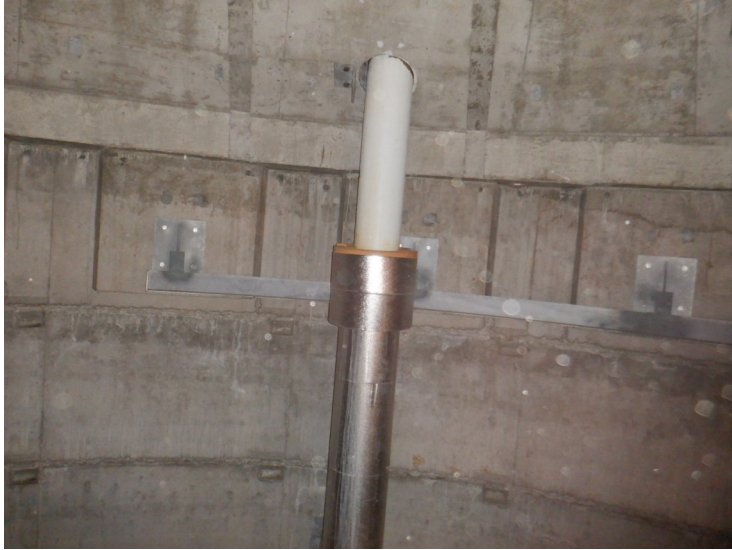
34) The fill/draw pipe insulation and aluminum jacket are in good condition. The painter's railing at the top of the column is in good condition.

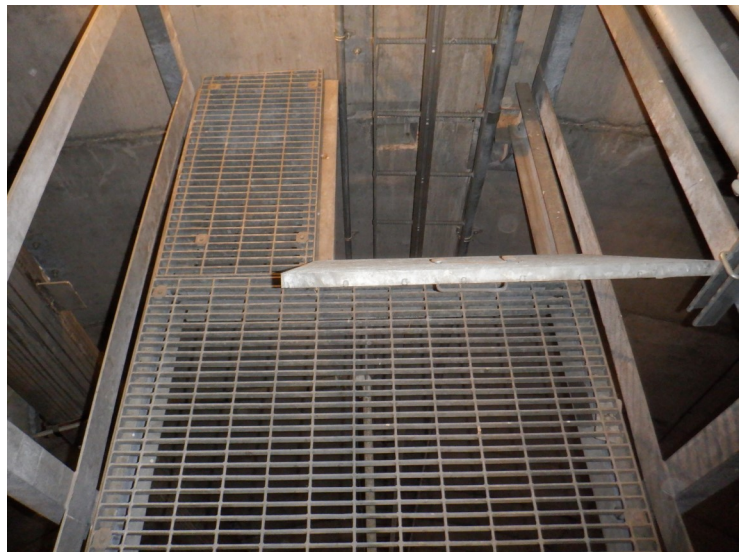
35) The interior platforms are galvanized and in good condition.

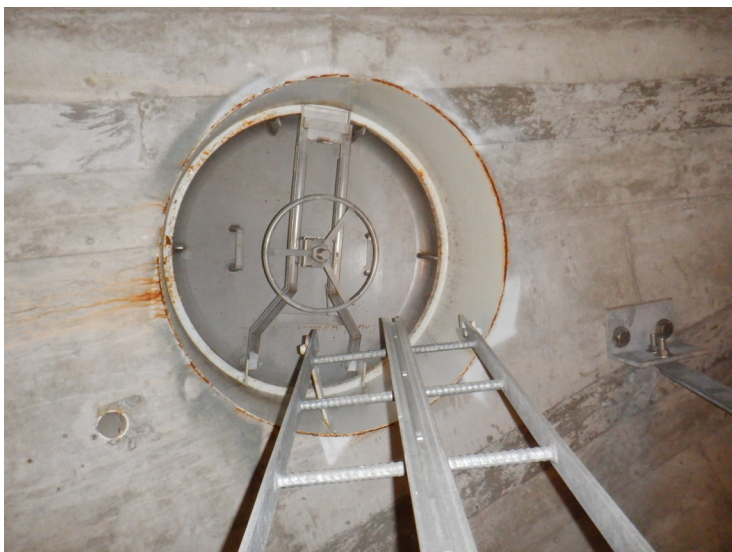
36) The wet interior manway in the domed bottom is in good condition.

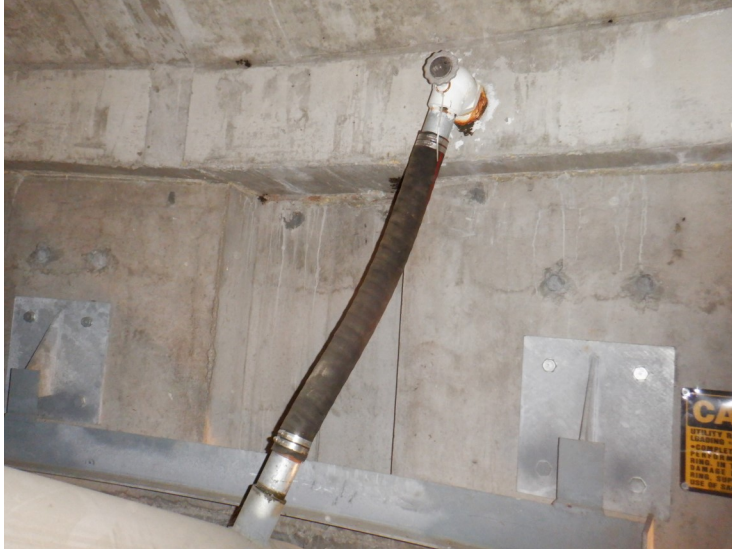
37) The mud valve was not operated during the ROV inspection.

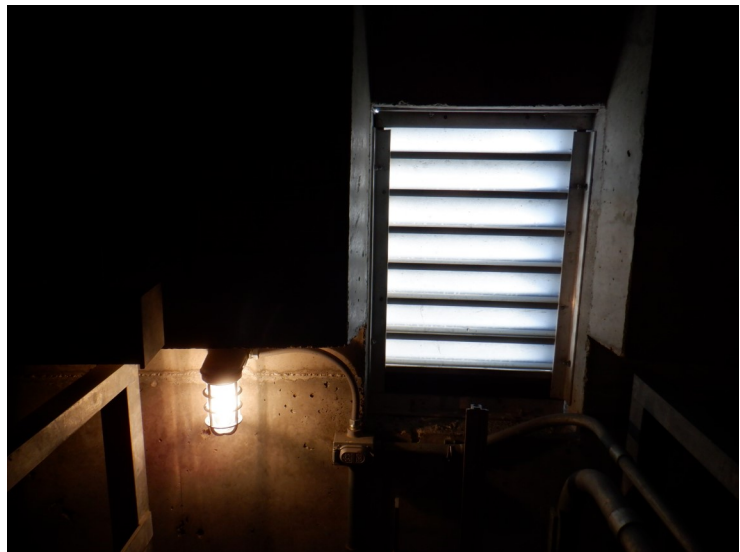
38) The louvered vent at the top of the column is in good condition.

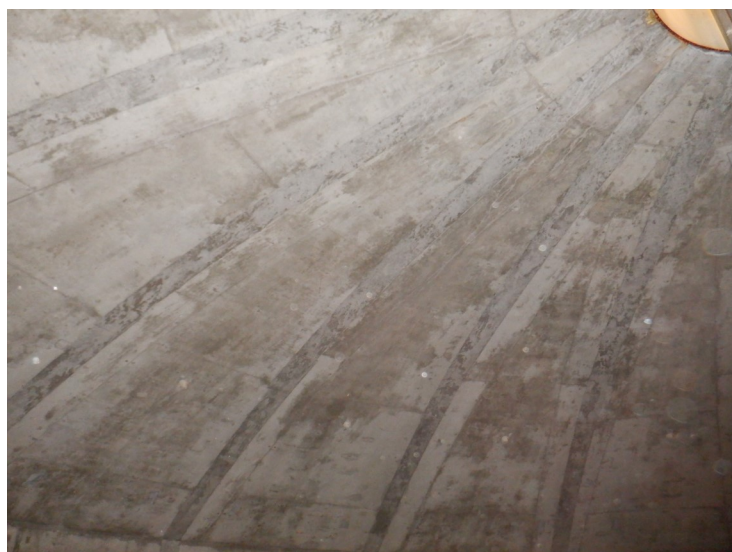
39) There is no concrete deterioration on the domed bottom.

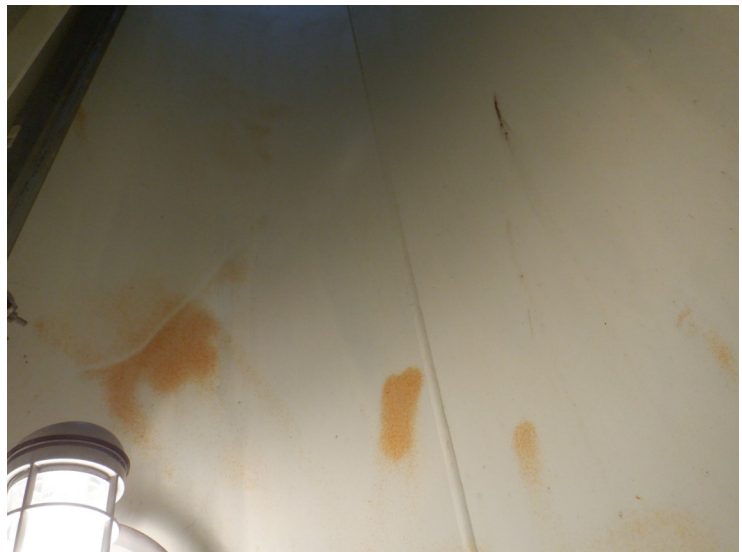
41) There are a few areas of rust bleedthrough in the access tube.

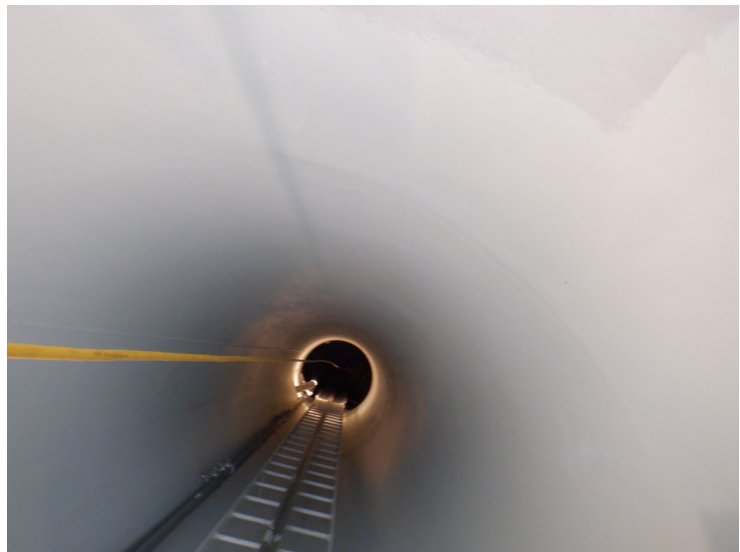
43) Same.

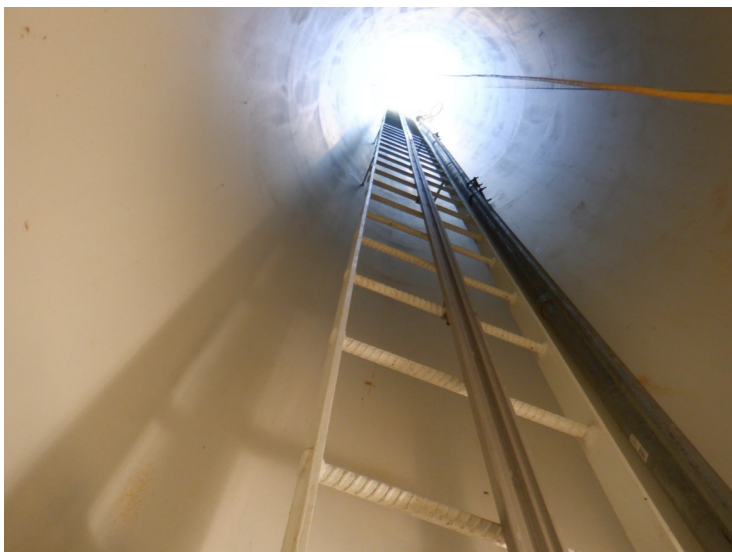
44) The access tube coating is in good condition overall.

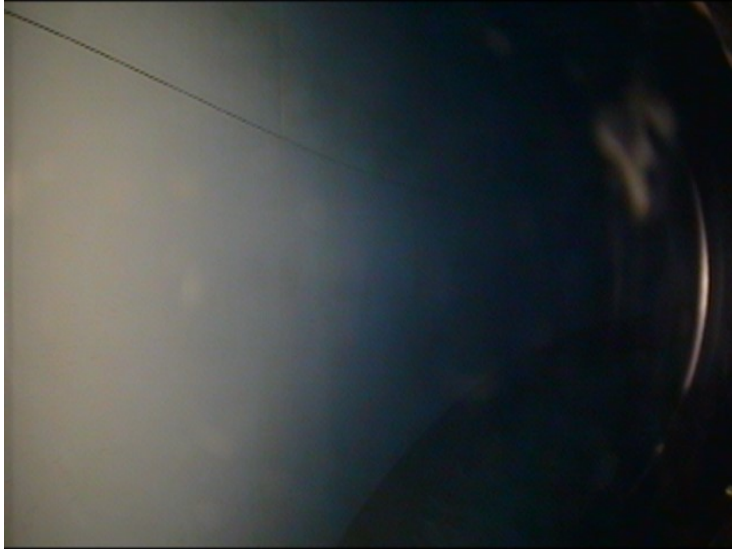
54) Same.

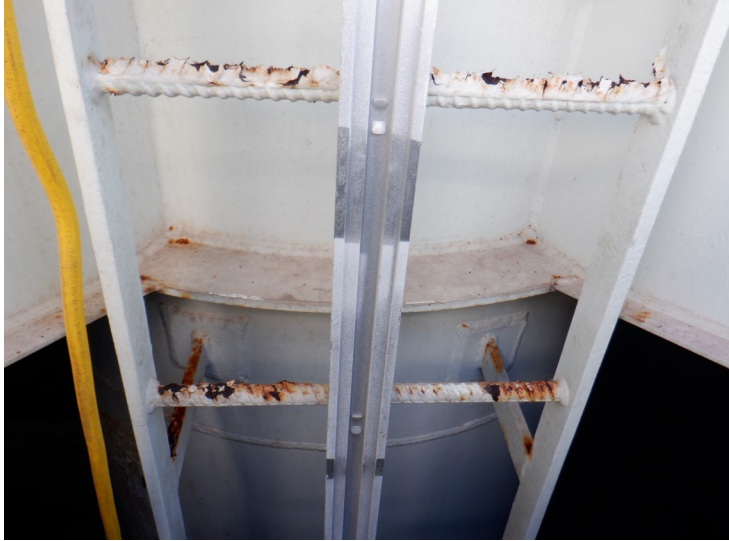
57) Same.

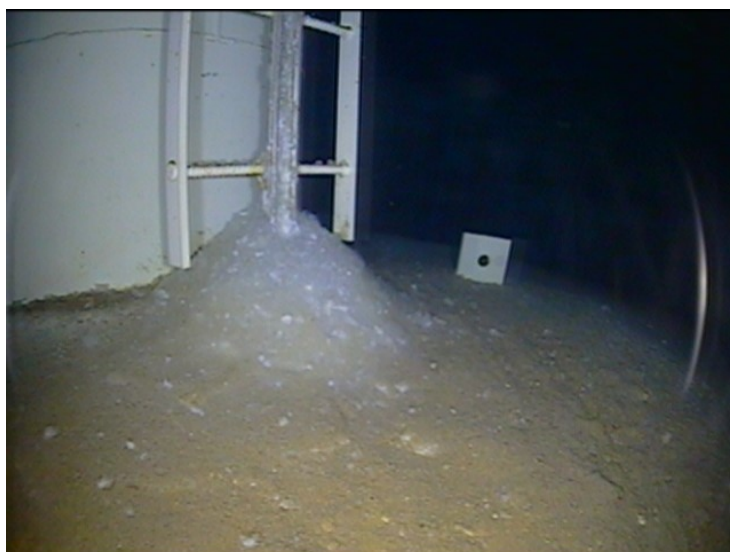
59) The wet interior ladder appears to be in good condition. The ladder is equipped with a fall prevention device.

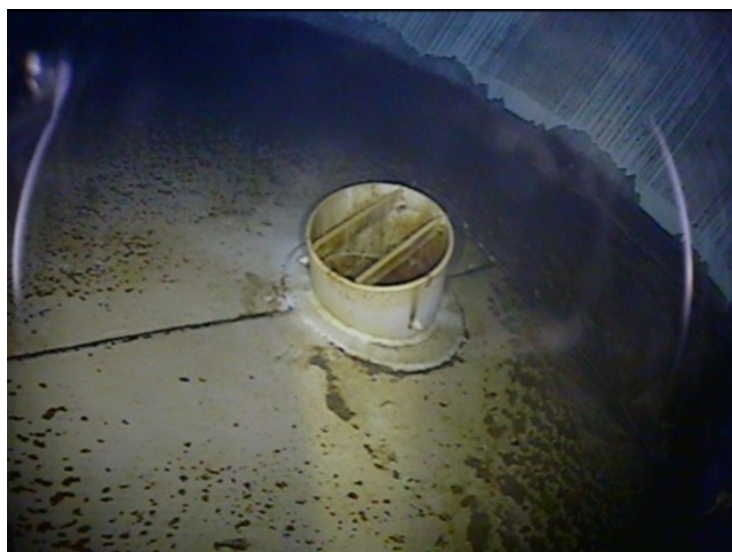
62) The mud valve was not operated during the ROV inspection.
