SECTION 8
APPENDIX

ASBESTOS SURVEY

120 Johnnycake Ridge Road
Painesville, Lake County, Ohio

Prepared for:
CT Consultants, Inc.
8150 Sterling Court
Mentor, Lake County, Ohio 44060

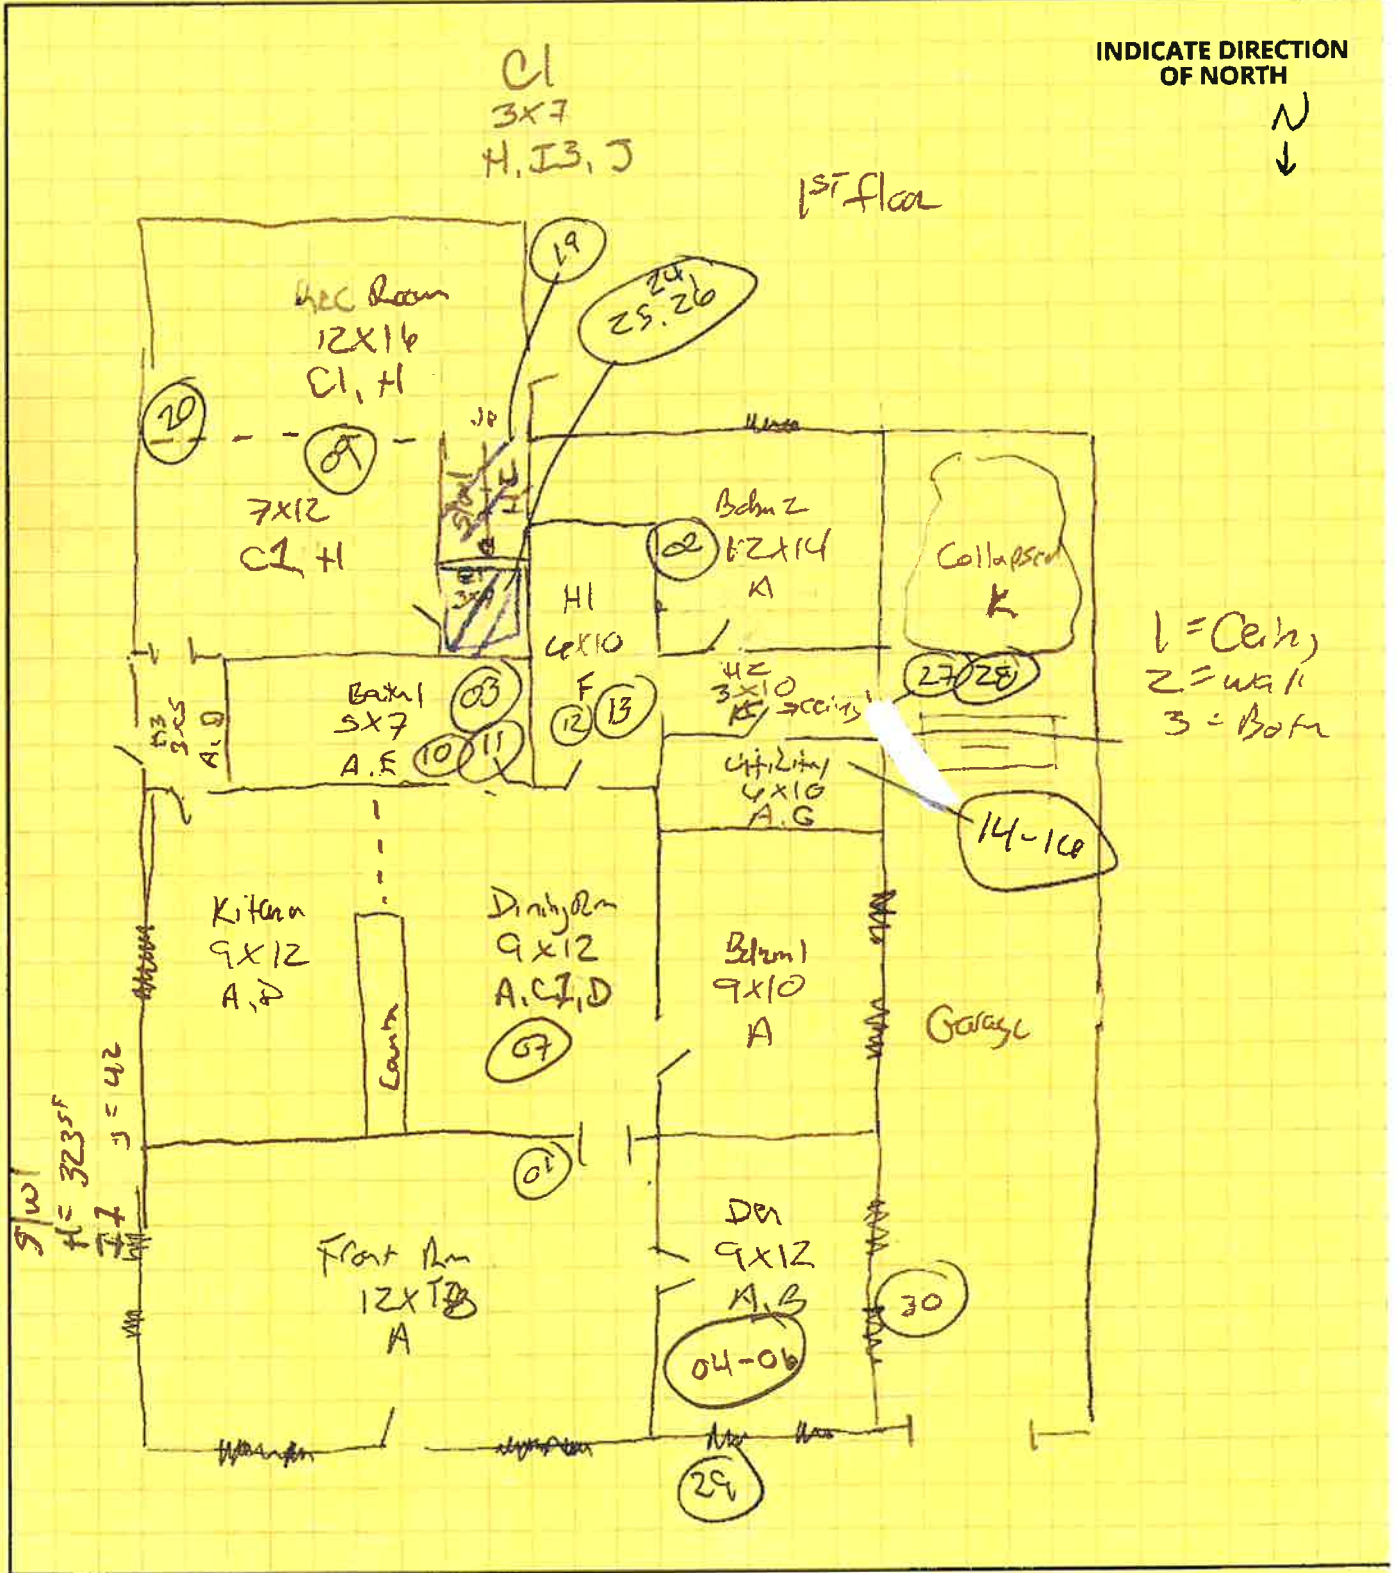
PROJECT 4968 Orchard Rd. Wala
PROJECT NO. HZ1094-08
PAGE NO. _____ OF _____
FIELD REPRESENTATIVE ca DATE 05/24/08
SCALE _____ (W)

HZW’s Asbestos Bulk Sampling Information form and a site sketch documenting the room designations and bulk sampling locations at the subject structure are included as **Attachment 1**. HZW’s Asbestos Bulk Sampling Information form documents the bulk sampling locations, each sample’s characterization (homogeneous area and functional space), sample validation, sample number, AHERA category, quantity/condition (if identified as containing asbestos) and asbestos content for each sample. The building materials highlighted in “red” font on HZW’s Asbestos Bulk Sampling Information form are required to be abated prior to demolition activities being performed. Any building materials identified as containing less than one (1) percent asbestos or any assumed Category I Nonfriable ACMs identified in good condition on HZW’s Asbestos Bulk
