SECTION 6
ABATEMENT/HAZARDOUS MATERIALS

DIVISION 02 EXISTING CONDITIONS – HAZARDOUS MATERIALS ABATEMENT

RE: **Pre-Demolition Hazardous Materials Assessment**
99 Erie Street, Painesville, Ohio
OH45652

EA Group, Mentor, Ohio was contracted by CT Consultants, Inc. to conduct a pre-demolition hazardous materials assessment for the structure at 99 Erie Street in Painesville, Ohio. The assessment activities included a survey for asbestos-containing materials (ACMs); representative sampling of various painted and unpainted building components that would become “demolition debris” for waste characterization purposes (toxicity characteristic leaching procedure [TCLP] for lead); an inventory of non-incandescent lighting and other “universal waste” materials, stored chemicals in large quantities and regulated refrigerants; and, a visual assessment for the presence of underground and above ground storage tanks. This report provides the results of the pre-demolition hazardous materials assessment.

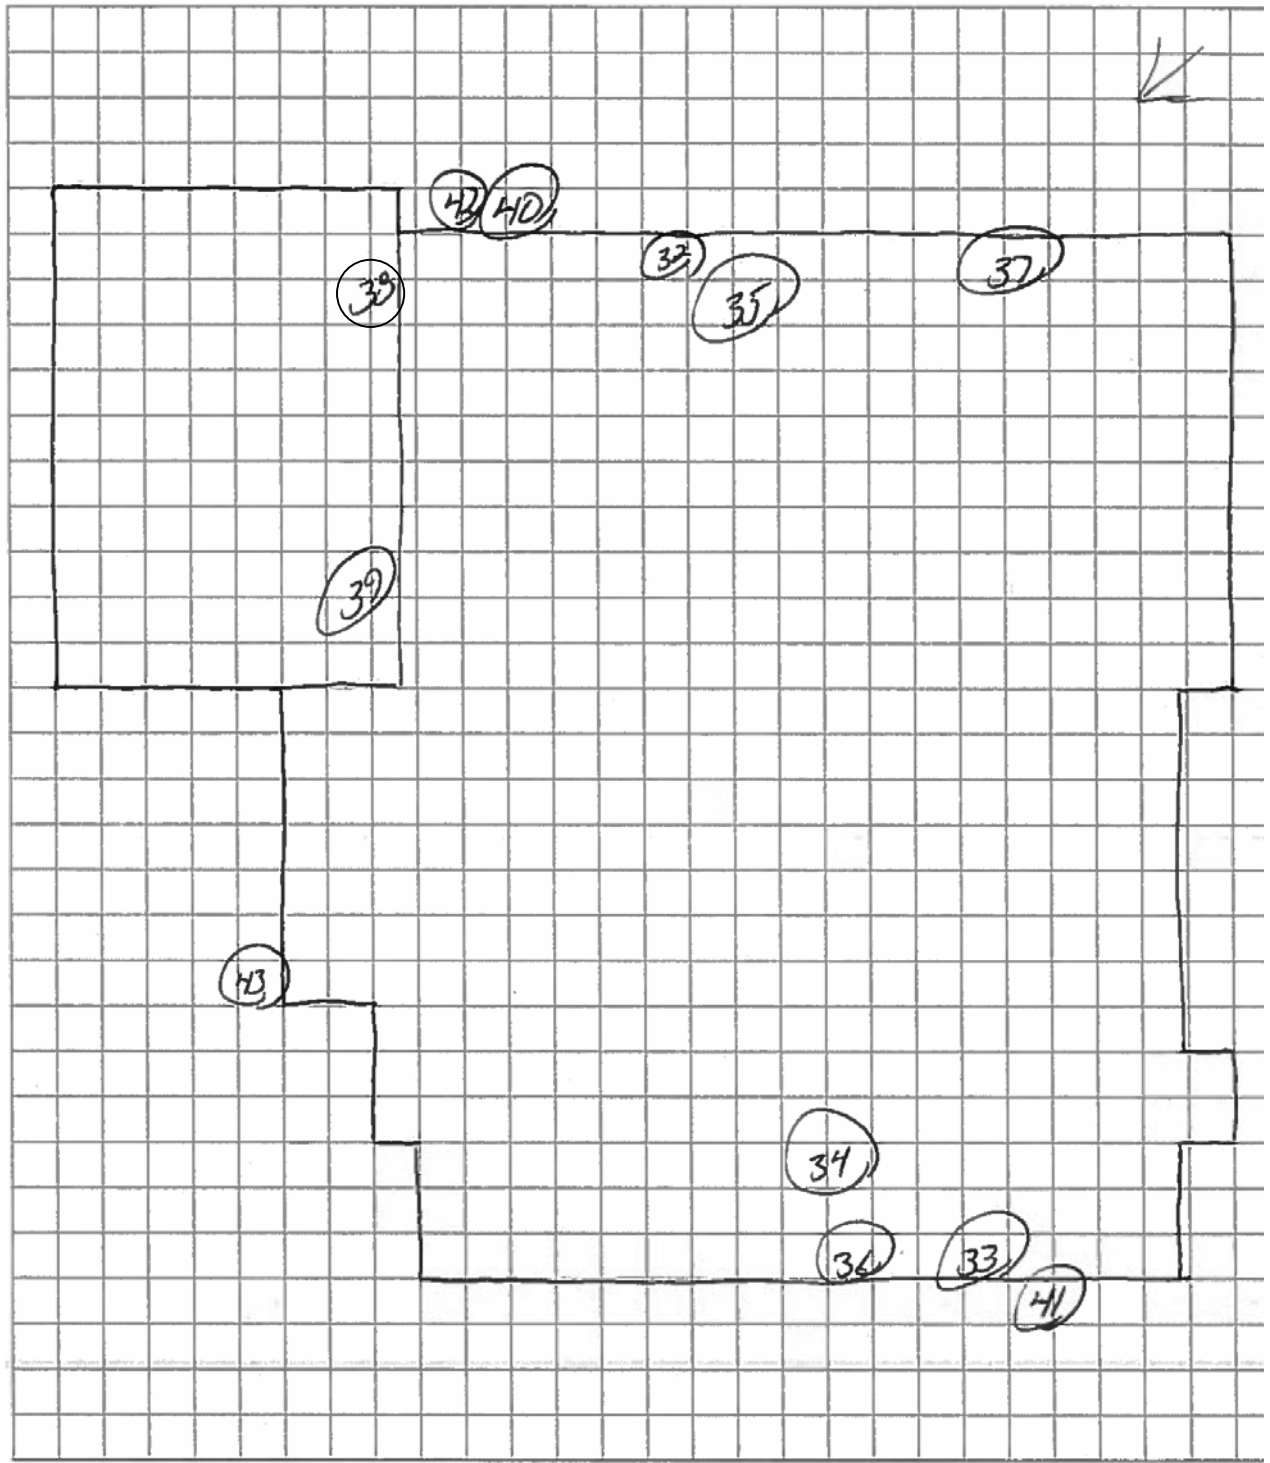
Asbestos Sampling Locations Diagram

Vacated Burger King - Interior
 175 East Erie Street, Painesville, Ohio

DRAWING FOR GENERAL REFERENCE PURPOSES ONLY.
ACTUAL ROOM CONFIGURATIONS MAY DIFFER FROM THOSE
SHOWN; ANNOTATIONS BY EA GROUP.
REFER TO SURVEY FOR DETAILS. NO SCALE.

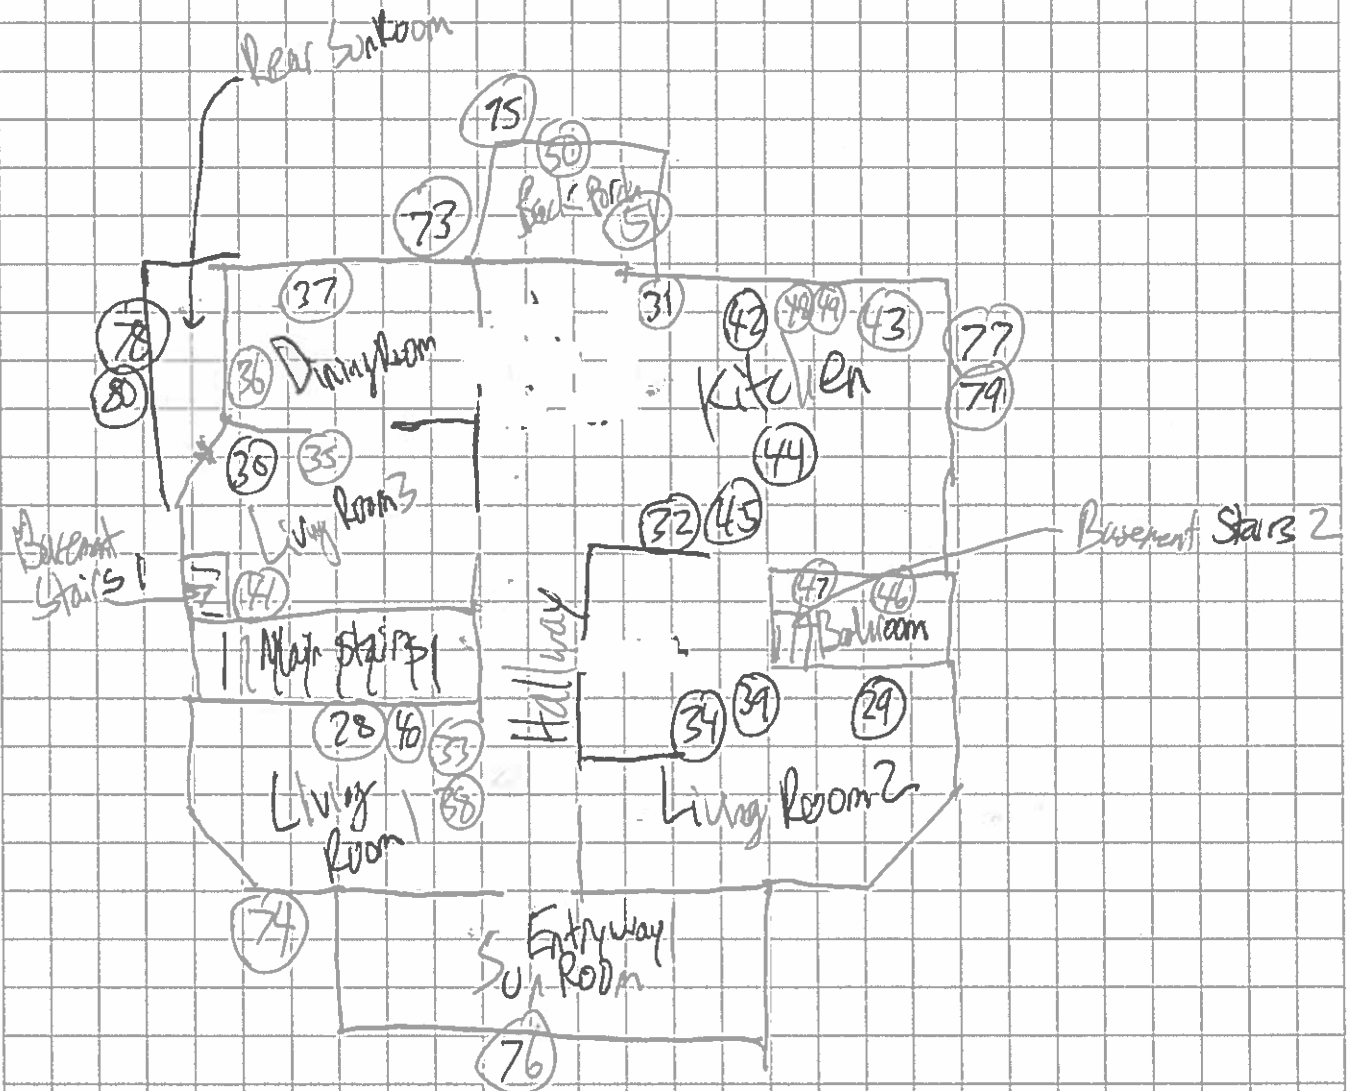
1st Floor

99 Erie St.

EA Group’s licensed Asbestos Hazard Evaluation Specialist Corey Falatic, ES36126, inspected the structure, developed sampling strategies, and procured bulk samples of suspect ACM on September 5 to 8, 2023. Homogeneous Groups of suspect ACM are identified on the *Asbestos Inspection Data Sheet* forms in Appendix A. Classification of any positively identified or assumed ACM has been made per National Emission Standards for Hazardous Air Pollutants (NESHAP) regulations, with notations for compliance with Occupational Safety and Health Administration (OSHA) regulations, if and where applicable. Room/area designations and sampling locations for the survey are provided on the attached schematics.
