Re: *Addendum No. 1*
High Service Area Water Tower Rehabilitation
City of Germantown, Ohio

- Pittsburg Tank & Tower Group - Inspection Report dated June 18, 2019.
- Dixon Engineering - Maintenance Inspection 750,000 Gallon Composite (Route 4) Report dated January 16, 2023.

**City of Germantown
RE: Germantown, OH
750,000 Gallon Composite Tank
Job No. 319262**

750,000 gallon composite (Route 4) elevated water storage tank owned by the City of Germantown, Ohio.

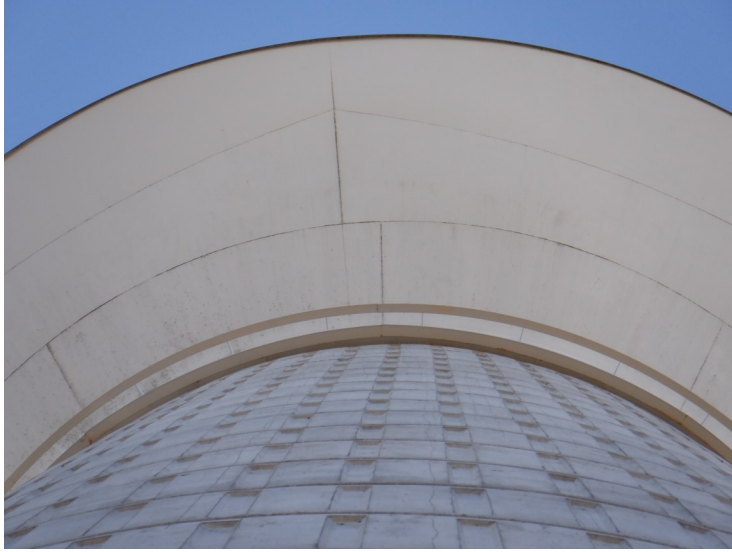
7) There is light mildew growth on the bowl but no significant coating deterioration.

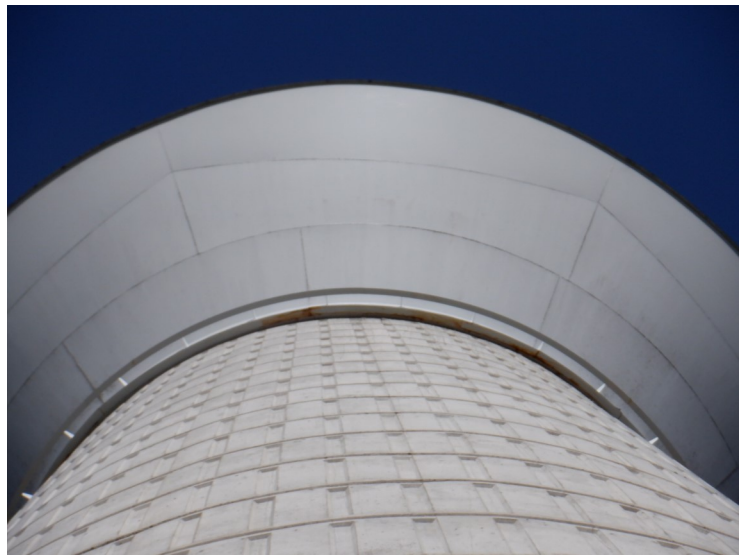
8) Same.

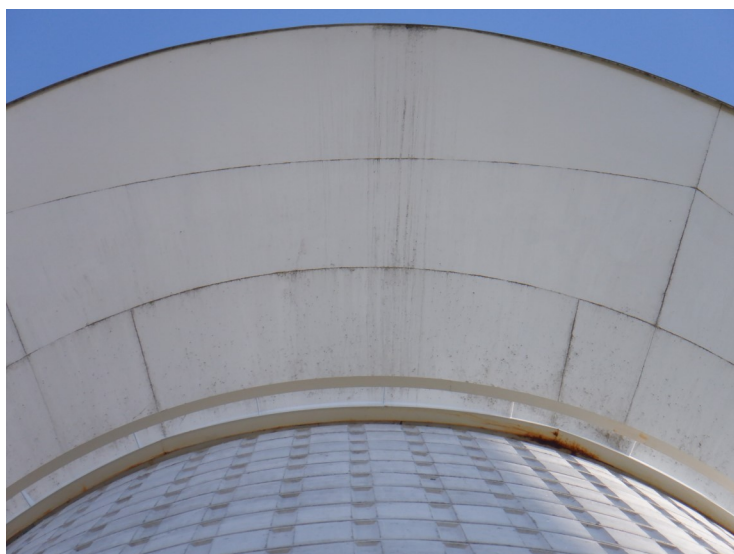
9) Same.

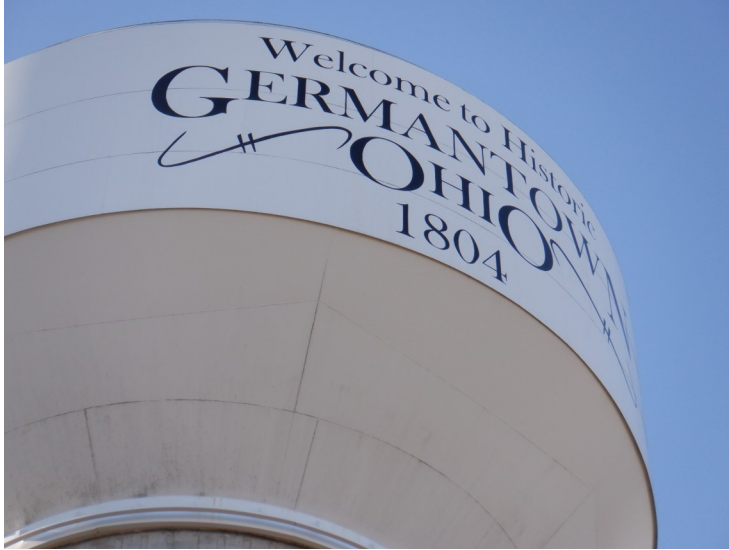
10) The sidewall coating is in good condition with no failures.

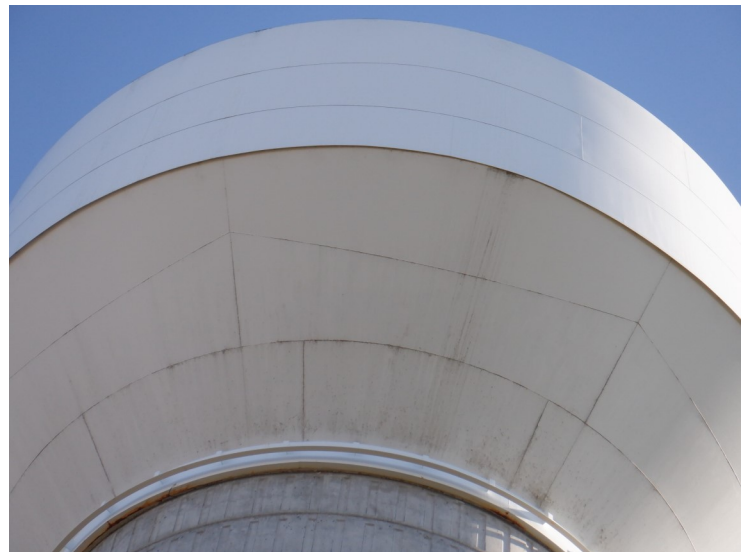
11) Same.

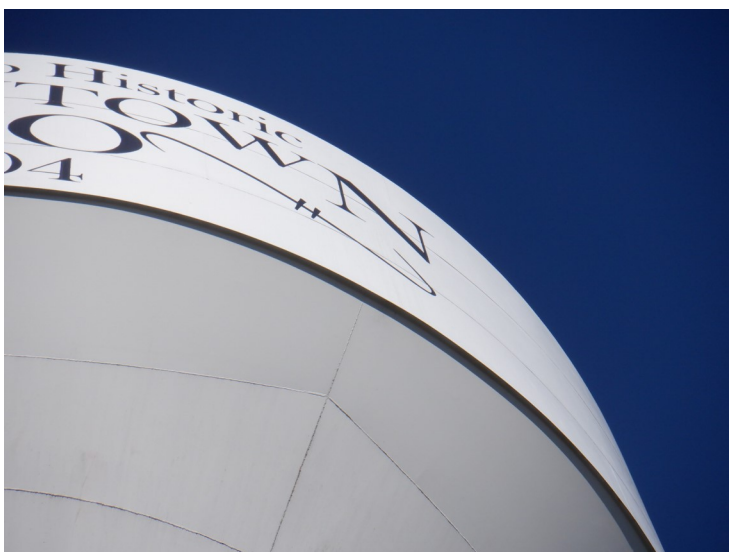
12) Same.

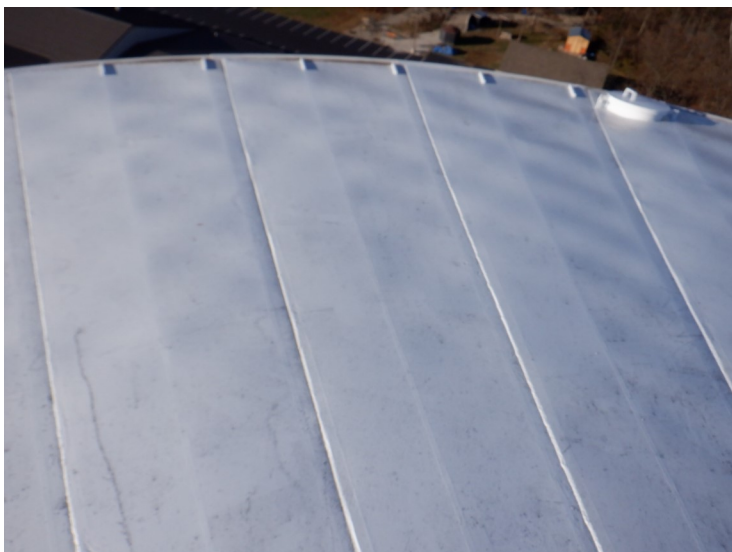
15) Same.

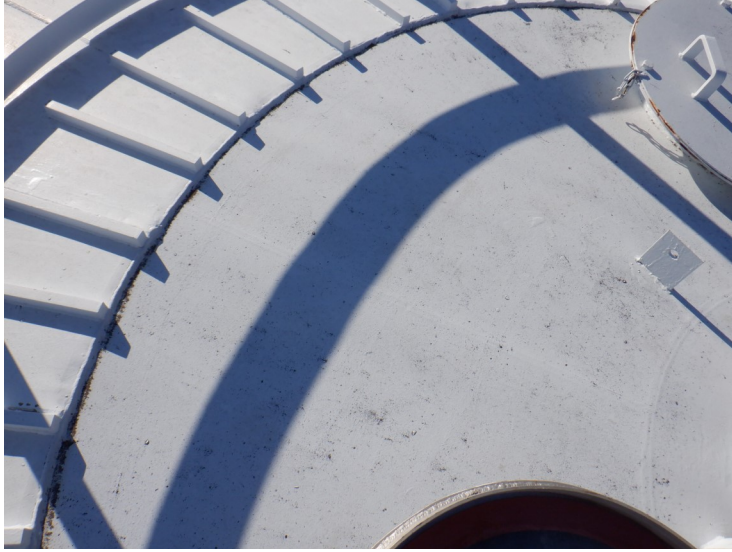
16) Same.

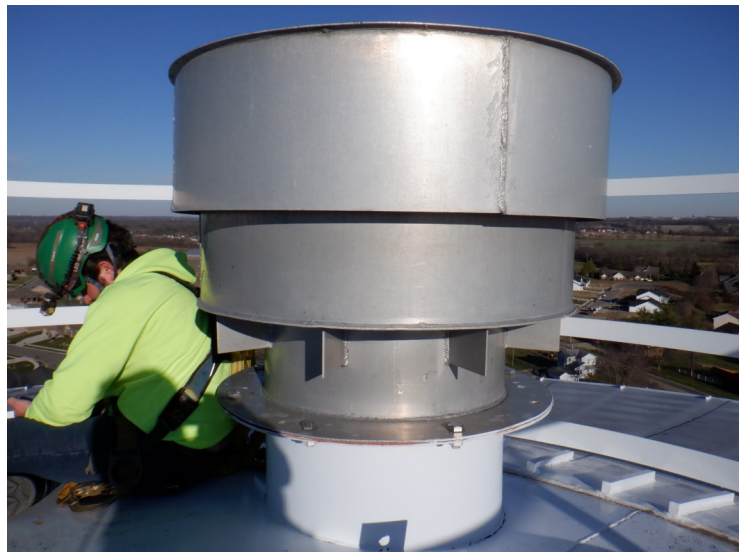
23) The roof vent is in good condition.

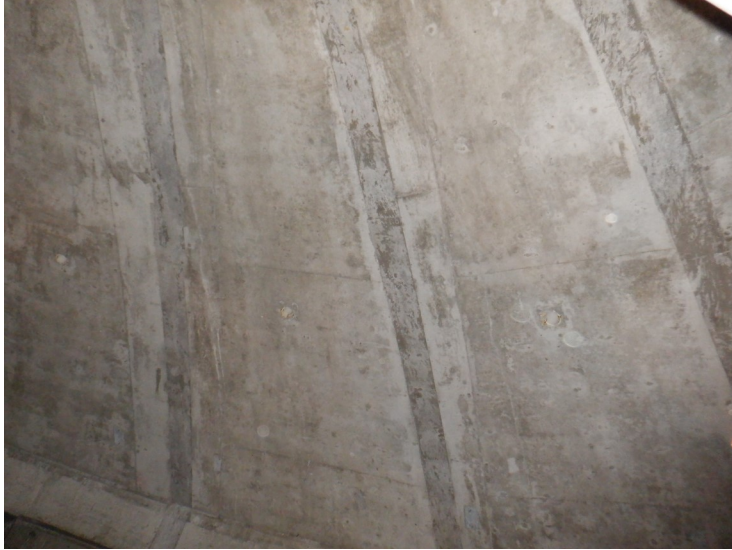
40) Same.

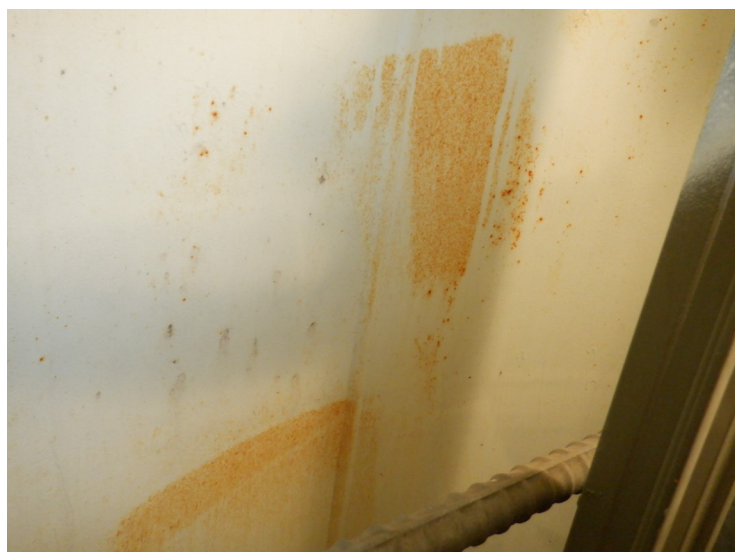
42) Same.

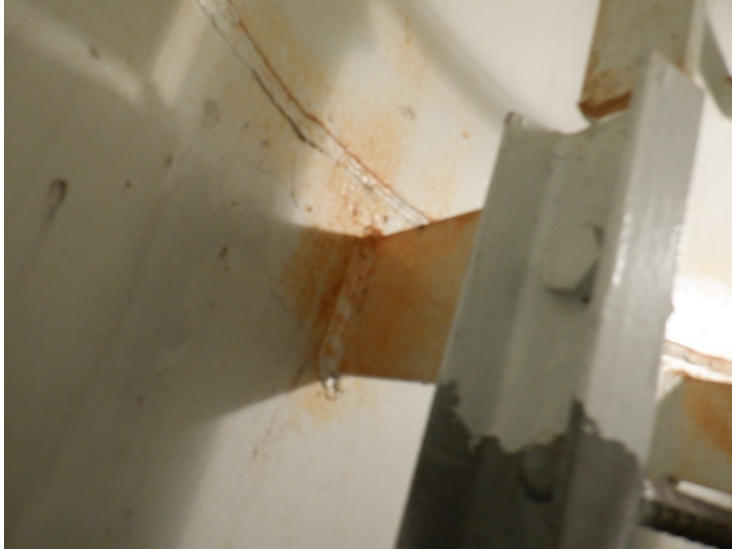
43) Same.

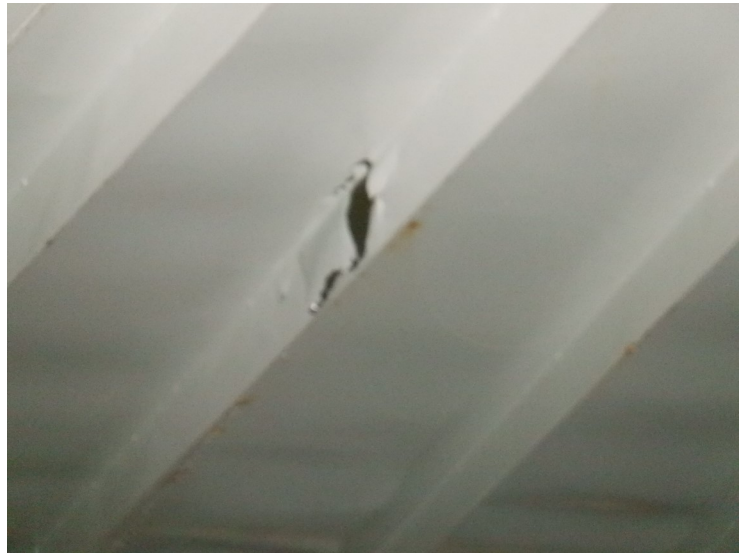
46) There are coating failures on the wet interior roof.

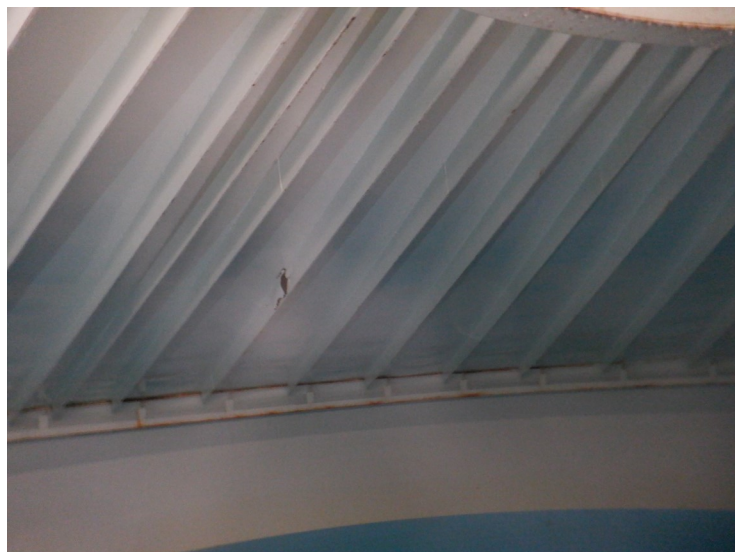
47) Same.

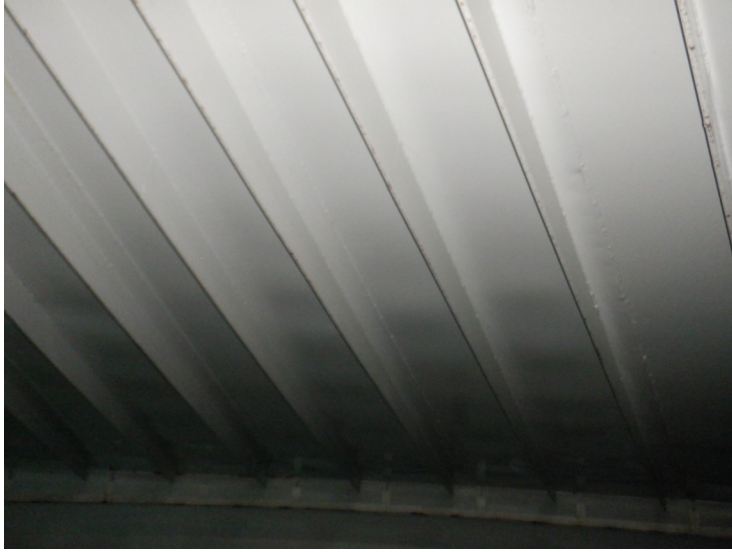
48) Same.

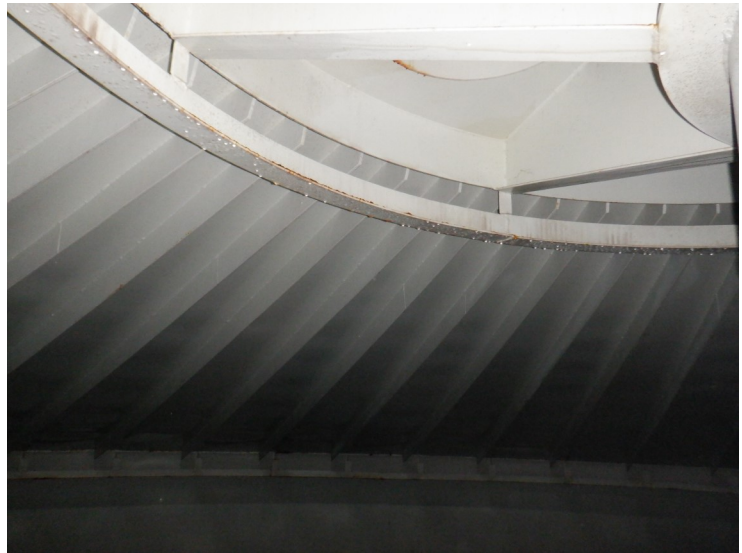
49) The wet interior roof coating is in fair condition overall.

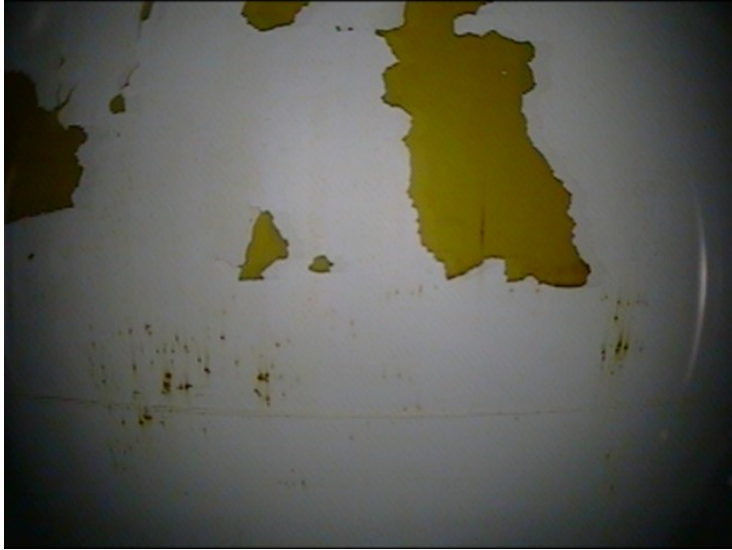
51) There are numerous coating failures on the wet interior sidewall.

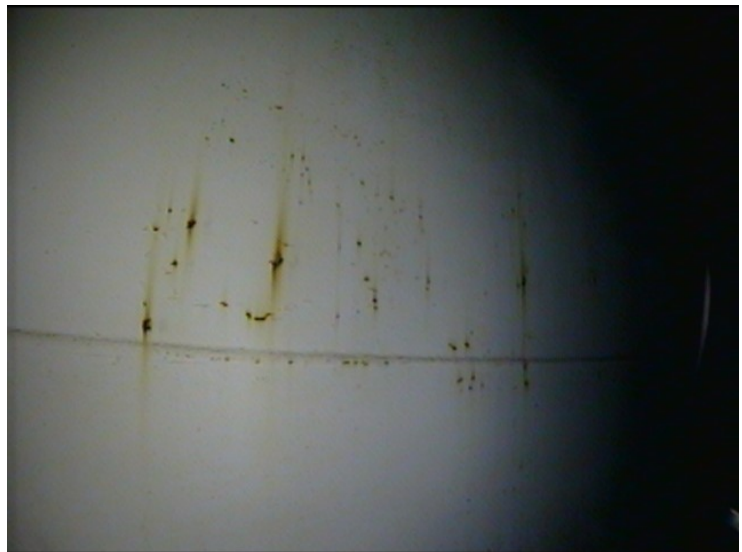
52) Same.

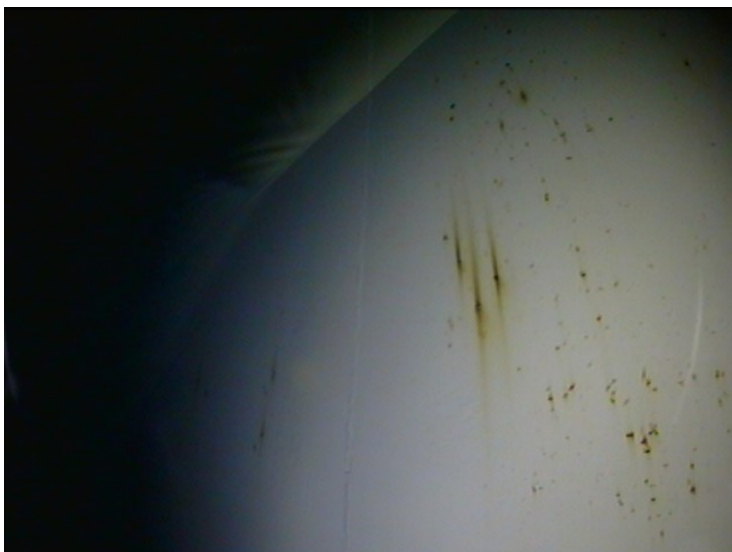
53) Same.

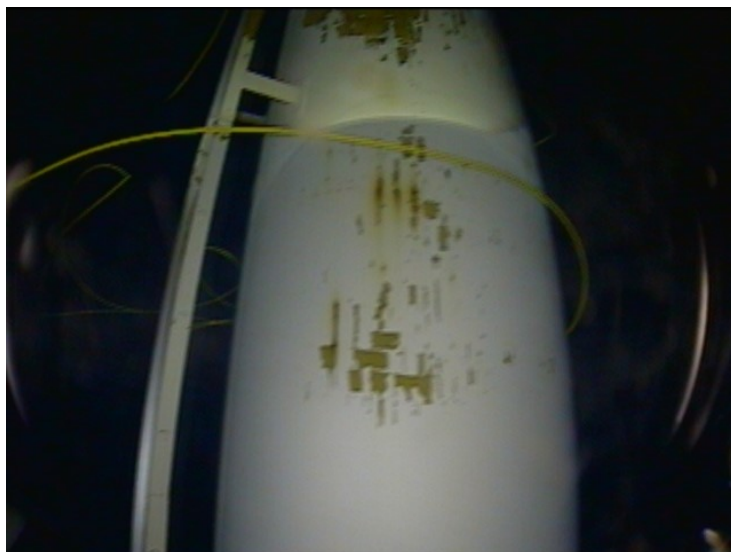
Access tube comments: **Approximately 3/4ths of the way up there is substantial delamination and spot coating failures. Appears to be from ice movement**

56) The access tube coating is in poor condition with multiple failures.

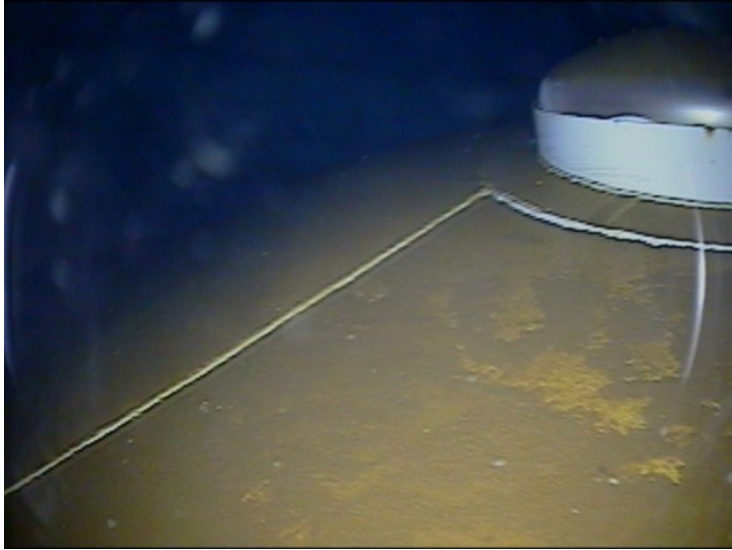
60) The domed bottom was covered in sediment the limited the amount of surface visible with the ROV.

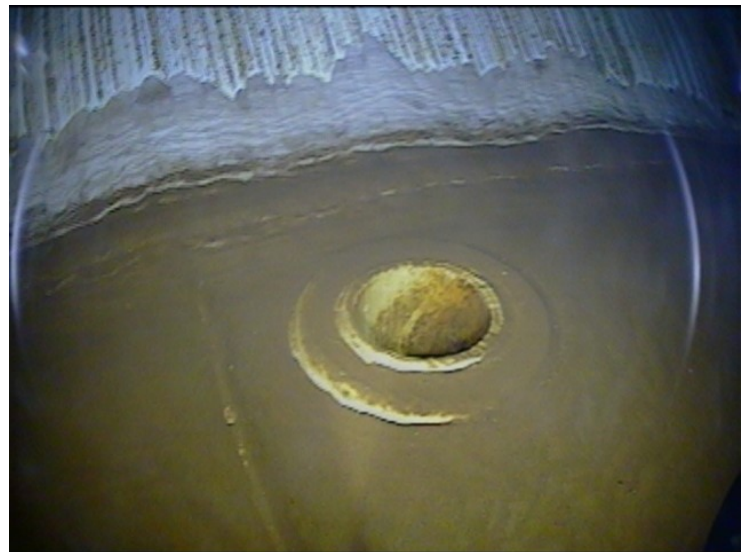
61) Same.
